March 24, 2020

PROPERTY INSPECTION REPORT

Concerning: 222 Lovely Lane, Delightful, TX 75165

By: Nathan Ross, Lic #20282

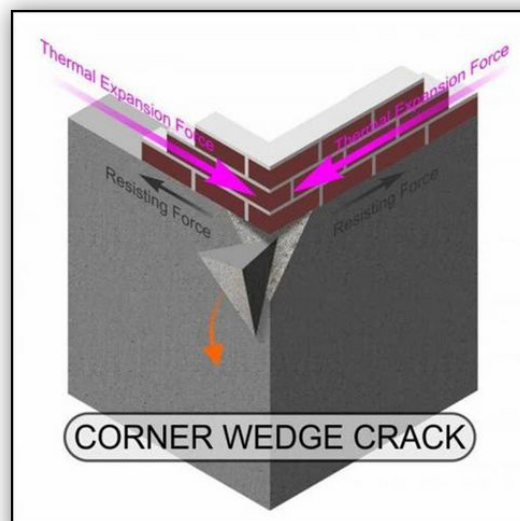
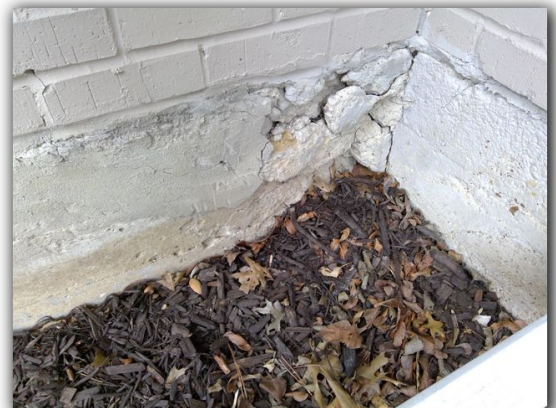
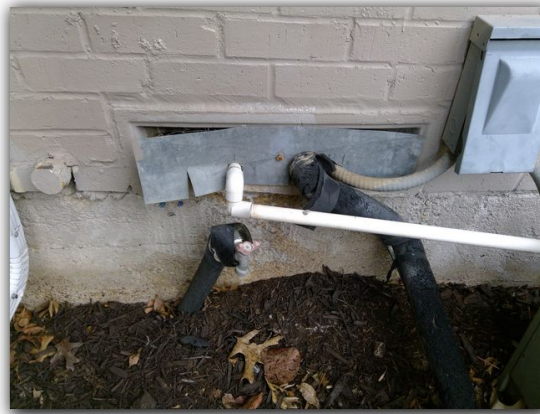
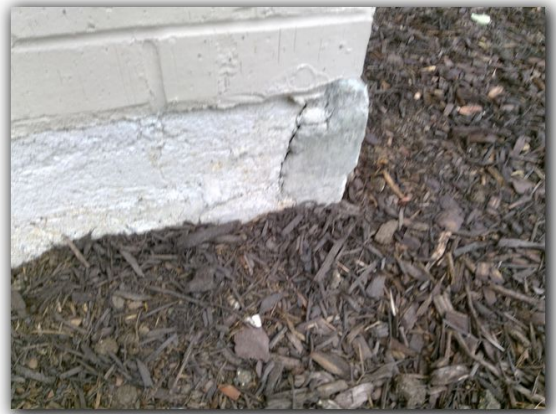
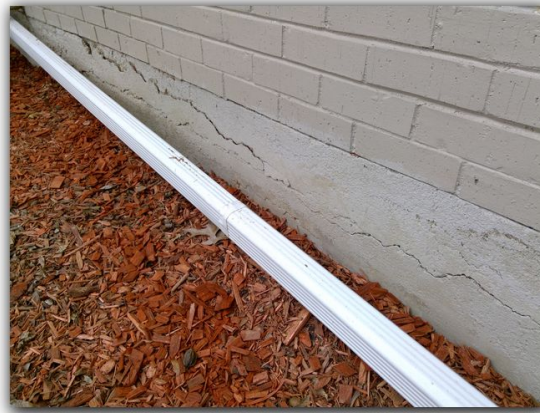
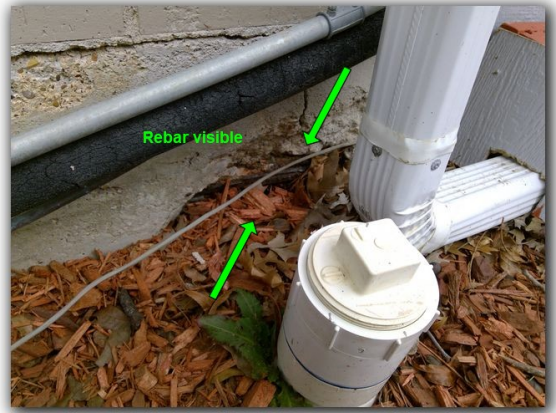
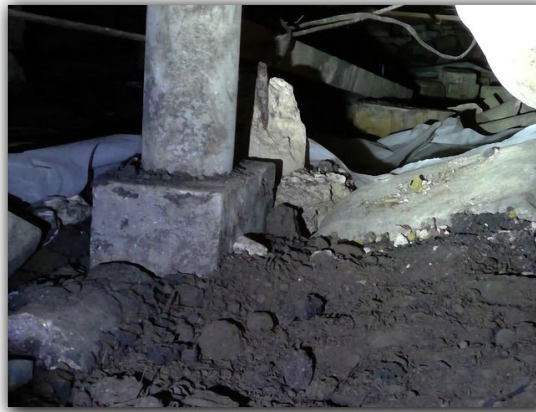
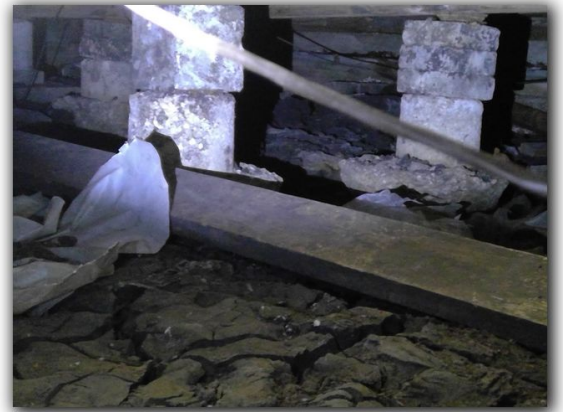
Foundation Needs Further Evaluation

Some of the pier and beam foundation structural components appear to have deficiencies that are beyond normal. The Buyer should have the cause and remedy investigated by a foundation repair company familiar with pier and beam type structures. The observations made to support the rendering of this opinion are listed but may not be limited to the following:

- **Note:** Previous repairs to the foundation components were observed. The homeowner should be consulted on the previous foundation work performed and possible warranty information that may apply.

- **Note:** Tree(s) in close proximity of the foundation was observed. Client should consider the installation of a root barrier to reduce the possibility of damage to the foundation from tree roots and moisture removal.

- All wood debris and/or trash should be removed from the crawl space.
- The crawl space does not appear to be adequately ventilated. Proper ventilation will help to control humidity and reduce the potential for rot. This condition should be further evaluated and corrected as necessary.

- Obstructed crawl space wall vents should be cleared and/or opened to help improve ventilation.
- One or more of the foundation perimeter beam corners were observed to be sheared off (corner pop). This is a common condition to observe and is do to thermal expansion and contraction of the different building materials. This condition does not adversely affect the foundation performance. However, in some cases, some cosmetic improvements may be necessary.

- Stress crack(s) were observed in the exterior foundation perimeter beam.
- The foundation rebar is visible at the edge of the foundation beam and needs to be properly covered on the south side of the structure.

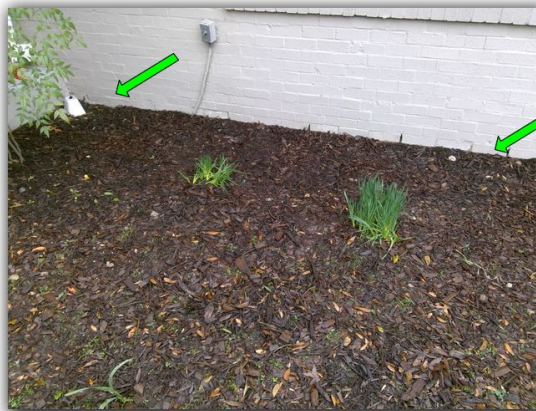
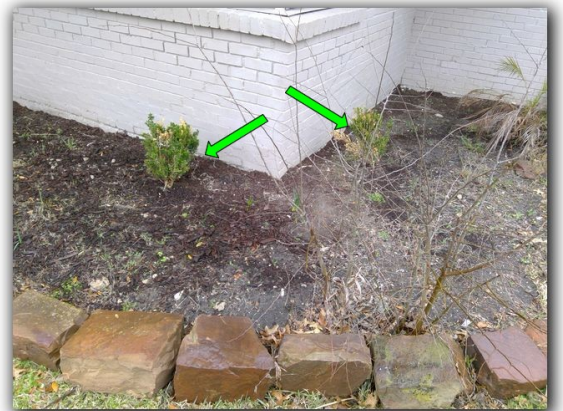
Grading & Drainage

- The soil line is too high on the north side, west side of the structure. Under current building standards there should be at least 4-inches of foundation visible below masonry veneer and 6-inches of foundation visible below wood type veneer.

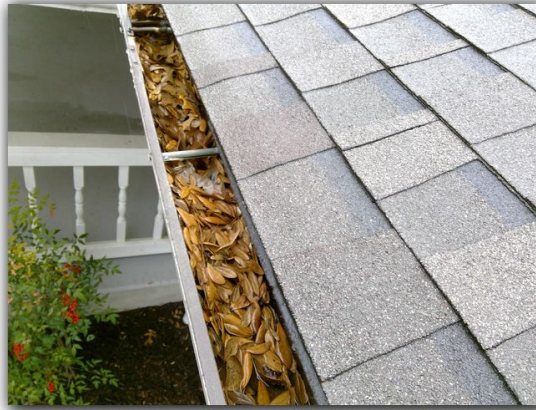
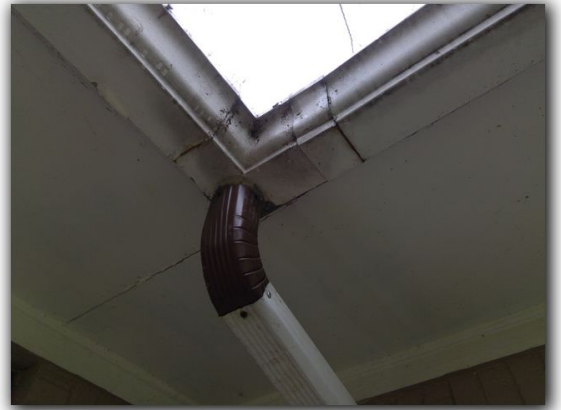
Gutter & Downspout System

- Minor leaks in the gutter joints and seams should be repaired.
- The gutters require cleaning.
- The gutters do not appear to have sufficient slope to drain properly on the north, east, west and south sides of the roof structure. If they do not perform as intended, the slope should be adjusted.
- **Note:** The gutter downspouts should discharge water at least thirty-six inches (36") away from the foundation perimeter beam. Storm water should be encouraged to flow away from the structure at the points of discharge.

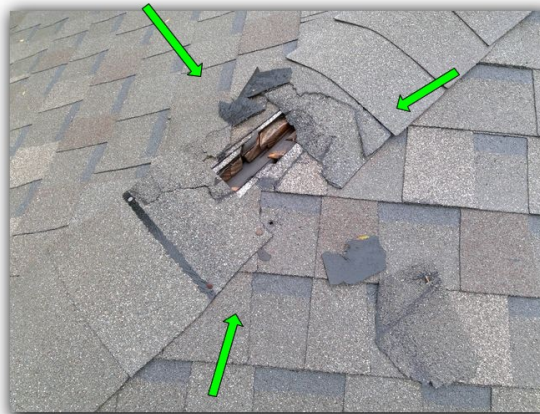
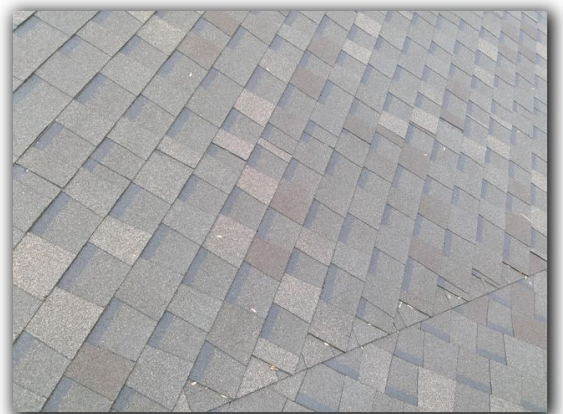
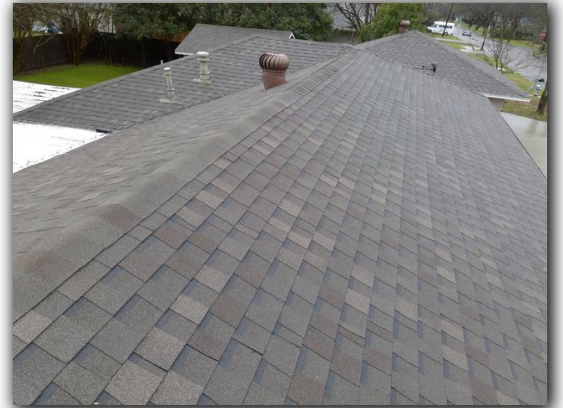
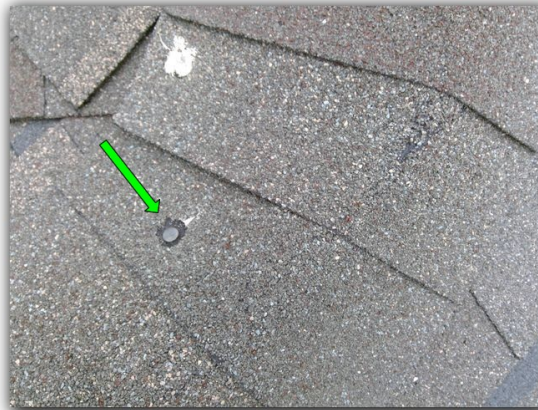
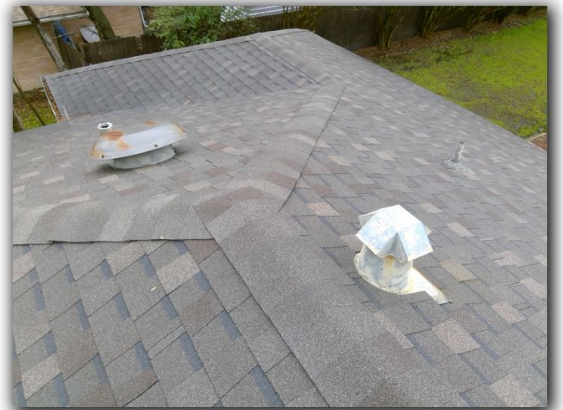
- The felt paper was observed to be installed under the lower metal drip edge flashing detail. The manufacturer installation requires the felt paper to be installed over the top of the metal drip edge flashing, in shingle like fashion, to help prevent water intrusion and/or damage to occur behind the fascia board and soffit/eave areas.

- Visible evidence of moisture intrusion (leaks) through the roofing material and/or flashing details were observed over the living room. The cause and remedy should be further evaluated and corrected as necessary.

- Missing shingle were observed on the north side of the roof structure.
- One or more of the ridge cap shingles were observed to be damaged.
- The composition roofing material has experienced granular loss in various locations throughout the roof.

- Shingle fasteners (staples and/or nails) were observed to be pushing through the roofing material in various locations.
- **Note:** Roof fasteners (nails and/or staples) were observed to be exposed and should be properly sealed at the ridge caps and flashing areas.

- **Note:** High shingle fasteners (staples and/or nails) were observed in various locations.
- **Note:** Prior repairs to the roofing material and/or flashing were observed in one or more locations.

- **Note:** All debris, such as leaf's and branches, should be removed from the roof structure.

You are strongly encouraged to have a properly certified roofing contractor to physically inspect the roof, prior to the expiration of any time limitations such as option or warranty periods, to fully evaluate the condition of the roofing material. The observation made to support the rendering of this opinion are listed but not limited to the following:

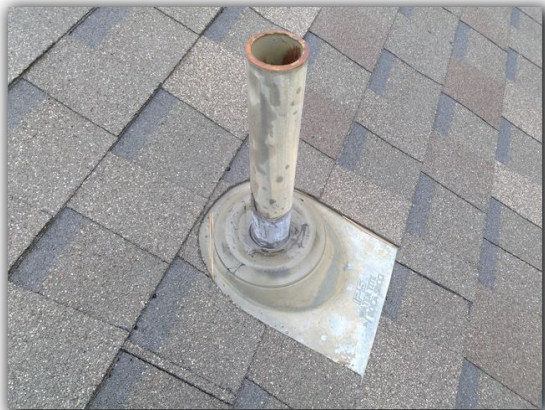
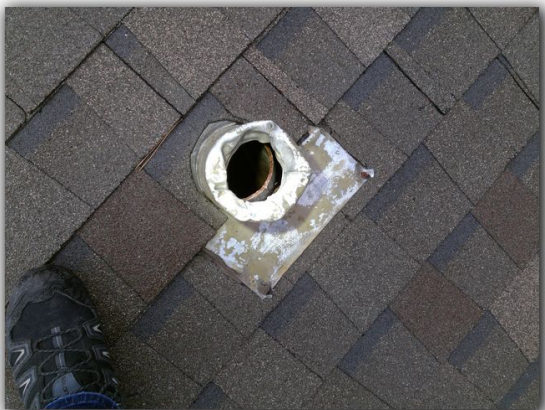
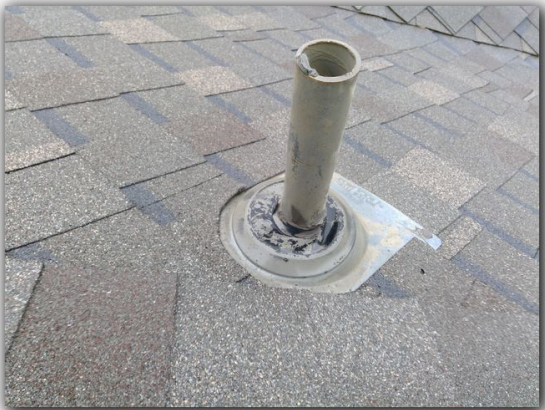
Flashing Details

The flashing details needs to be checked, reset or repaired as necessary. The observations made to support the rendering of this opinion are listed but may not be limited to:

- One or more of the roof level plumbing vent stack flashing details are buckled downward around the plumbing stack. This condition could allow water penetration at this point and corrective measures are recommended.
- The storm collar(s) at the roof level gas equipment vent pipe(s) need to be properly sealed to help prevent water intrusion into the structure.
- The lead jack flashing at the plumbing vent stack needs to be checked, reset or repaired as necessary. The lead jack flashing detail was observed to be improperly installed at one or more of the roof level plumbing vent pipes. The lead flashing should run full length of the vent pipe and turn down into the top of the vent pipe to help prevent water intrusion at this point.
- Some of the metal flashing details were observed to be rusted and should be corrected as necessary.

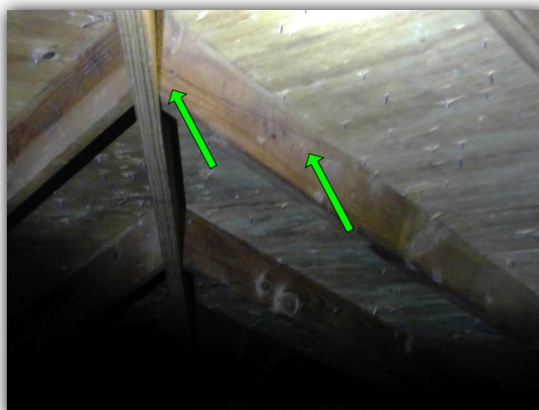
Roof Structure

- Split rafter(s) were observed in the attic area over garage the area(s).

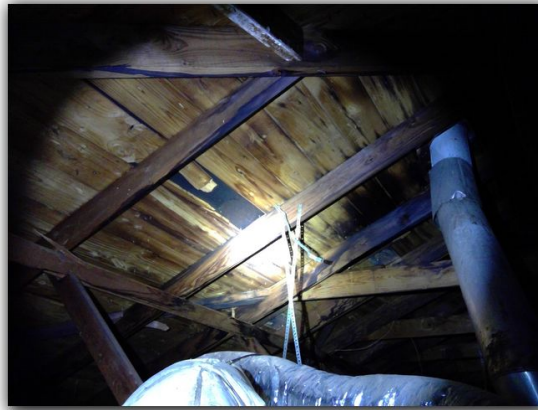
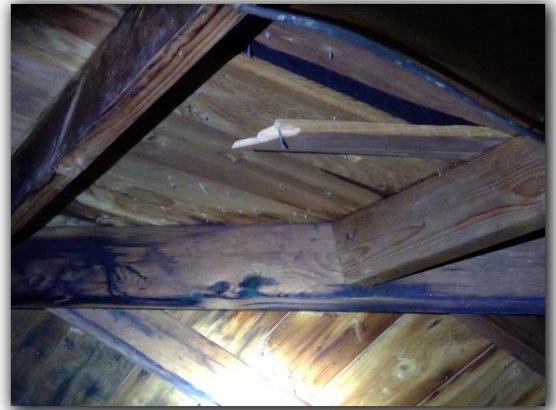
Roof Sheathing

- Some noticeable sags and/or depressions were observed in the roof sheathing (decking).
- Some roof sheathing (decking) deterioration and/or damage was observed in one or more locations.
- **Note:** There are visible water stains on the roof sheathing (decking) in one or more locations.

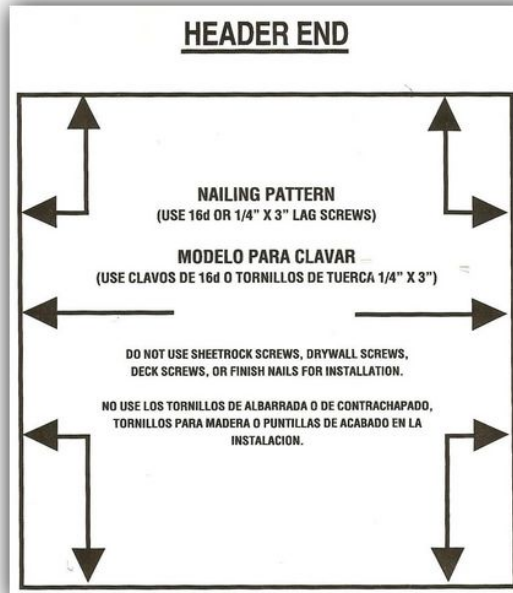
Garage Attic Ladder

- The attic ladder was observed to be installed with improper fasteners. The attic ladder should be secured in place with 16d nails or 3-inch lag bolts. This condition should be further evaluated and corrected as necessary.

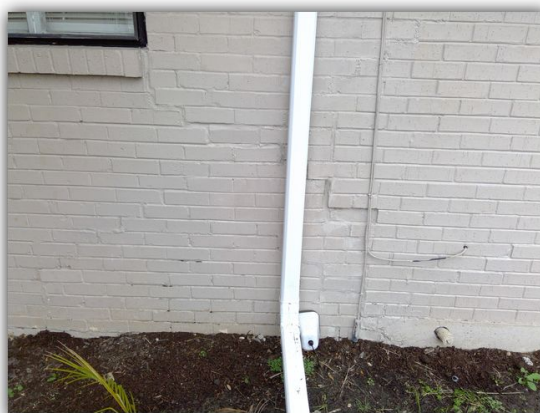
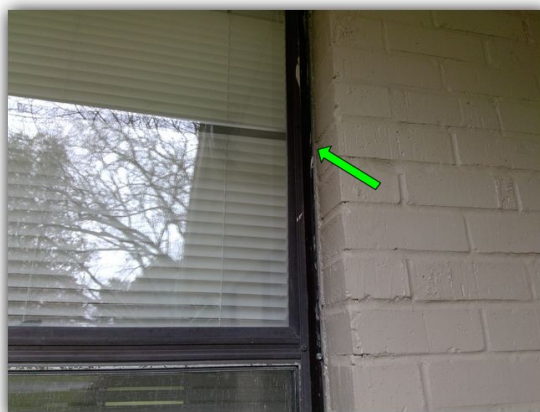
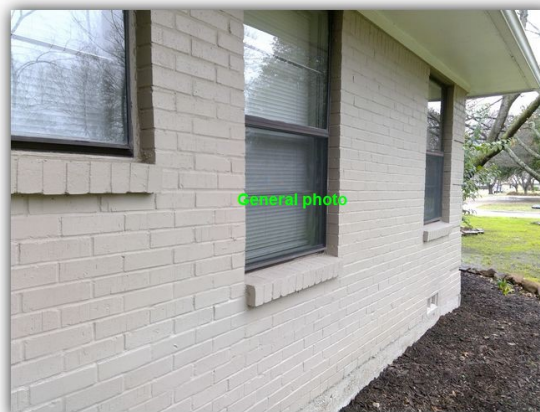
- Caulking improvements are recommended for the area between the exterior veneer and the window frames. It is recommended to use an elastomeric caulking.
- The area between the exterior cladding / veneer and all of the wall penetrations / openings need to be properly sealed. Areas such as utility connections, downspouts, hose bibbs, lighting fixtures, receptacles etc. It is recommended to use an elastomeric caulking / sealant.
- **Note:** The exterior masonry veneer has been painted. This condition could limit the Inspectors visual observations and ability to render accurate opinions as to the performance of the structure.
- **Note:** Previous repairs to the exterior masonry mortar / grout was observed on the north, east, west and south sides of the structure.

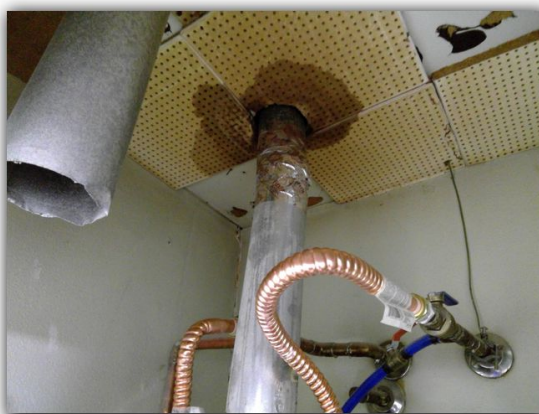
- Water stains observed on the ceiling at and/or around the water heater flue area. The sealant at the flue roof level storm collar needs to be further investigated and corrected as necessary.

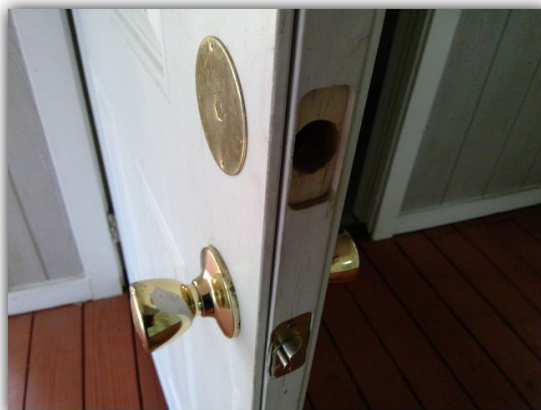
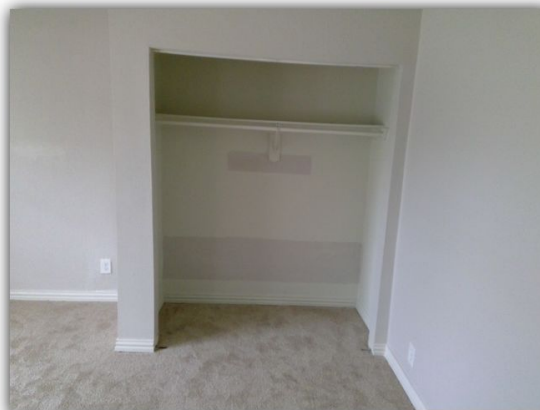
Interior Doors

- The door hardware is missing to the utility room closet.
- The door is not latching properly to the utility closet.
- The door is missing to the side middle bedroom closet.

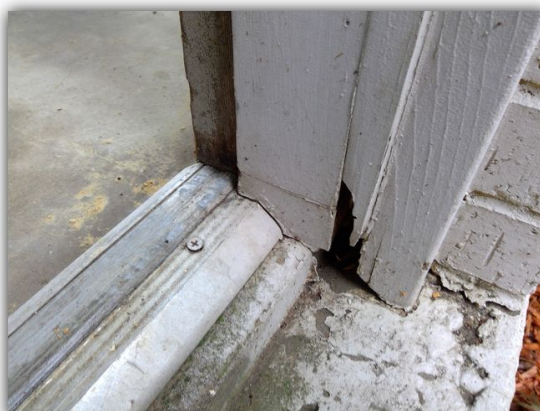
Exterior Doors

- Visible evidence of previous water intrusion was observed at and/or around the exterior garage entry door(s). The cause and remedy should be investigated and corrected as necessary.
- The exterior door frame has some deterioration and/or damage to the garage entry door(s).
- The door has some surface damage to the garage.
- The door hardware is missing to the garage.

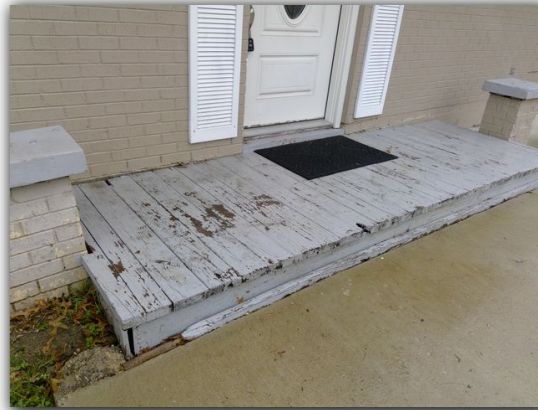
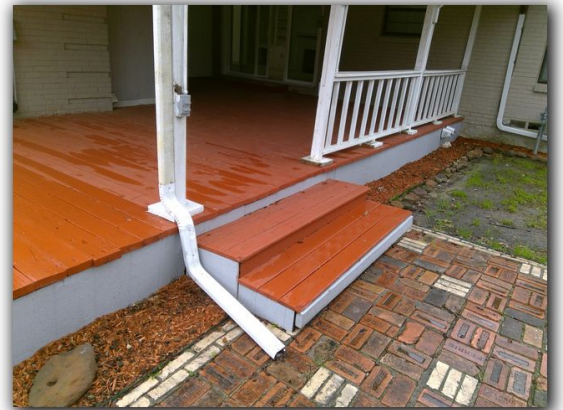
- **Note:** The deck has been built at grade level (Wood/Ground contact should be avoided). This configuration is prone to rot and insect activity.
- The guard railing balusters and/or spindles are installed too far apart under current building standards. This may be an “as-built” condition but Per TREC standards of practice we are required to report this condition as a deficiency. You may consider corrective measures for improved safety.

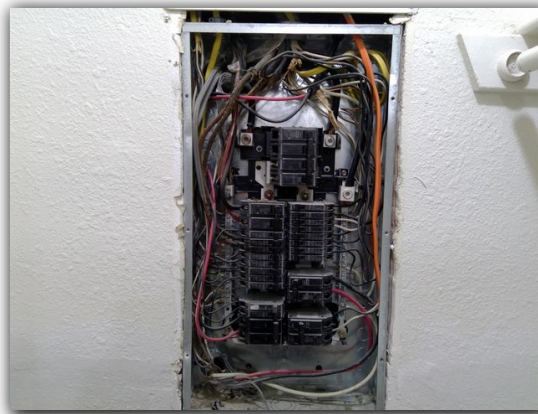
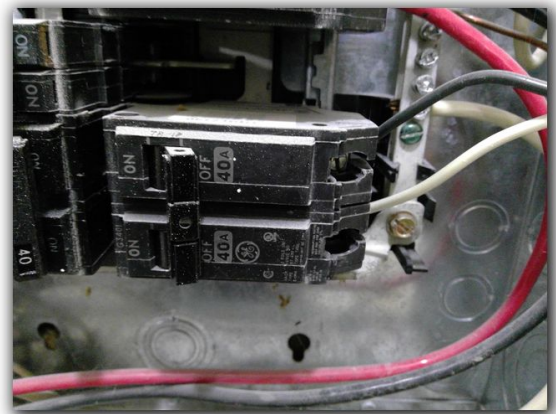
- The breakers (overcurrent devices) in the electrical panel are not properly labeled.
- One or more of the cabinet cover plate screws are missing and need to be replaced.

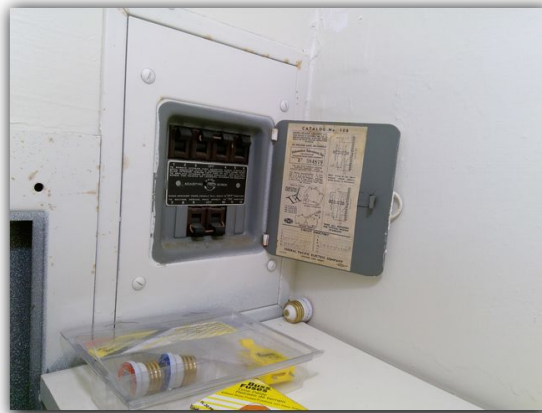
- The breakers (overcurrent devices) in the electrical panel are not properly labeled.
- The electrical panel is located in a clothes closet. Under current electrical standards, this is no longer an accepted practice. This is an “as-built” condition but Per TREC standards of practice we are required to report this condition as a deficiency.
- None of the required dwelling unit devices, receptacle and lighting outlets (switches, receptacles and fixtures) are connected to an arc-fault circuit-interrupter (AFCI) circuit device. Under the current National Electrical Code, all of the living area devices, receptacle and lighting outlets (switches, receptacles and fixtures) should be connected to an arc-fault circuit interrupter (AFCI) device.
- The trip-tie is damaged to one of the 240-volt double pole breaker. Repair is recommended.

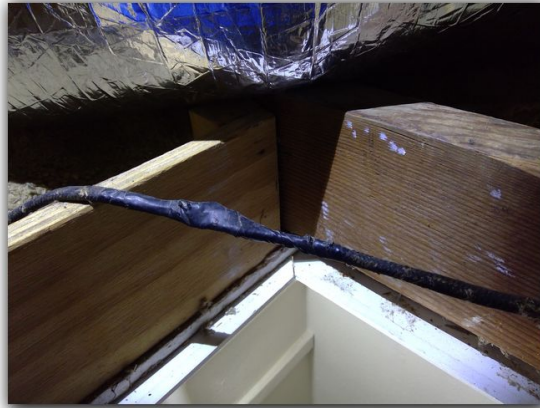
- All exposed distribution wiring should be properly enclosed in conduit. Exposed wiring was observed in the clothes closet.
- Spliced electrical wires were observed in the attic area. Spliced wires in the attic should be properly enclosed in junction box(es) and secured to the ceiling joist. Spliced wires were located over the attic.
- Open electrical junction box(es) were observed in the attic area. All open junction box(es) in the attic should be properly enclosed. Open junction box(es) were located over the attic.

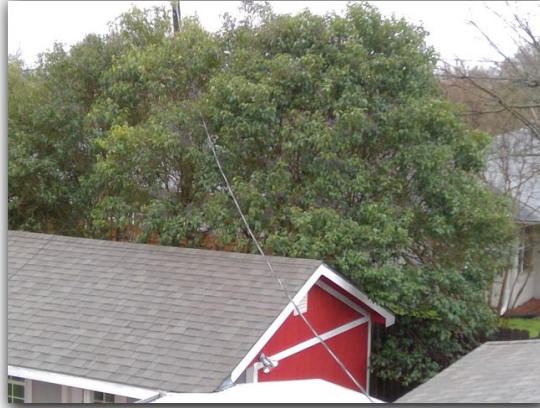
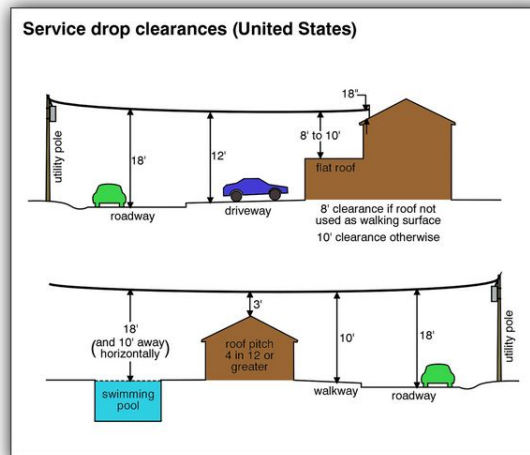
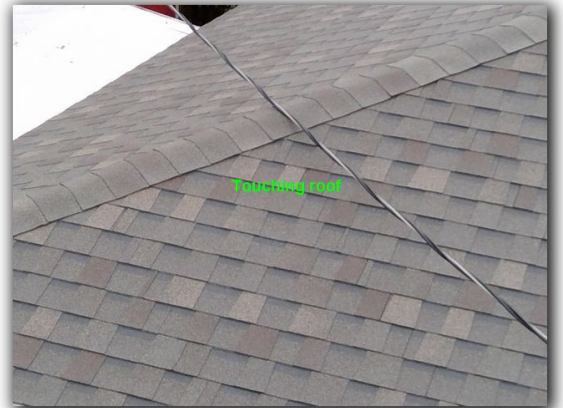
- The tree branches should be trimmed away from the overhead service wires.
- The electrical service wires hang to low over the roof structure. The electrical service wires from the service pole to the structure should clear all roof structure components by a minimum of 3-feet.
- The service wires were observed to be in contact with the roof structure. This condition does not meet electrical standards and should be corrected as necessary.

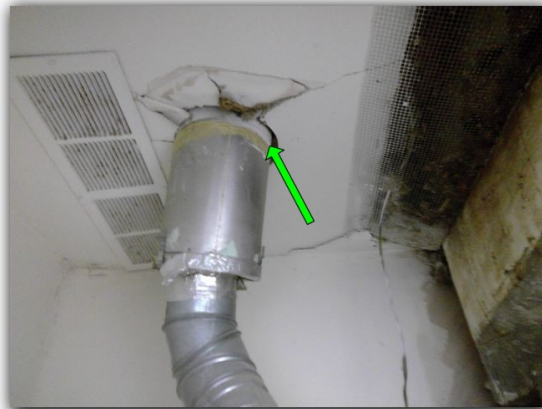
- The heating unit compartment has inadequate combustion air ventilation. There should be a minimum of 100 square inches of combustion air ventilation provided within 12-inches of the top and bottom of the closet.

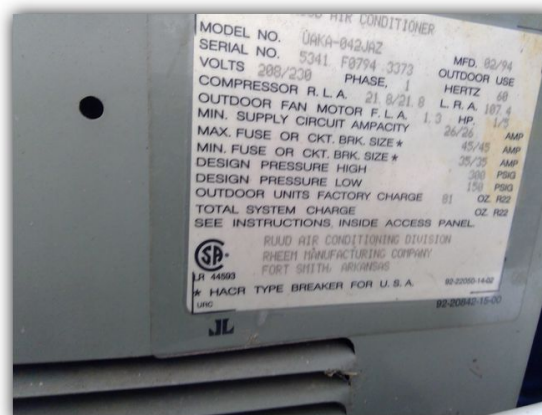
- **Note:** Previous water leakage was observed from around the base of the indoor coil housing. This condition should be closely monitored.
- **Note:** The primary condensate drain line is terminated next to the exterior foundation perimeter beam. It is recommended that the drain line terminate further away from the foundation beam or to an approved waste system.

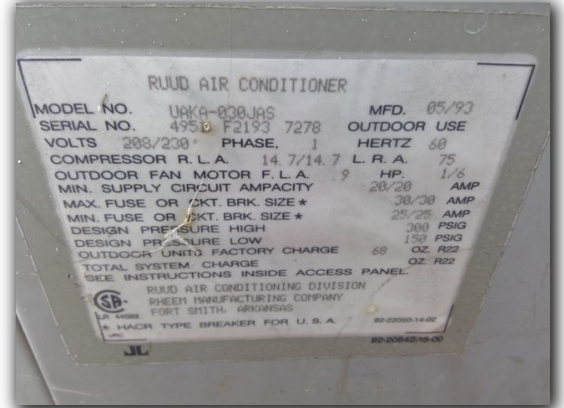
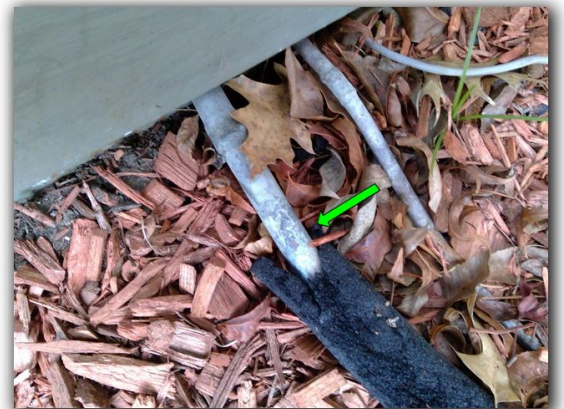
- **Note:** Previous water leakage was observed from around the base of the indoor coil housing. This condition should be closely monitored.

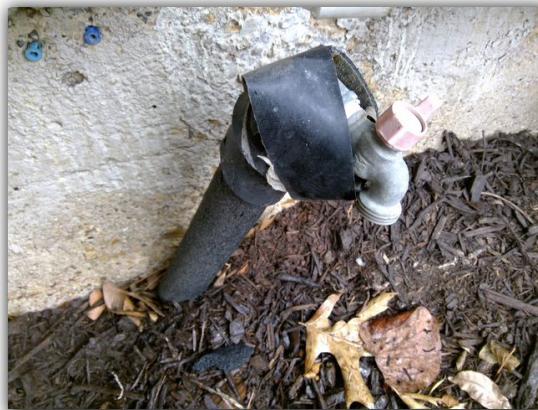
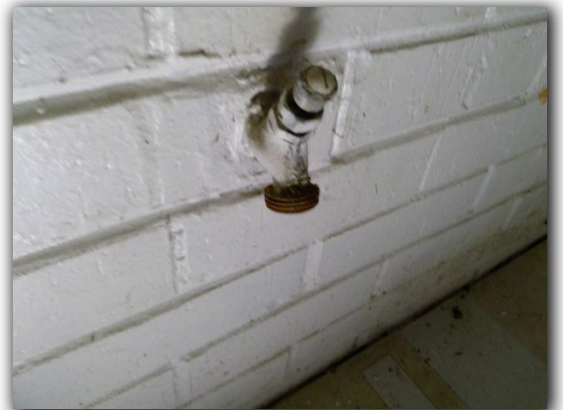
- One or more of the exterior water hose bibbs (faucet) do not have a back-flow or anti-siphon device (Vacuum Breakers) in place. **Note:** *This is not uncommon to observe with a home of this age.*
- The exterior water hose bibb (faucet) handle is damaged and/or missing on the back side of the structure.

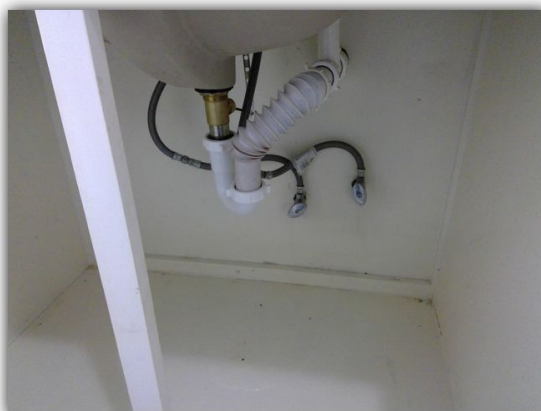
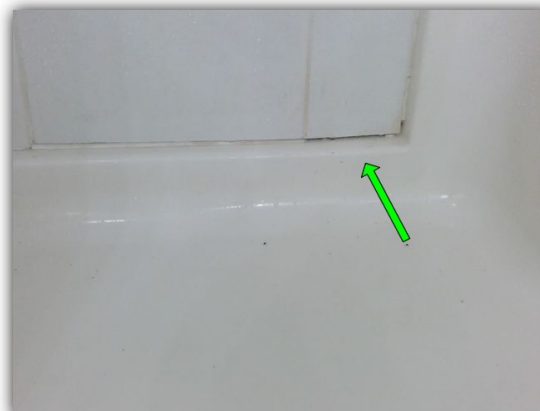
- Cracked, deteriorated and/or missing shower stall grout and/or caulking should be repaired or replaced as necessary.

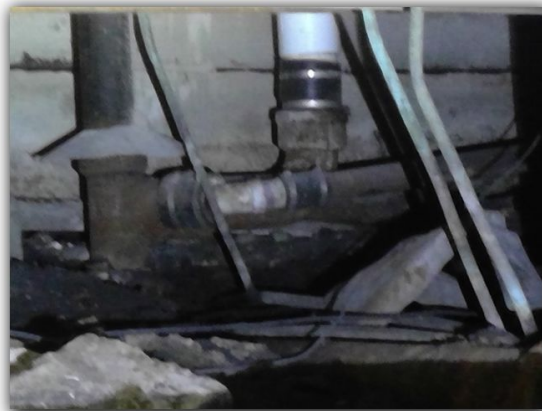
- The cast iron plumbing system has visible rust and corrosion on the exterior surfaces of the piping system. This is a good indicator that failures may occur in the near future. Further evaluation of the cast iron plumbing system is recommended.

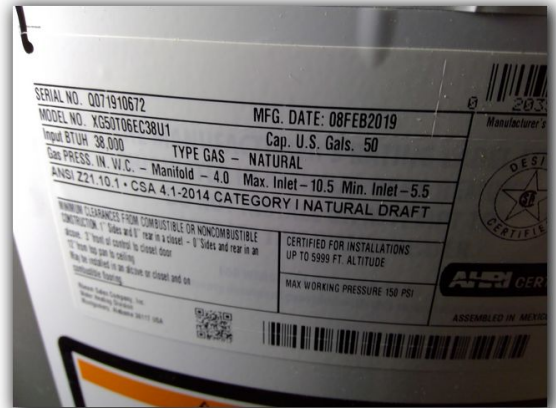
- The pan under the water heater was observed to be damaged and repairs are recommended.
- The water heater flue (vent pipe) has inadequate clearance from combustable materials. Double walled vent pipes should have at least 1-inch of clearance and single walled vent pipes should have at least 6-inches of clearance from combustable material.
- The water heater compartment has inadequate combustion air ventilation. There should be a minimum of 100 square inches of combustion air ventilation provided within 12-inches of the top and bottom of the closet.
- **Note:** The debris in the water heater pan should be cleaned out to help prevent the pan drain line from being clogged.

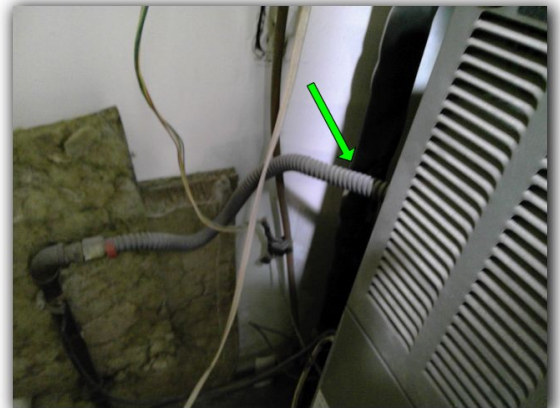
- There are Teflon coated brass gas appliance connectors in use at one or more of the gas appliances. Brass is no longer an acceptable material to be used as a gas supply connector and should be replaced with an approved gas appliance flexible connector.
- The gas service line for the family room should not be made of copper. Under current installation standards, copper is no longer an acceptable material to use for gas lines.

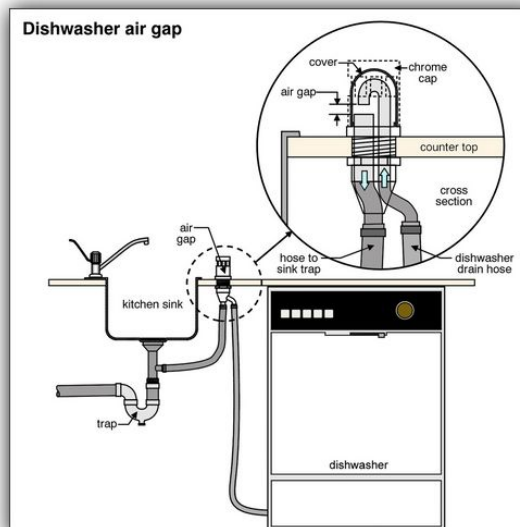
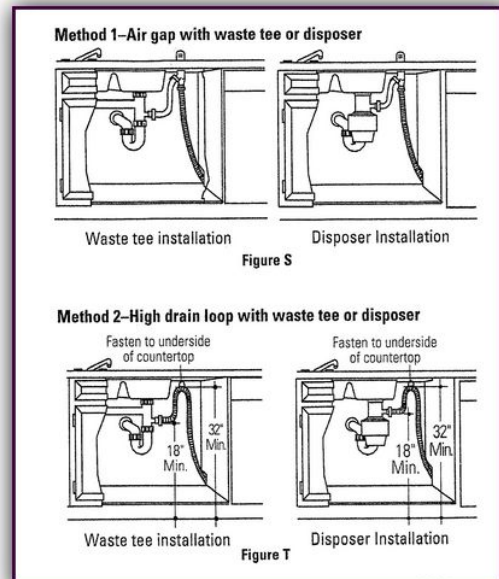
- The dishwasher was inoperative at the time of this inspection.
- The dishwasher drain hose is not properly installed to prevent back flow or anti-siphoning. It is recommended that an air gap device or high drain loop be installed in the drain line.
- Some rusting of the dishwasher interior components was observed.
