## PROPERTY INSPECTION REPORT

Prepared For: Sally Samples

Concerning: Luxury Blvd, Arlington, TX 76006

By: Nathan Ross, Lic #20282

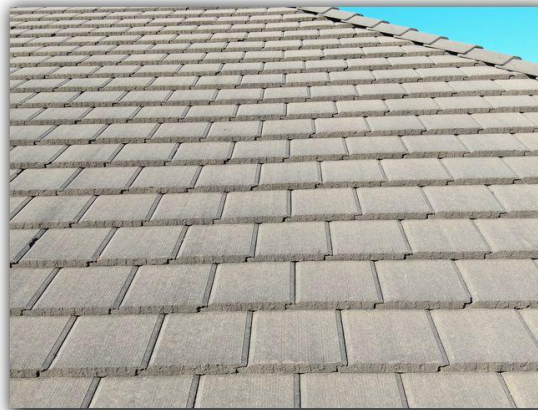
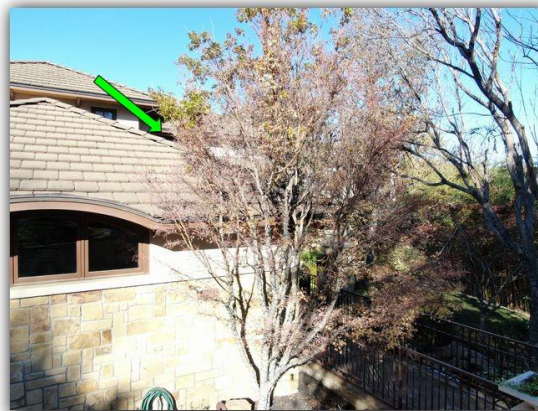
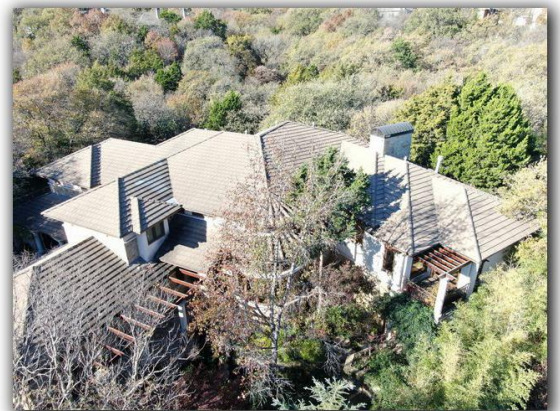
- Tree and shrub branches need to be trimmed away from the roofing material at all times to help prevent damage to the roofing material. It is the opinion of this Inspector that there are some branches too close to the roofing material at this time and corrective measures are needed.

- **Note:** Prior repairs to the roofing material and/or flashing were observed in one or more locations.
- **Note:** Roof fasteners (nails and/or staples) were observed to be exposed and should be properly sealed at the ridge caps and flashing areas.

- **Note:** Minor corner cracks were observed on several of the tiles. This is a common condition to observe and no repairs are recommended.
- **Note:** The tile top finish coat was observed to be thinning and/or deteriorated in various locations throughout the roof structure.

- **Note:** Some discoloration of the roofing material was observed.
- **Note:** All debris, such as leaves and branches, should be removed from the roof structure.

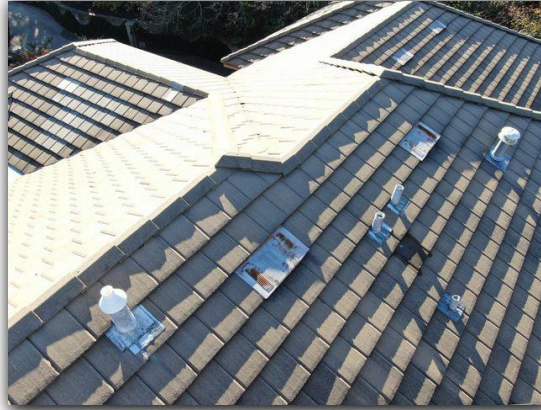
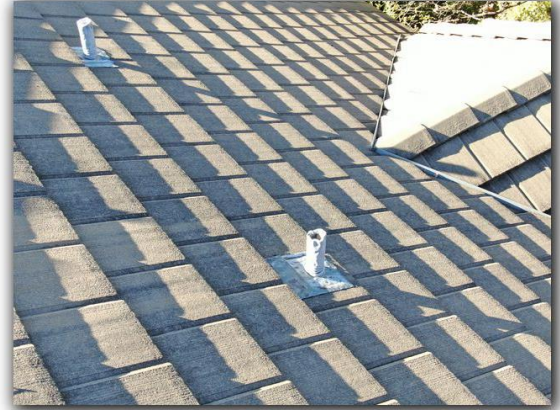
#### Flashing Details

- The lead jack flashing at the plumbing vent stack needs to be checked, reset or repaired as necessary. The lead jack flashing detail was observed to be improperly installed at one or more of the roof level plumbing vent pipes. The lead flashing should run full length of the vent pipe and turn down into the top of the vent pipe to help prevent water intrusion at this point.
- Some of the metal flashing details were observed to be rusted and should be corrected as necessary.

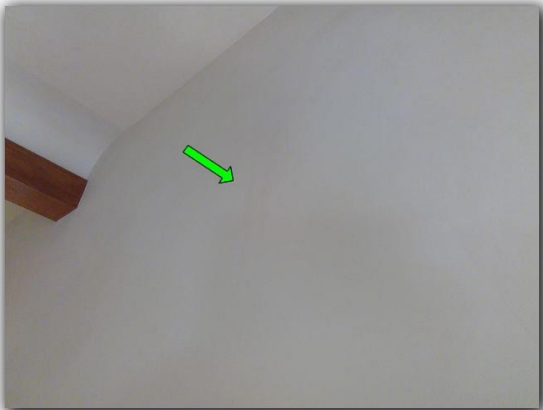
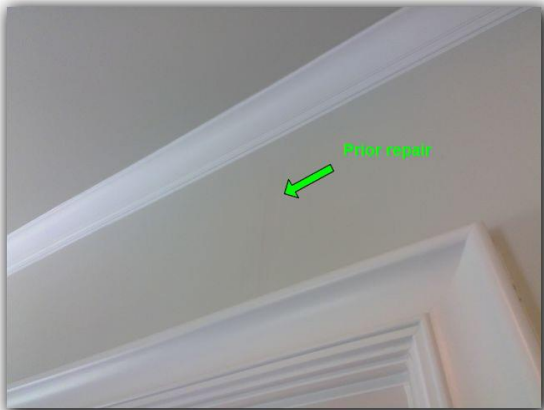
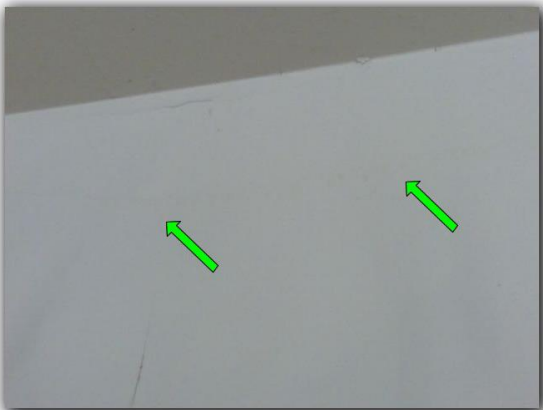
- Moisture stains were observed on the walls in the garage, master bedroom. The cause and remedy should be further evaluated and corrected as necessary.
- The wall texture has some deterioration and/or damage in the garage.
- Wall surface damage was observed in the front entry hallway closet.
- **Note:** There is evidence of painting and patching to the interior finish and prior interior finish repairs. This condition could limit the Inspectors visual observations and ability to render accurate opinions as to the performance of the structure.

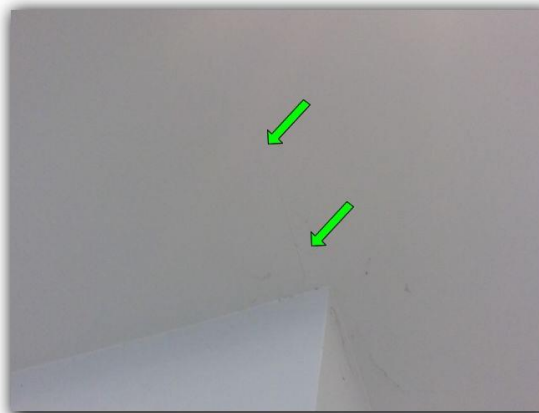
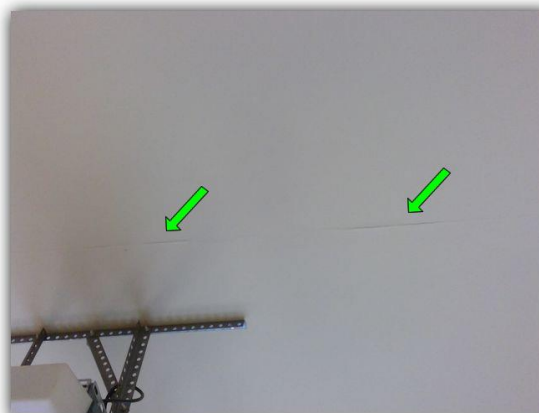
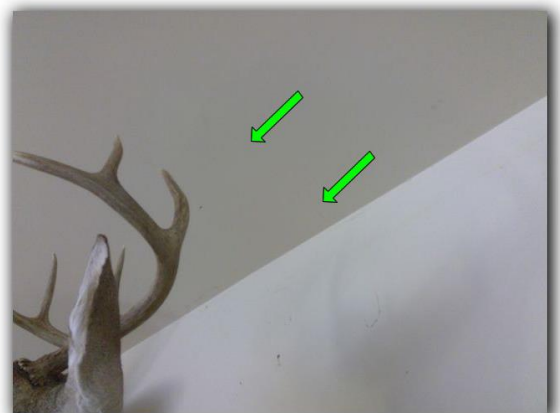
**Note:** Nail heads were observed to be pushing through the interior finish in one or more locations.

- Ceiling stress cracks were observed in the garage 1, garage 2.
- Ceiling joint cracks were observed in the kitchen, pantry.

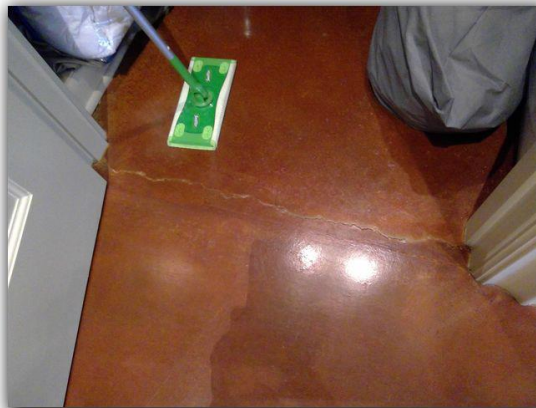
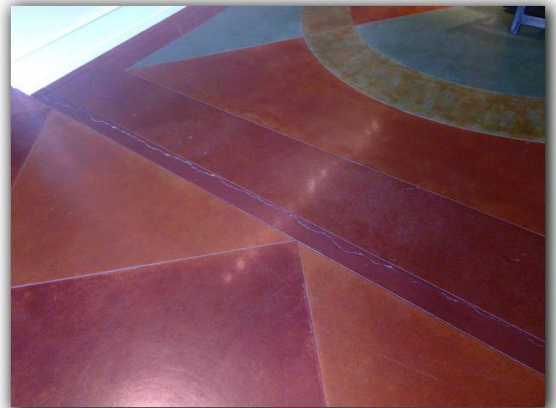
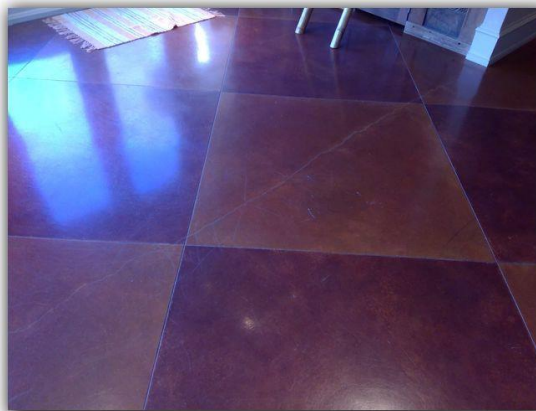
**Floors**

- The floor tile(s) were observed to be cracked and/or damaged in upstairs bedroom hallway, upstairs living room, gameroom.
- **Note:** Some cracking of the garage concrete floor finish was observed.

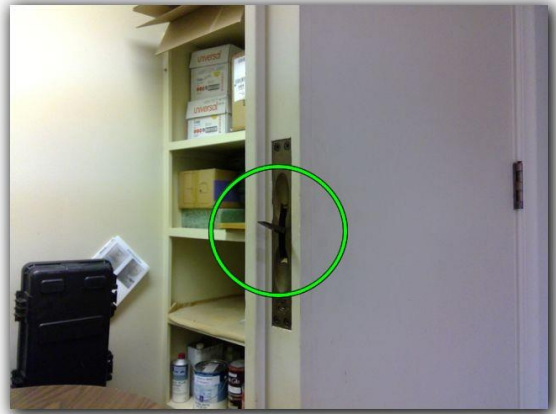
**Interior Doors**

- The door is not latching properly to the upstairs rear corner bedroom, garage closet.
- The door hardware is loose to the rear middle bedroom.
- The door is sticking to the front entry closet.
- **Note:** One or more of the door stoppers were observed to be missing.

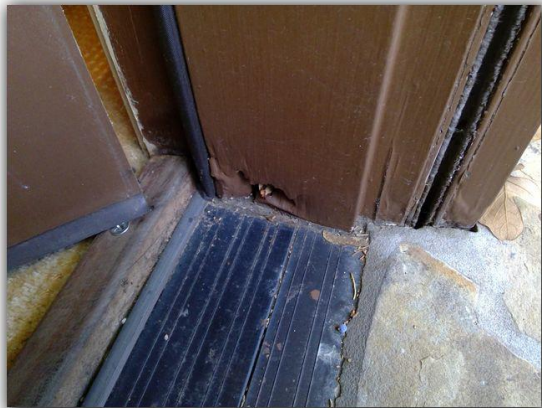
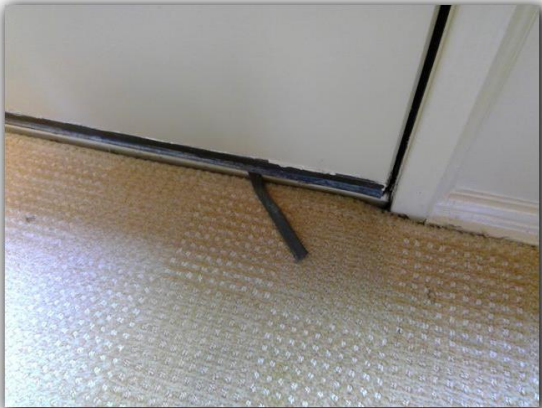
**Exterior Doors**

- The exterior door frame has some deterioration and/or damage to the master bedroom back balcony entry door(s).
- The door has some surface damage to the master bathroom back balcony door, backyard entry door.
- Weather-stripping improvements are recommended for the master bedroom back balcony entry exterior door(s).
- Visible evidence of previous water intrusion was observed at and/or around the exterior living room balcony entry side middle bedroom door(s). The cause and remedy should be investigated and corrected as necessary.
- The door frame has some surface damage to the sideyard entry door.
- The door hardware does not function properly to the front entry door.
- The thermal-pane glass has lost its seal to the front entry exterior door(s). This has resulted in condensation and/or a fog like film to develop between the panes of glass.

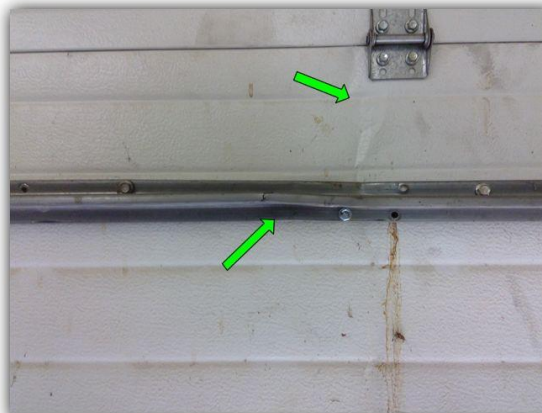
**Overhead Garage Door 1**

- Some damage to the overhead garage door was observed.
- It is recommended to lubricate the overhead garage door components, such as rollers, tracks and hinges.

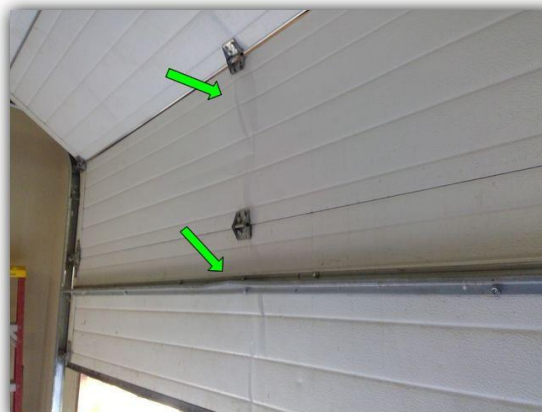
**Overhead Garage Door 3**

- Some damage to the overhead garage door was observed.

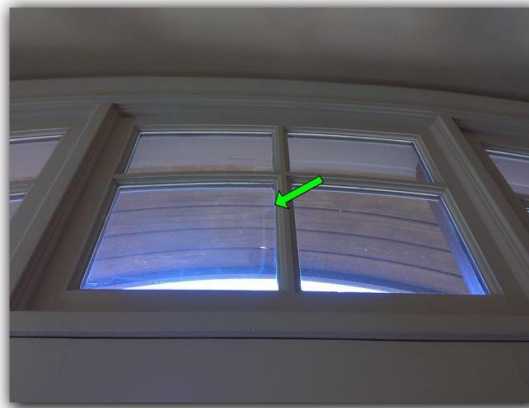
- Window lock(s) were observed to be damaged and/or missing in the breakfast area.
- Visible evidence of water intrusion was observed at and/or around the window(s) in the Green/Sunroom. The cause and remedy should be investigated and corrected as necessary.
- **Note:** I was unable to visually inspect or operate of some of the windows due to height, window treatments, personal effects, large, heavy or fragile storage and/or furniture.
- **Note:** The windows are dirty and need to be cleaned. Dirt on the windows can limit visibility when inspecting the thermal panes and their seals. It is recommended to inspect clean windows for best results.

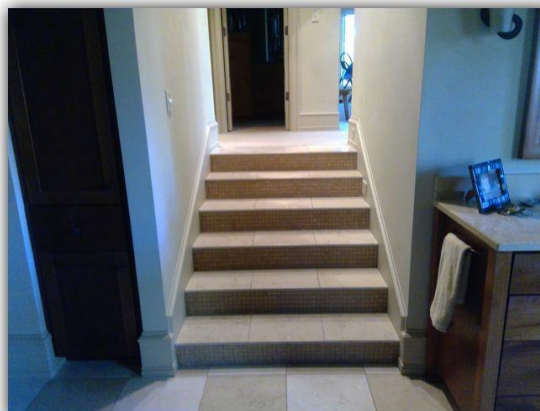
#### Interior Stairway Master Bathroom

- There is no handrail in place for the stairwell. For improved safety, it is recommended that a handrail be installed.

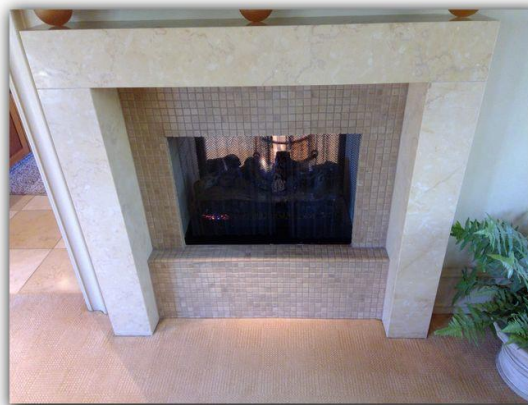
### Master Bedroom Fireplace / Chimney

- The non-combustible hearth extension outside the firebox does not meet current building standards and does not help reduce fire hazard potentials.  
Under current building standards, hearth extensions should extend at least 16-inches in front of and at least 8-inches beyond each side of the fireplace opening. Where fireplace opening is 6-square feet or larger, the hearth extension shall extend at least 20-inches in front of and at least 12-inches beyond each side of the fireplace opening.
- Note:** There are gas logs installed in the firebox at the time of this inspection. I was unable to view the floor of the firebox at the time of this inspection.

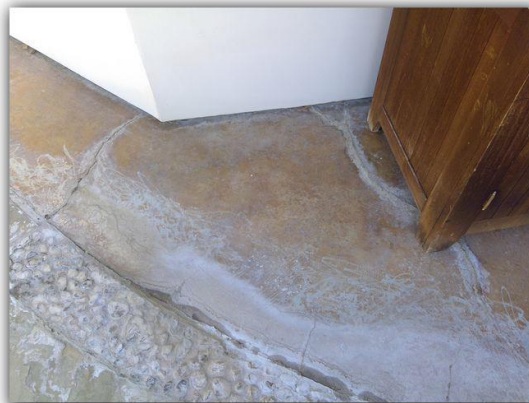
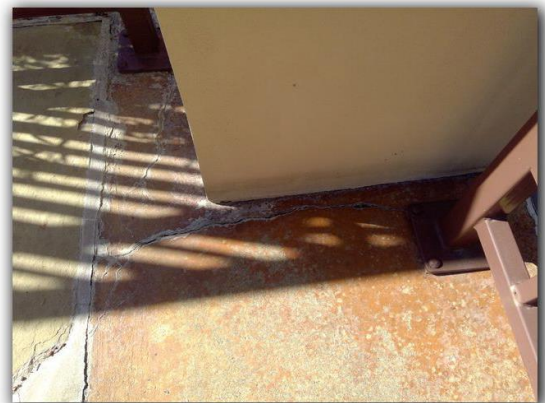
**Living Room Balcony**

- Some deflection and/or cracking of the patio concrete flatwork was observed.
- The balcony floor / flatwork appears to be holding water. This condition needs to be further evaluated and corrected as necessary.

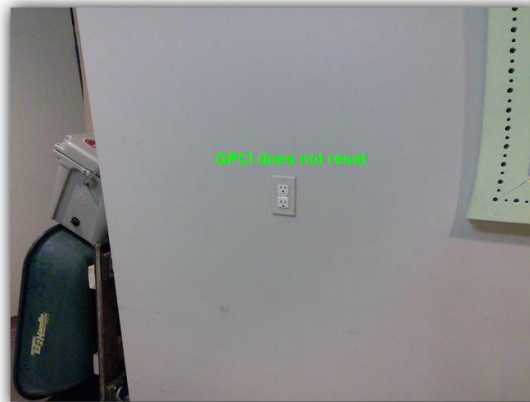
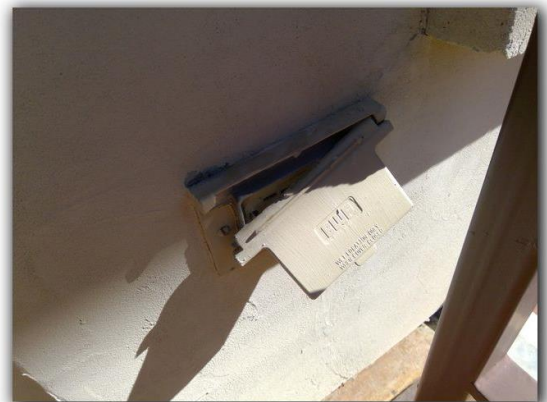
- Not all of the laundry room receptacles appear to be connected to a ground fault circuit interrupter (GFCI) device. Under current electrical standards, all of the receptacles in the laundry room should have GFCI protection.

- One or more of the receptacle cover plates are damaged in the attic.
- **Note:** Several of the receptacles have been painted over.

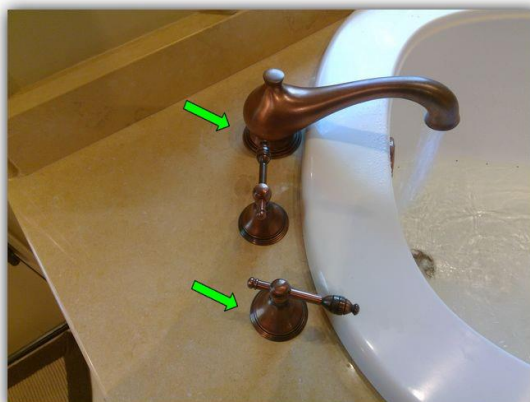
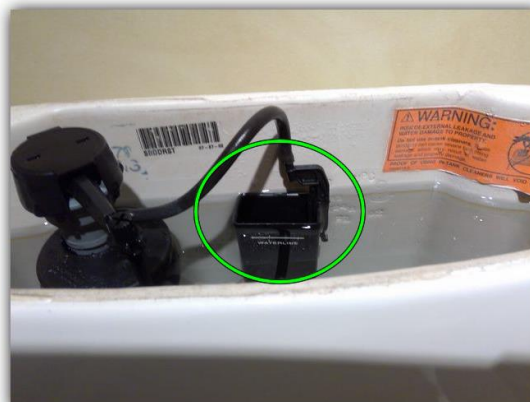
#### *Commode / Toilet*

- The commode tank overflow tube should be adjusted so to be at least 1-inch lower than the ballcock assembly (tank valve) head seal. The lack of this air-gap could cause a cross connection and should be corrected as necessary.
- Note- The sauna/steam room and associated componenets are beyond the scope of a general home inspection. Any concerns should be directed towards the builder and corrected if necessary.

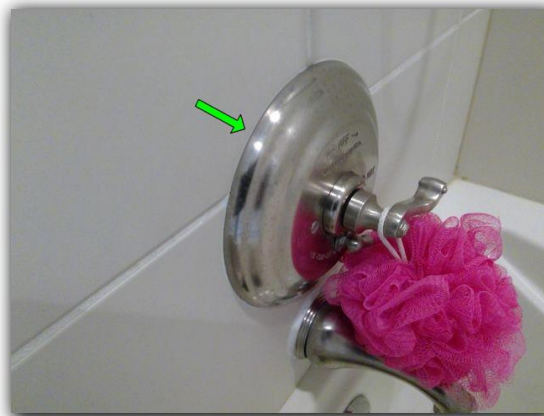
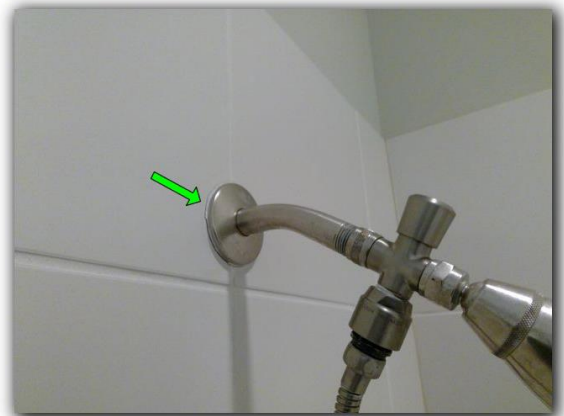
#### *Bathtub*

- The faucet assembly is not sealed at the wall. This condition has the potential to allow water to leak back into the wall cavity.
- The shower head assembly is loose within the wall cavity area.

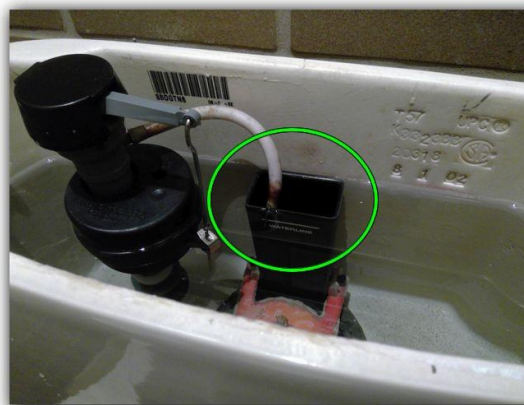
#### *Commode / Toilet*

- The commode tank overflow tube should be adjusted so to be at least 1-inch lower than the ballcock assembly (tank valve) head seal. The lack of this air-gap could cause a cross connection and should be corrected as necessary.

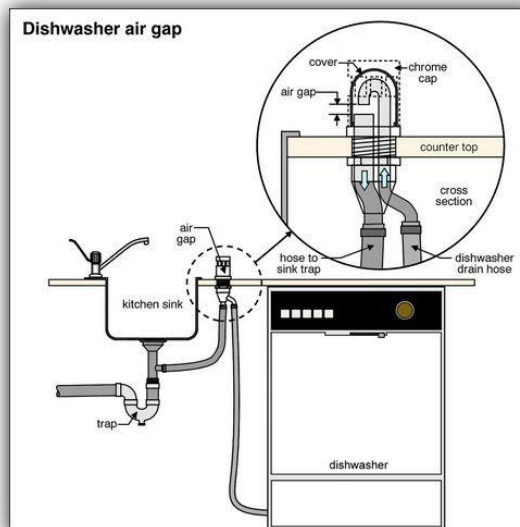
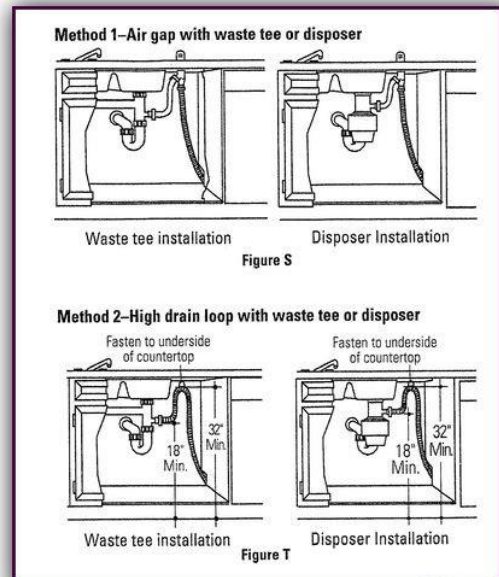
#### Dishwasher #2

- The dishwasher drain hose is not properly installed to prevent back flow or anti-siphoning. It is recommended that an air gap device or high drain loop be installed in the drain line.
