PROPERTY INSPECTION REPORT

Concerning: Pleasantville Place, Anywhere, TX 77777

By: Nathan Ross, Lic #20282

02/20/2020

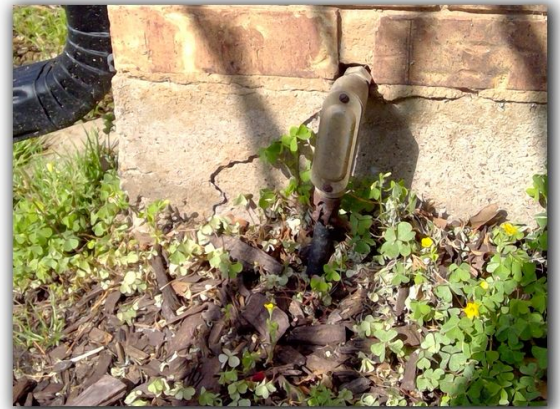
- One or more of the foundation perimeter beam corners were observed to be sheared off (corner pop). This is a common condition to observe and is do to thermal expansion and contraction of the different building materials. This condition does not adversely affect the foundation performance. However, in some cases, some cosmetic improvements may be necessary.

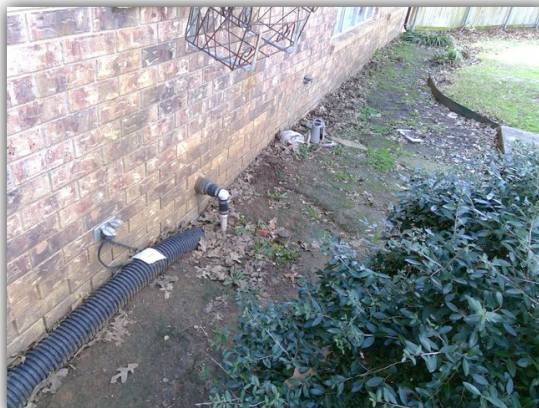
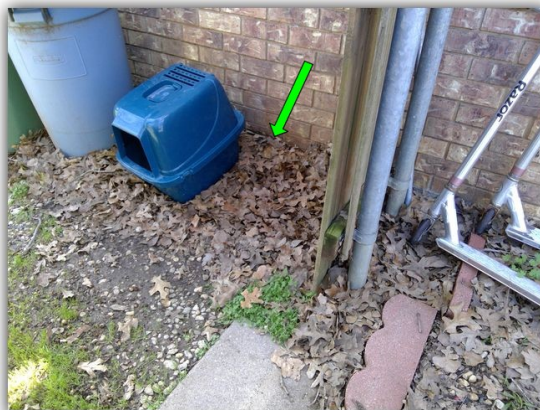
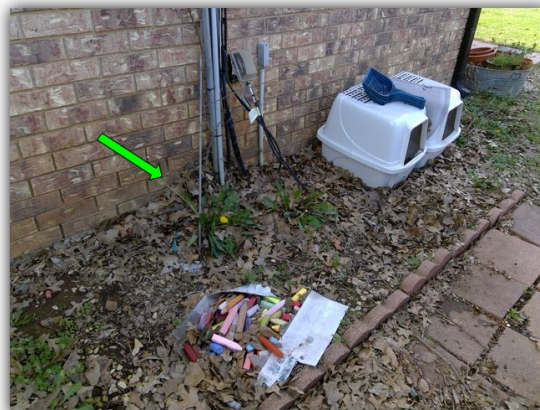
Grading & Drainage

- The soil line is too high on the east side, north side of the structure. Under current building standards there should be at least 4-inches of foundation visible below masonry veneer and 6-inches of foundation visible below wood type veneer.
- Poor to negative site drainage was observed on the north side of the structure. Proper drainage is needed to help prevent water from standing and/or pooling next to the foundation beam. Corrective measures may be needed if the water stands within 10-feet of the foundation perimeter beam for more than 24-hours.

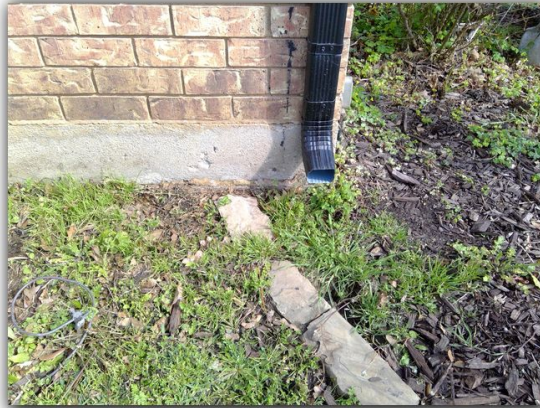
Gutter & Downspout System

- **Note:** The gutter downspouts should discharge water at least thirty-six inches (36") away from the foundation perimeter beam. Storm water should be encouraged to flow away from the structure at the points of discharge.

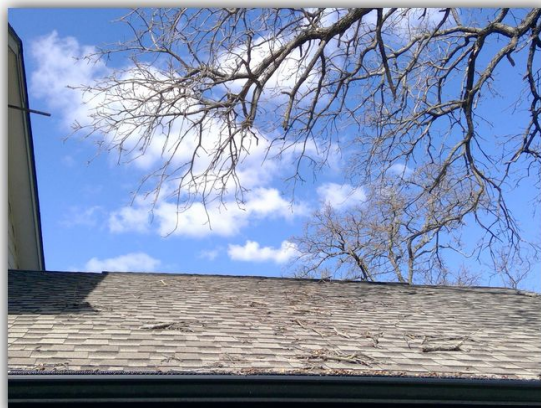
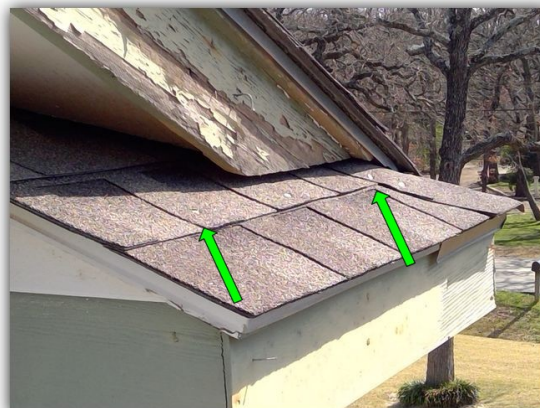
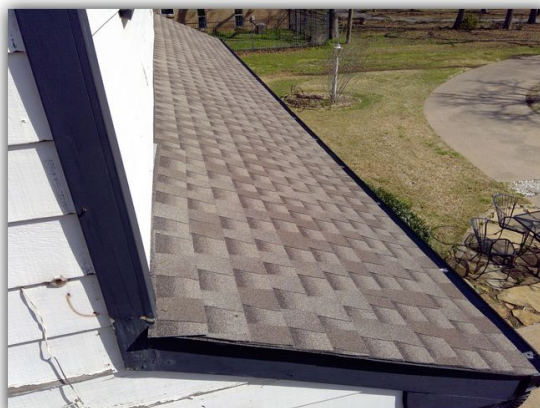
- **Note:** Roof fasteners (nails and/or staples) were observed to be exposed and should be properly sealed at the ridge caps and flashing areas.
- **Note:** High shingle fasteners (staples and/or nails) were observed in various locations.
- **Note:** All debris, such as leaf's and branches, should be removed from the roof structure.
- **Note:** The tree and shrub branches should be trimmed away from the roofing material at all times.

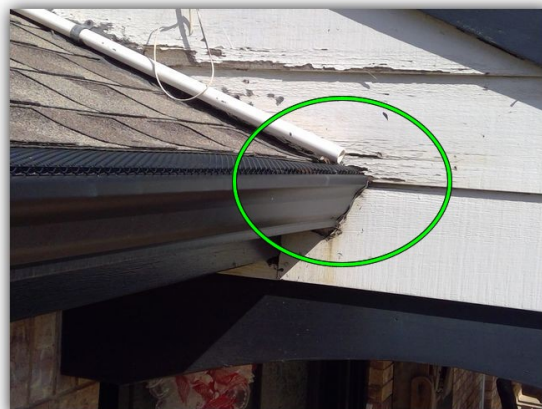
Flashing Details

- There was no kickout flashing details observed at the lower bottom edge of the roof line interface and the sidewall that continues past the edge of the roof. The lack of this kickout flashing will allow water to penetrate at these points.

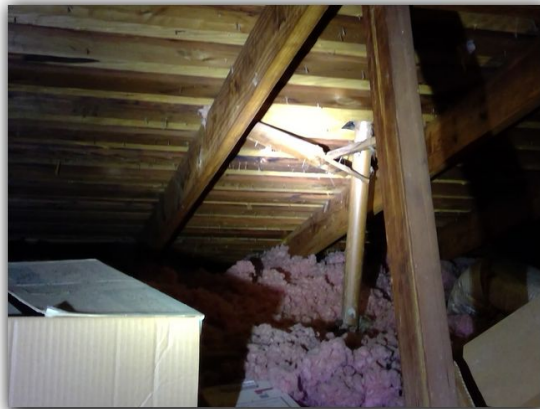
Roof Sheathing

- Some roof sheathing (decking) deterioration and/or damage was observed in one or more locations.
- **Note:** There are visible water stains on the roof sheathing (decking) in one or more locations.

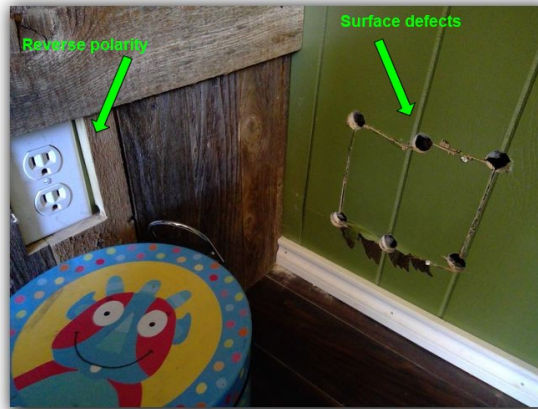
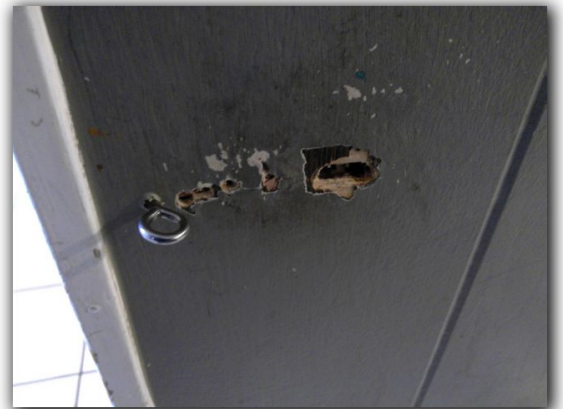
- The wall texture has some deterioration and/or damage in the various locations throughout the house.
- Wall surface damage was observed in the gameroom.

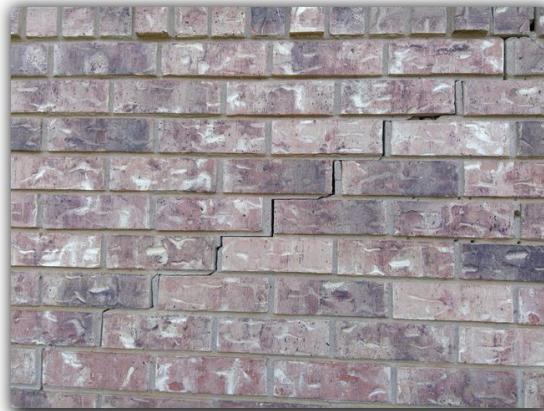
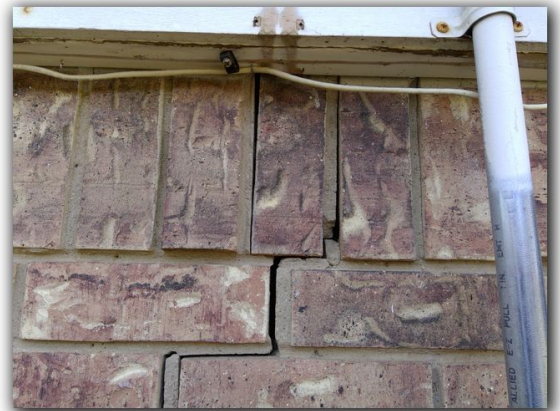
- The soldier bricks were observed to be loose on the east side of the structure. Some improvements are recommended.
- Mortar improvements are recommended for the exterior masonry veneer on the east side, north side of the structure.

- Deflection cracks were observed in the exterior veneer on the east side of the structure.
- **Note:** Minor mortar and/or brick cracks were observed in the exterior veneer on the north side of the structure.

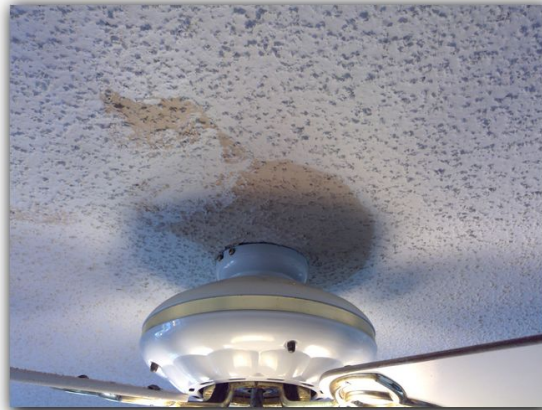
- Water stains were observed on the ceiling finish in the kitchen. The cause and remedy should be further evaluated and corrected as necessary.

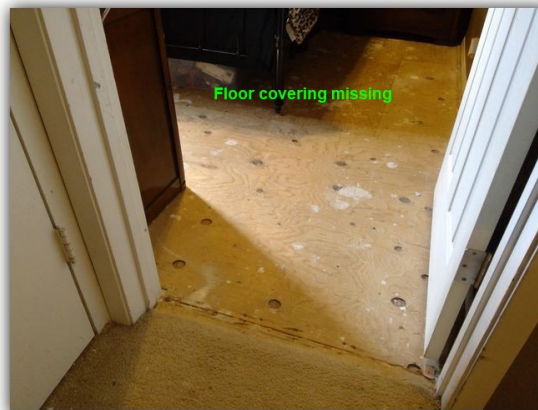
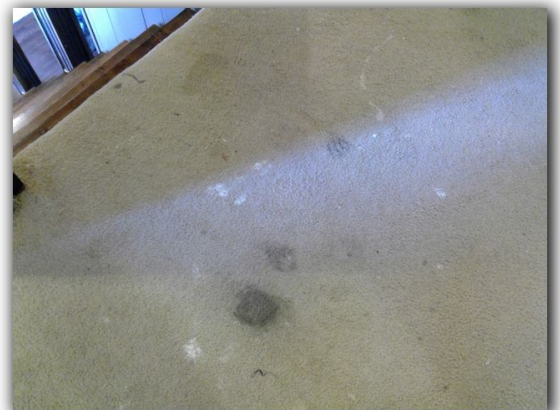
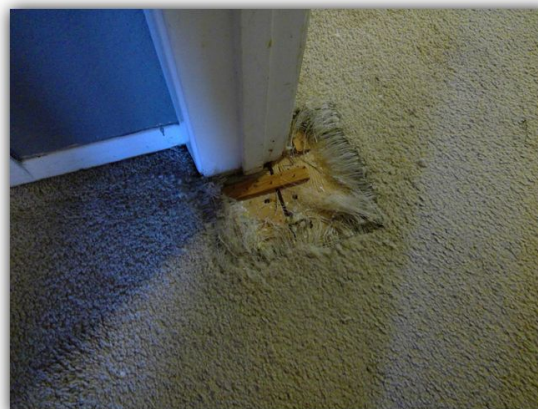
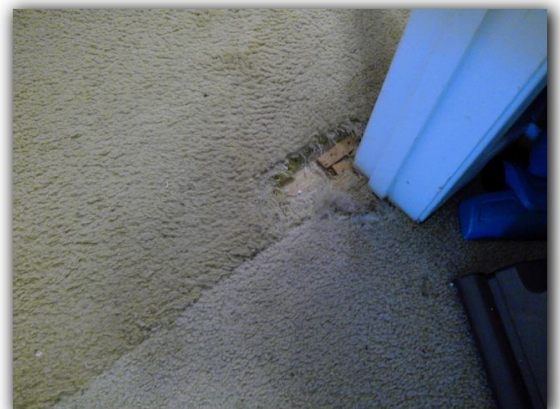
Floors

- The floor covering is noticeably worn and/or damaged in one or more locations of the home.
- The floor covering is noticeably stained in one or more locations of the home.
- The floor covering was observed to be damaged in the front corner bedroom, master bedroom, various locations throughout the house.
- The floor tile(s) were observed to be cracked and/or damaged in kitchen.
- The floor covering was observed to be missing in the upstairs front middle bedroom.
- **Note:** The upstairs sub-floors (flooring) observed to squeak when walked over.

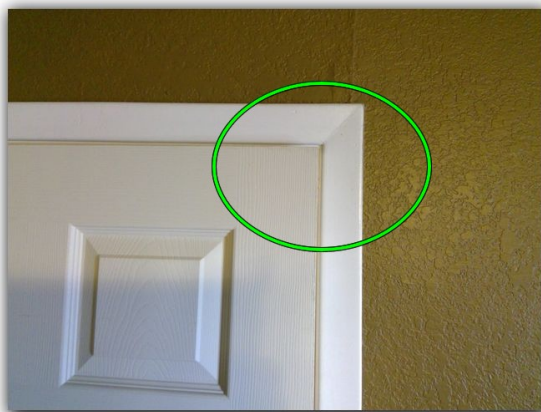
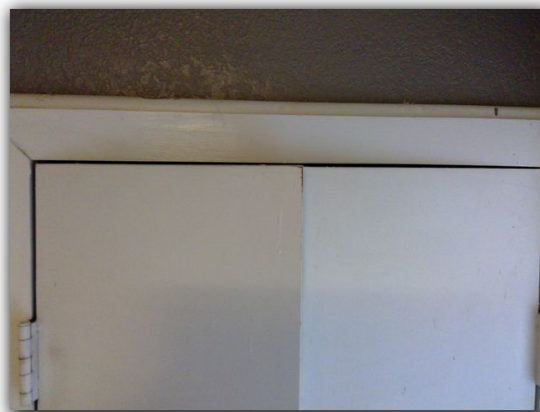
Interior Doors

- The door is sticking and will not close properly to the upstairs front middle bedroom, bedroom hallway closet, various locations throughout the house.
- The door is not latching properly to the laundry room.

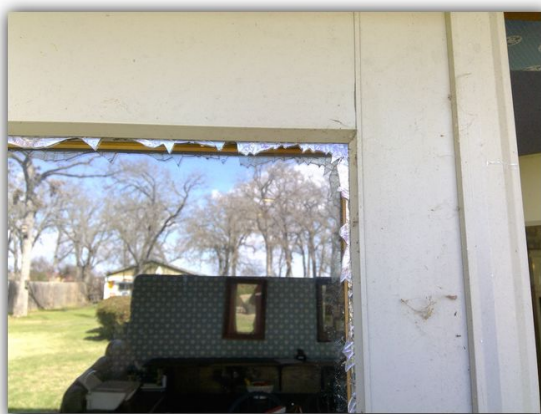
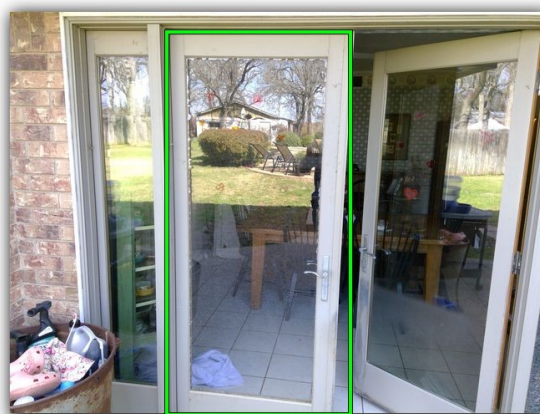
Exterior Doors

- The door has some surface damage to the backyard entry door.
- The glass in the backyard entry door(s) were observed to be cracked and/or broken.
- Weather-stripping improvements are recommended for the front entry exterior door(s).

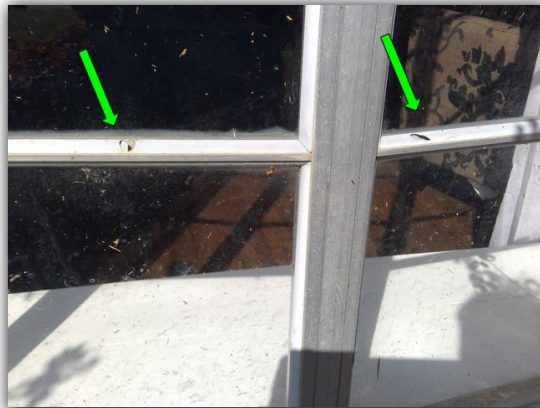
- The window weather-stripping is damaged and/or missing at one or more of the windows and improvements are recommended.

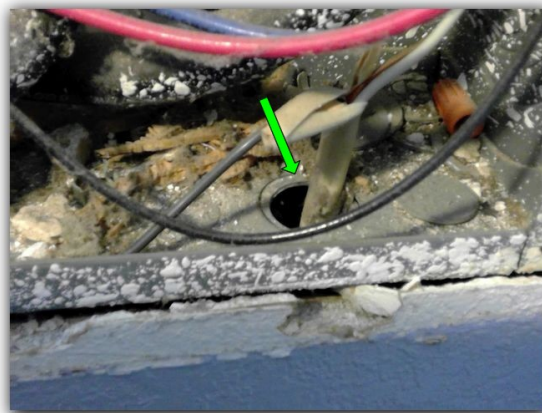
- One or more of the breakers in the electrical cabinet were observed to be double lugged (i.e. two wires under one screw). The breakers in place are not listed or labeled for this type of installation and should be corrected as necessary.

- The electrical cabinet does not appear to be properly bonded to the electrical system.
- The wires entering the electrical cabinet are not properly secured or protected from the sharp edges of the cabinet.

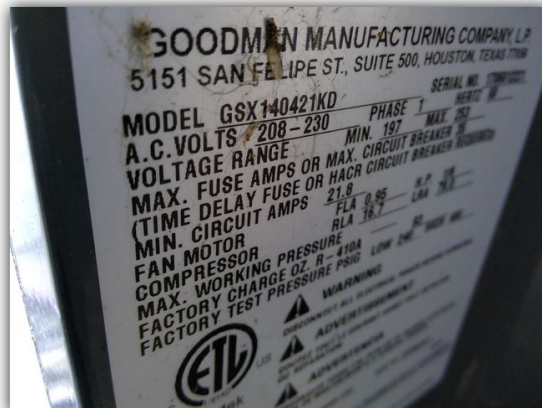
- The condensate discharge terminate into the roof structure. Discharging the condensation water onto the roof structure does not meet current installation standards and will prematurely age the roofing material. Corrective measures are recommended.
- The outdoor unit of the air conditioning system requires cleaning.
- The outdoor unit of the air conditioning system requires cleaning.
- The electrical service disconnect is installed behind the outside condenser/coil. This does not meet the clearance requirements of the National Electrical Code or the International Residential Code and should be corrected as necessary.
- **Note:** Previous water leakage was observed from around the base of the indoor coil housing. This condition should be closely monitored.

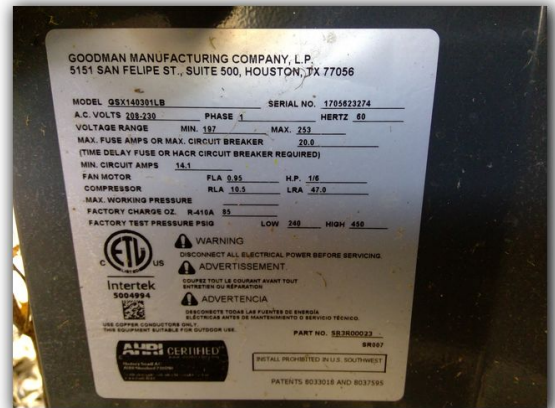
- Damaged, deteriorated and/or missing insulation on the refrigerant lines should be repaired or replaced at the outside condenser.
- The electrical service disconnect is installed behind the outside condenser/coil. This does not meet the clearance requirements of the National Electrical Code or the International Residential Code and should be corrected as necessary.
- The material used to support the heating and cooling equipment in the secondary condensate drain pan is not made of a water resistant material. This condition does not meet current mechanical installation standards.
- **Note:** Previous water leakage was observed from around the base of the indoor coil housing. This condition should be closely monitored.

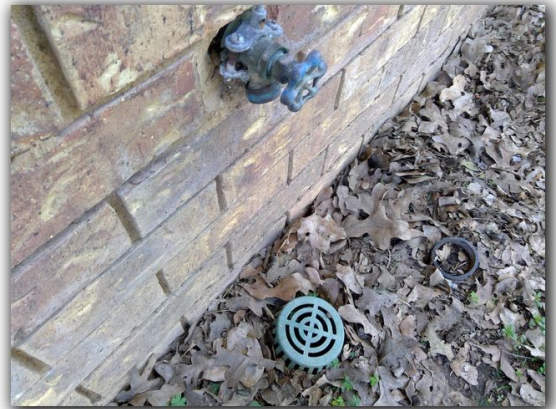
Exterior Faucets/Fixtures

- One or more of the exterior water hose bibbs (faucet) do not have a back-flow or anti-siphon device (Vacuum Breakers) in place. **Note:** *This is not uncommon to observe with a home of this age.*
- The water is turned off to the exterior water hose bibb (faucet) on the north side of the structure. This condition should be further evaluated and corrected as necessary.
- **Note:** The exterior water hose bibb(s) (faucet) adjacent to the home should be protected from physical damage and/or possible freeze.

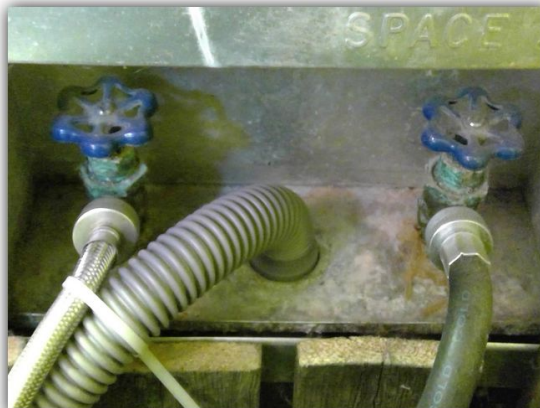
Laundry Connections

- Some rust and/or corrosion was observed at the laundry connection hose bibbs.

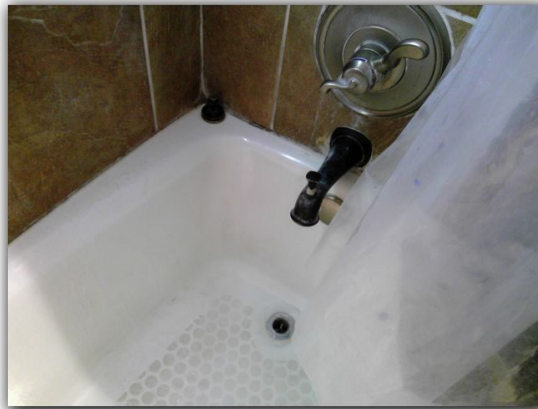
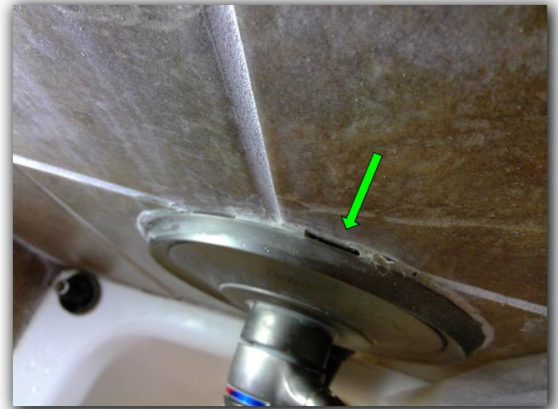
- The stopper does not appear to be functioning properly.
- The faucet assembly is not sealed at the wall. This condition has the potential to allow water to leak back into the wall cavity.

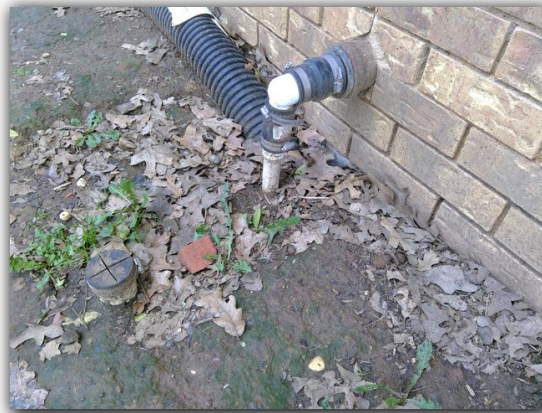
- The cast iron plumbing system appears to have had some previous repairs performed. This is a good sign that additional failures may occur in the near future. Further evaluation of the cast iron plumbing system is recommended.

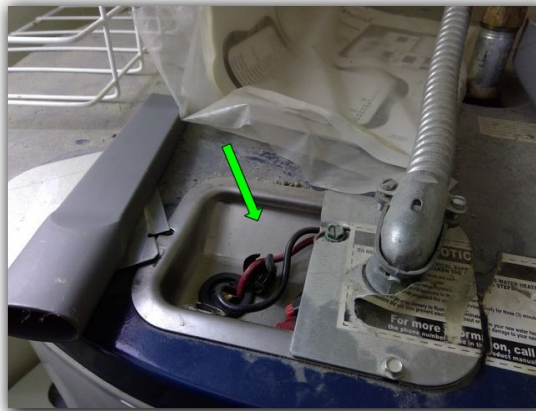
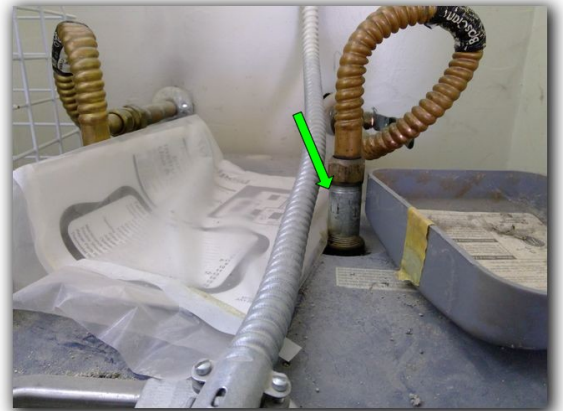
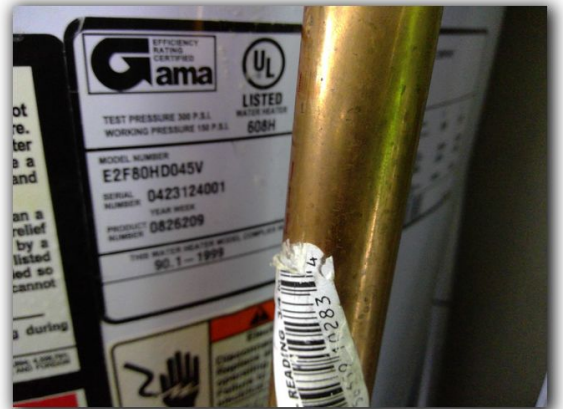
- The fittings at the top of the water heater are made of dissimilar metals (galvanized steel connected to copper and/or brass). It is recommended to replace the galvanized steel fittings with brass or copper fittings or install a dielectric union between the two dissimilar metals to prevent electrolysis from occurring.
- The spliced wires at the top of the water heater should be properly enclosed for reasons of safety.
- There is no pan installed under the water heater.

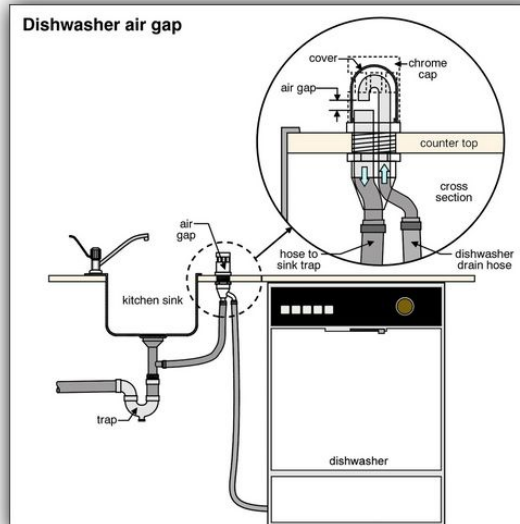
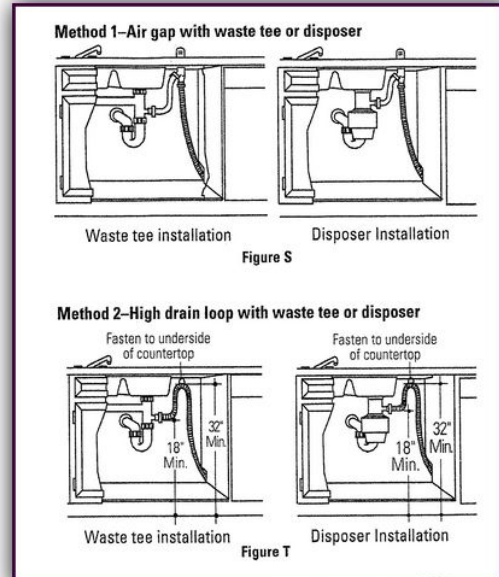
- The dishwasher drain hose is not properly installed to prevent back flow or anti-siphoning. It is recommended that an air gap device or high drain loop be installed in the drain line.

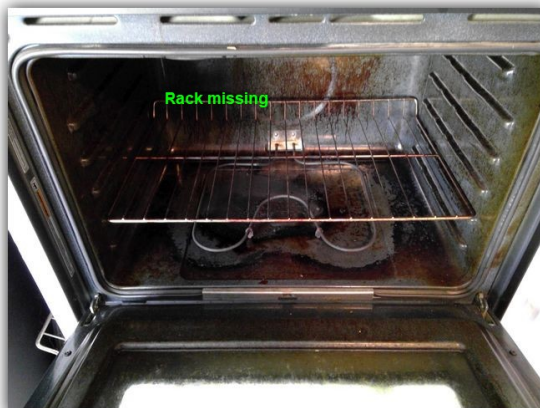
- The oven racks are missing.

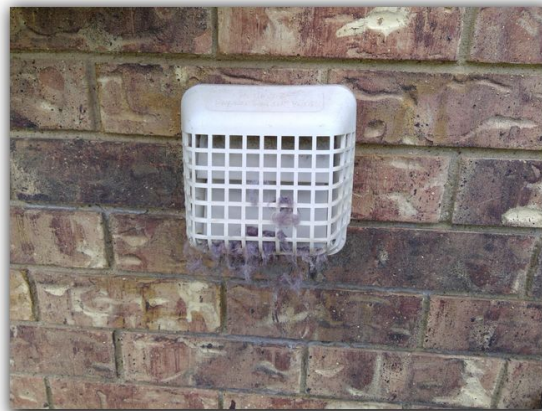
- The dryer exhaust duct (vent pipe) is dirty and needs to be cleaned.
- The dryer duct termination was observed to be screened. Screening the termination is not permitted under current installation standards. **Note:** Screening the dryer termination will cause the dryer duct to clog and will not allow the dryer to operate efficiently.

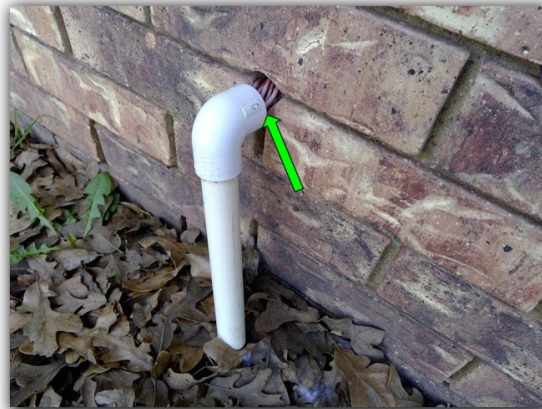
- I was unable to locate a moisture (rain / freeze) sensor device for the sprinkler system. This is an “*as-built*” condition, but *Per TREC standards of practice we are required to report this condition as a deficiency.*
- The conduit that is protecting the sprinkler system wires is damaged.
- One or more of the sprinkler heads need to be adjusted and/or straightened so to disperse water properly in station(s); **2, 8, 11.**
- One or more of the sprinkler heads need to be adjusted so not to disperse water onto concrete flatwork (such as; roadways, sidewalks, porches, patios or driveways) in station(s); **3, 6, 11.**
- One or more of the sprinkler heads need to be adjusted so not to spray water onto the exterior walls, surfaces or windows in stations; **6, 7.**
- One or more of the sprinkler heads do not pop-up high enough to disperse water properly in station(s); **7, 9.**

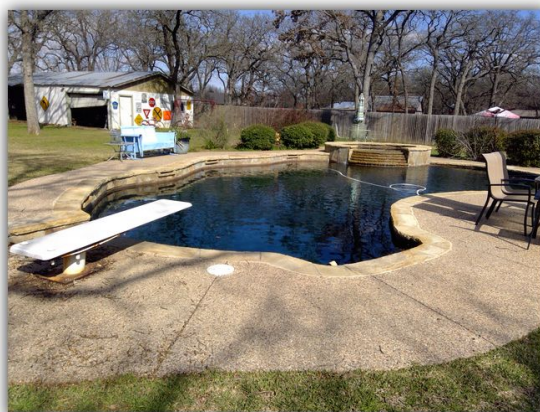
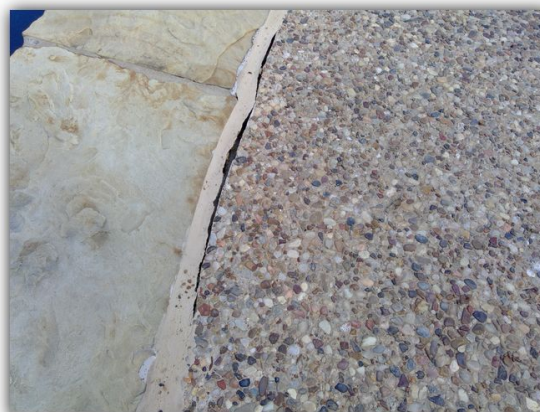
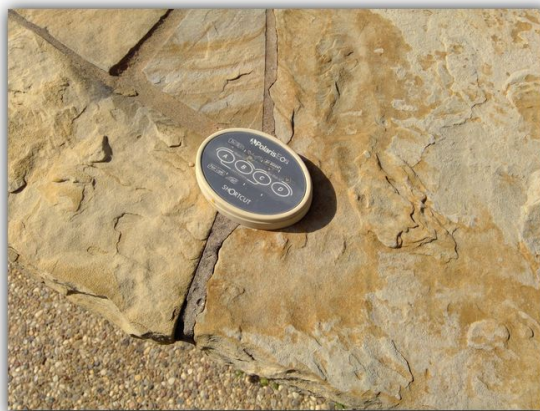
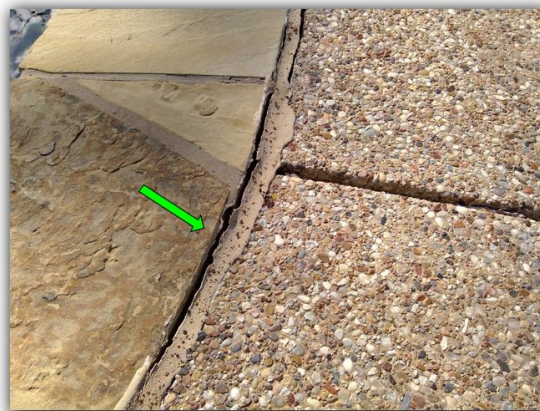
- All pedestrian access gates should open outward away from the pool and should be self-closing and have a self-latching device. Where the release mechanism is located less than 54 inches from the bottom of the gate. A second release mechanism should be located on the poolside of the gate at least 3 inches below the top of the gate.
- Under current standards, all of the homes entry doors that give access to the pool area should be equipped with an audible alarm that can be heard throughout the house, sound continuously for 30-seconds, and be mounted at least 54-inches from the doors threshold. A self-closing and self-latch door device can be used in lieu of the audible alarm system as long as the protection is not less than the audible alarm.
