December 28, 2020

PROPERTY INSPECTION REPORT

Concerning: 1138 New House St, Fort Worth, TX 76008
(Address or Other Identification of Inspected Property)

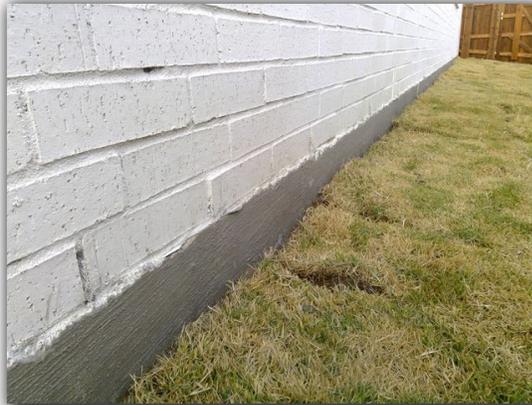
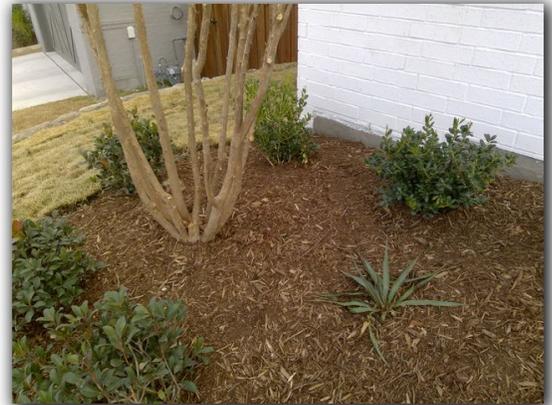
- **Note:** The application of a skim coat was observed in one or more areas of the foundation perimeter beam. Client should be aware that this can reduce the visibility of the perimeter beam and could cover up the possibility of damage to the foundation. This should be monitored and corrected if necessary.
- **Note:** Tree(s) in close proximity of the foundation was observed. Client should consider the installation of a root barrier to reduce the possibility of damage to the foundation from tree roots and moisture removal.

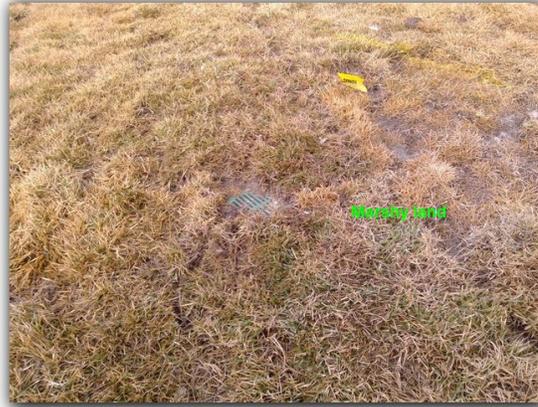
Grading & Drainage

- There is standing water around a subsurface drain termination on the south side. This can indicate a blockage in the system. Proper drainage is needed to help prevent water from standing and/or ponding next to the foundation beam. Corrective measures may be needed if the water stands within 10-feet of the foundation perimeter beam for more than 24-hours.

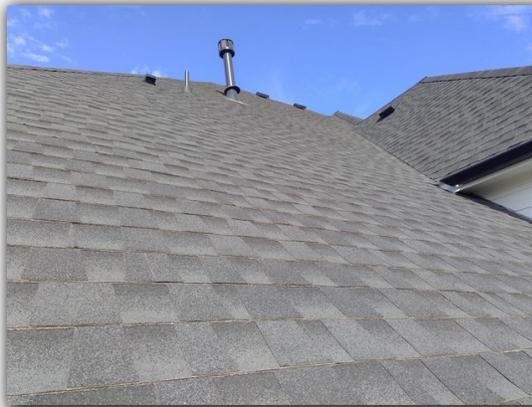
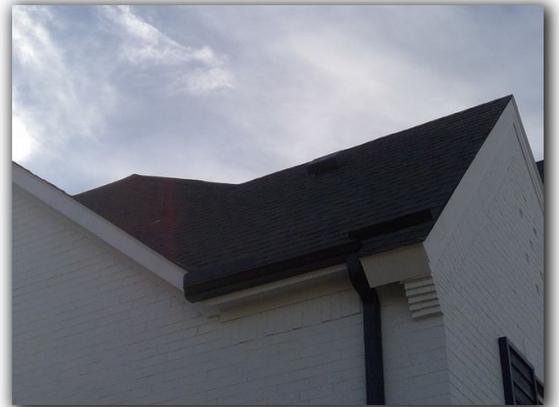
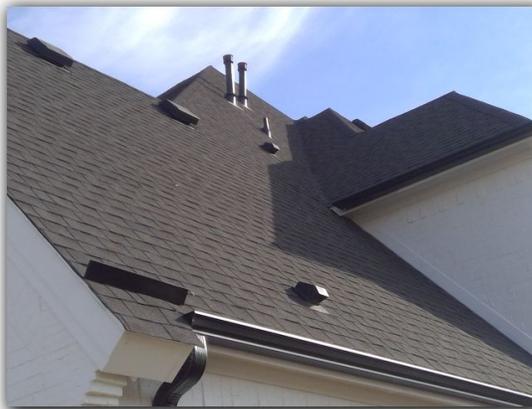
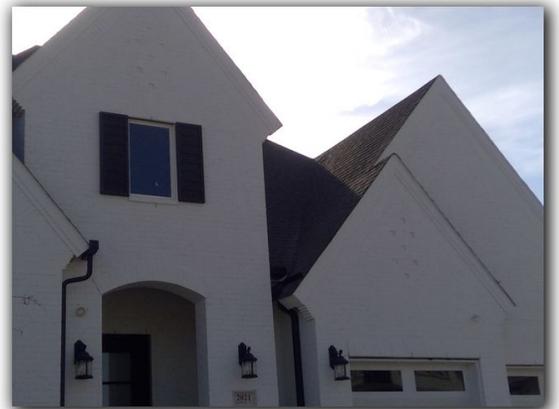
- **Note:** High shingle fasteners (staples and/or nails) were observed in various locations.

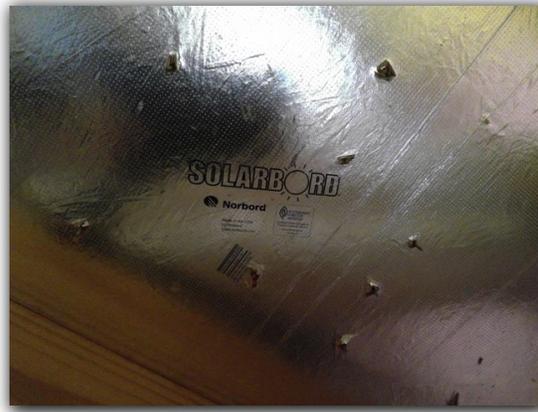
Roof Sheathing

- Note: A radiant barrier type of product is installed inside the attic structure. While this can help to improve the energy efficiency of the structure. These types of products can limit the visibility for the inspector. For best results it should be removed prior to any inspections.

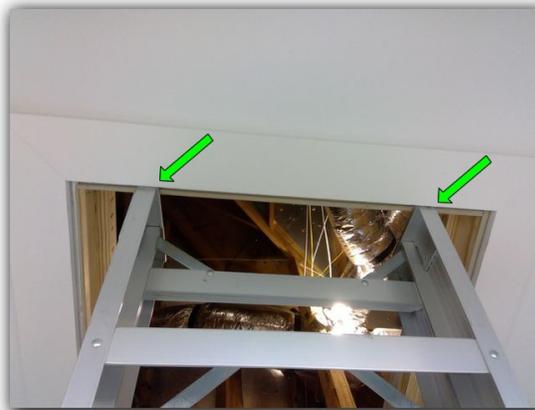
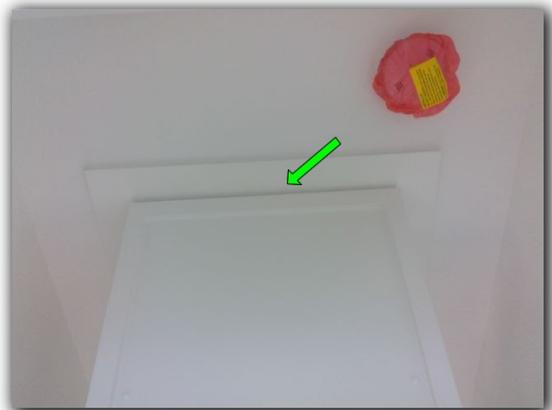
Upstairs Attic Ladder

- The upstairs attic access has been improperly installed and there does not appear to be enough clearance to extend the ladder. This should be corrected to ensure proper access can be obtained.

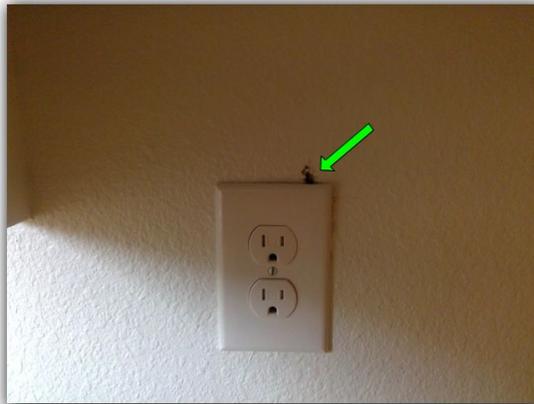
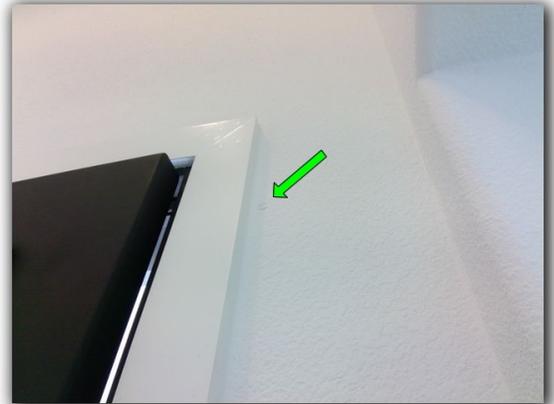
- The wall texture has some deterioration and/or damage in the pantry, front entrance area.

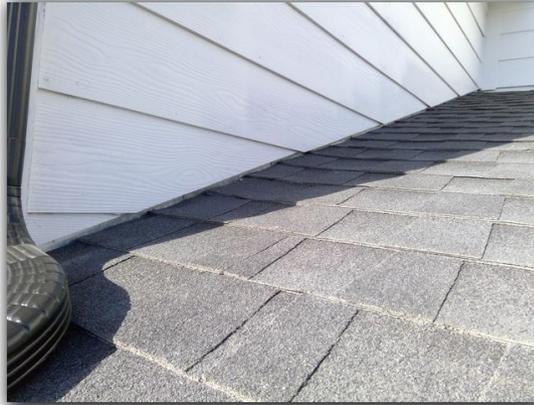
Exterior Walls & Surfaces

- The sidewall veneer / cladding is too close to the roofing material. Under current building standards, there should be at least 2-inch of clearance between the roofing material and the sidewall veneer / cladding.

At the juncture of the roof and vertical surfaces, flashing and counterflashing shall be provided per the roofing manufacturer's Instructions. Provide a 2" clearance between the roofing and the bottom edge of the siding and trim.

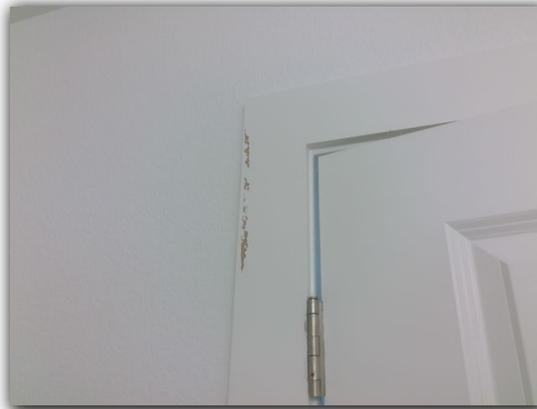
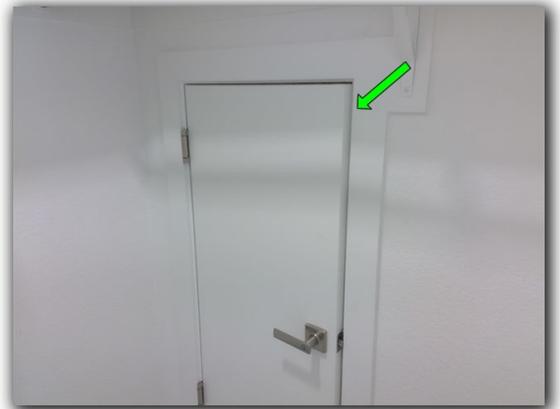
Interior Doors

- The door frame has some texture damage to the upstairs guest bathroom.
- The door is sticking to the attic door.
- **Note:** One or more of the door stoppers were observed to be missing.

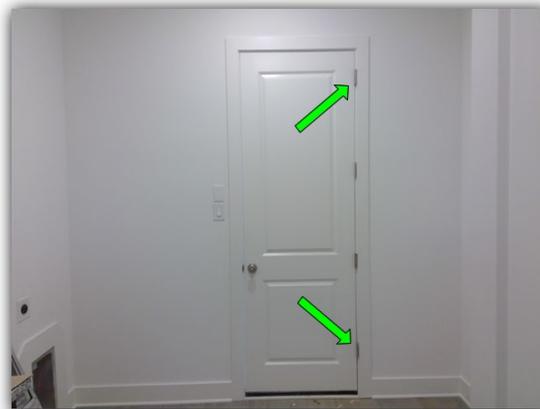
Garage Entry Door

- The garage entry door is not equipped with a self-closing device.

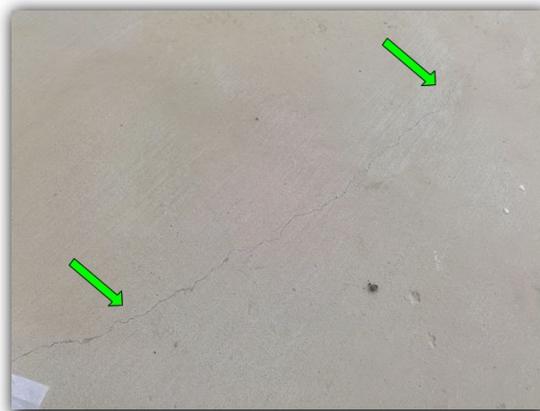
Some deflection and/or cracking of the patio concrete flatwork was observed.

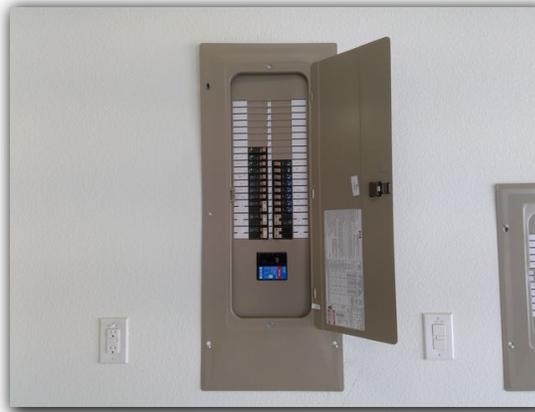
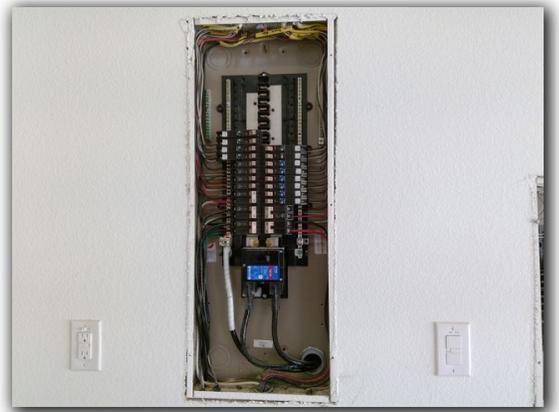
- One or more of the cabinet cover plate screws are missing and need to be replaced.

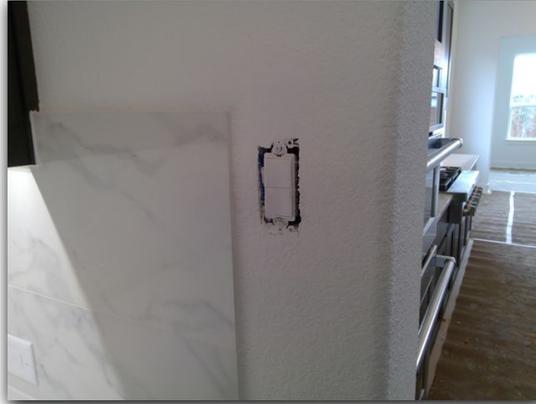
- The switch is missing its cover plate in the kitchen.
- **Note:** I was unable to determine the operation end of one or more of the switches.

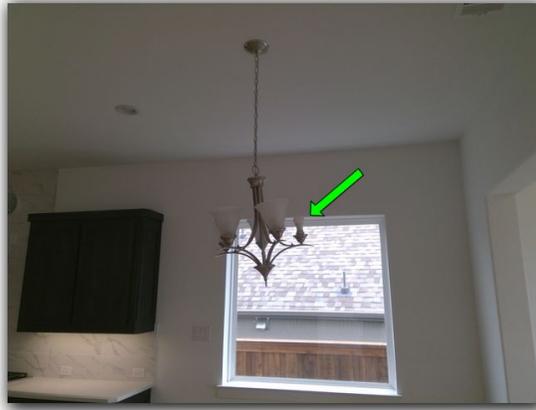
Fixtures

- One or more of the light fixture globes and/or covers are damaged in the breakfast area.

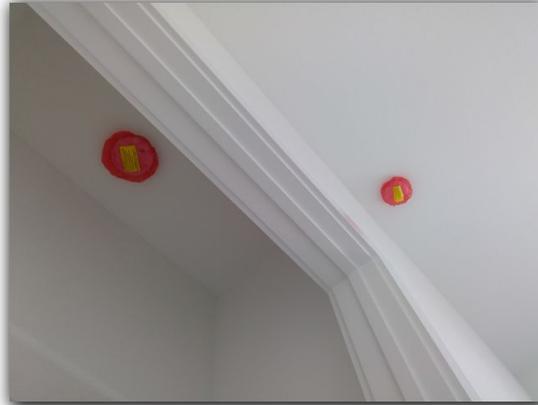
- The plastic covers should be removed from the smoke alarms to ensure proper operation.

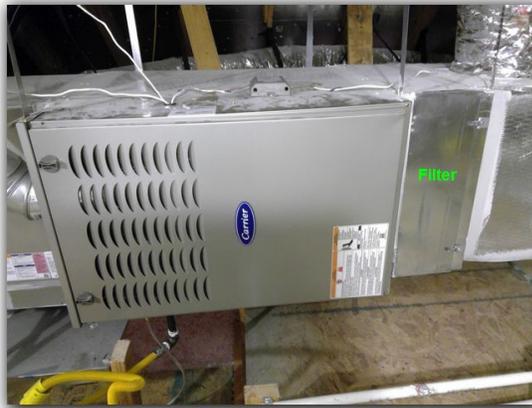
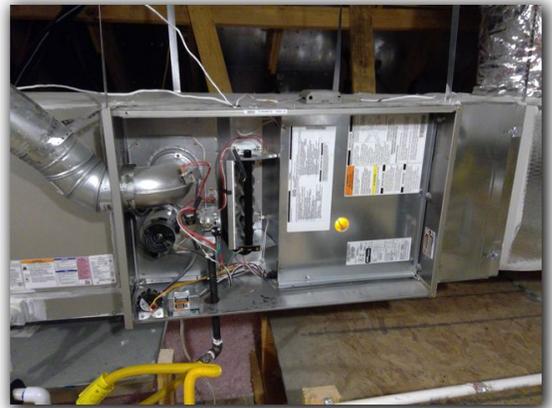
- The dirty air filter should be replaced.

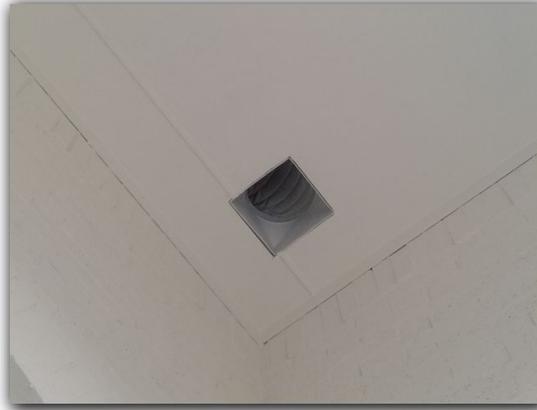
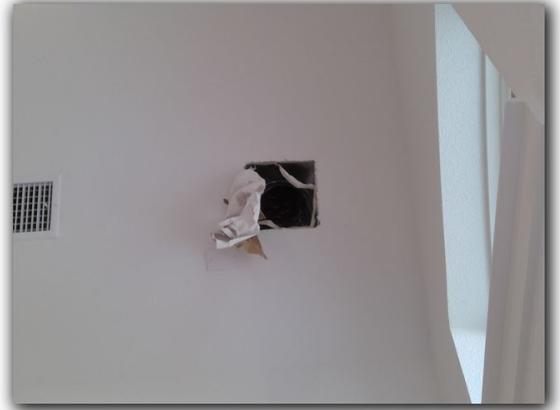
- The fresh air intake appears to be missing its interior and exterior covers. It should be further evaluated and corrected as necessary.

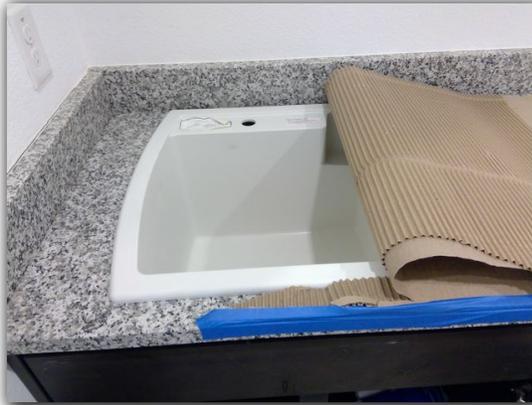
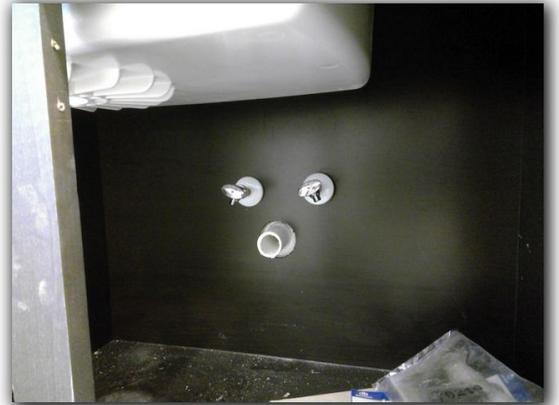
Laundry Sink

- The laundry sink is missing its hardware and associated components.

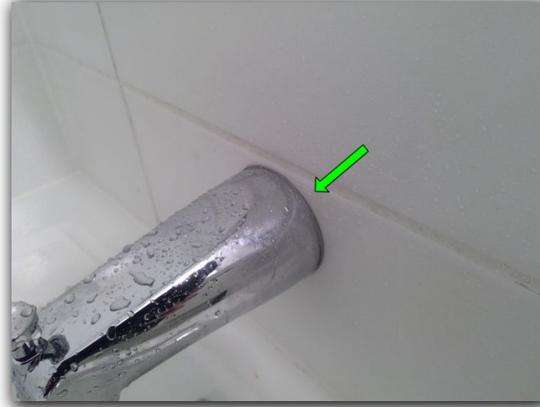
- The tub spout is not sealed at the wall. This condition has the potential to allow water to leak back into the wall cavity.

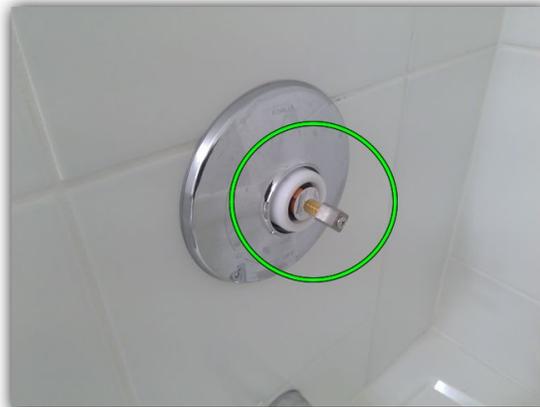
- The faucet handle is missing.

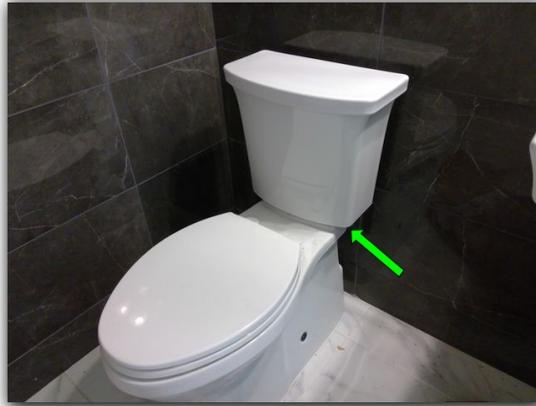
- The commode tank is loose at the bowl connection.

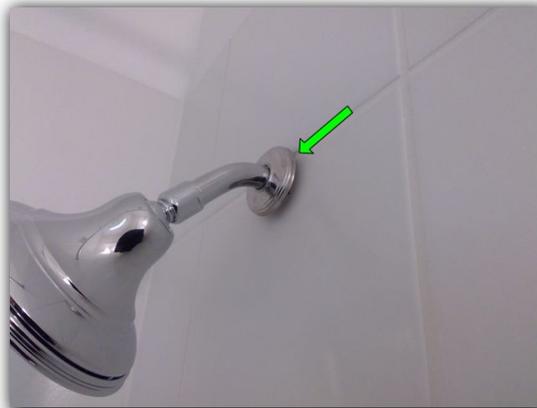
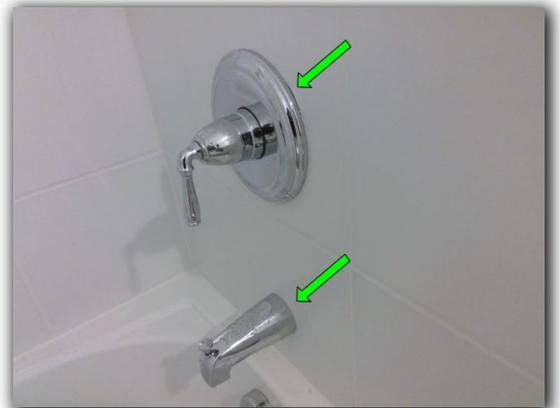
- The shower head assembly is loose within the wall cavity area.
- The tub spout is not sealed at the wall. This condition has the potential to allow water to leak back into the wall cavity.
- The faucet assembly is not sealed at the wall. This condition has the potential to allow water to leak back into the wall cavity.

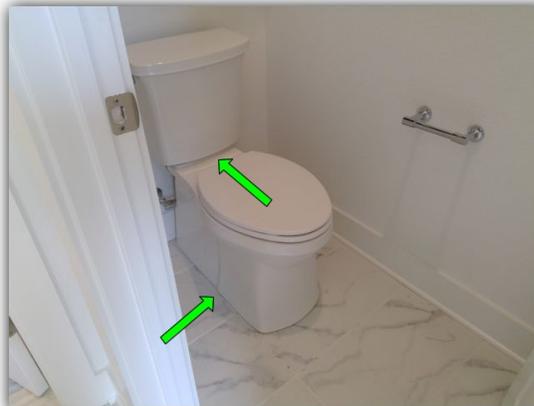
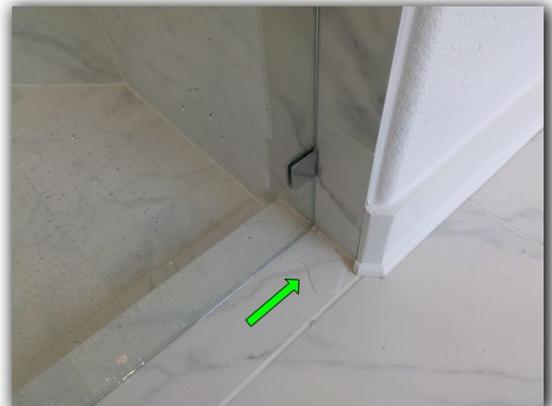
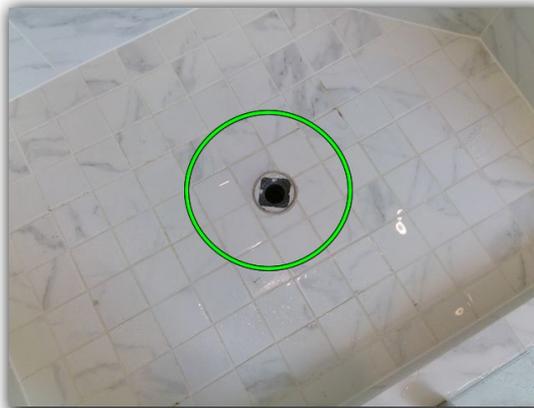
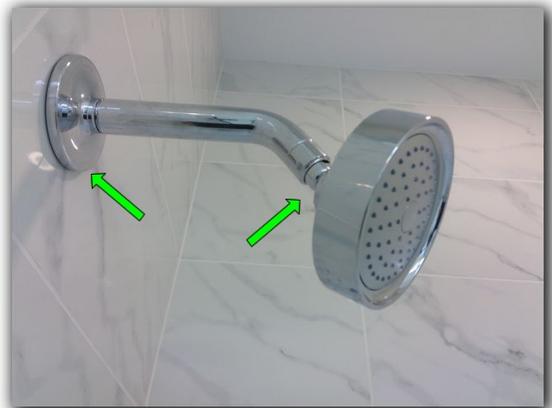
- The shower spout is leaking at the neck connection.
- The shower head assembly is loose within the wall cavity area.
- The shower enclosure is not water tight and leaks to the area adjacent to the shower. This condition should be further evaluated and corrected as necessary.
- The shower drain cover is missing.

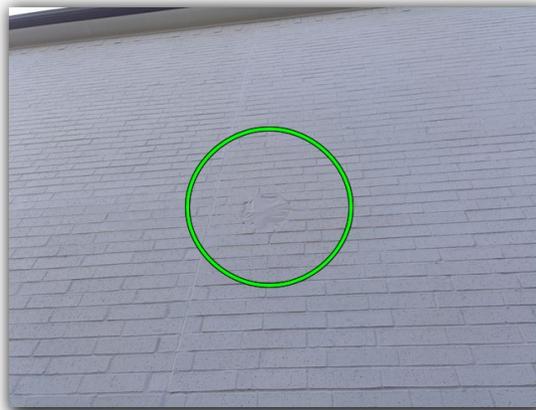
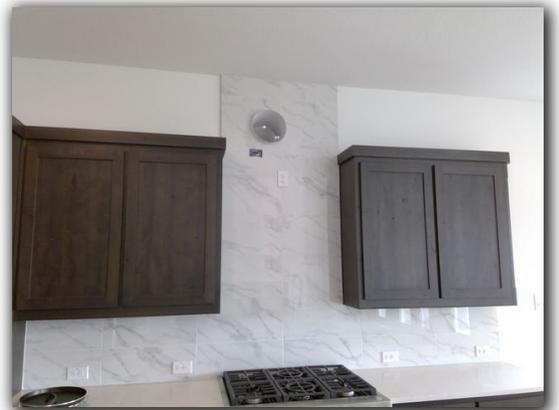
- The range hood and its associated components are missing.
