February 20, 2020

PROPERTY INSPECTION REPORT

Concerning: 69 Joyfull Way, Dallas, TX 75206

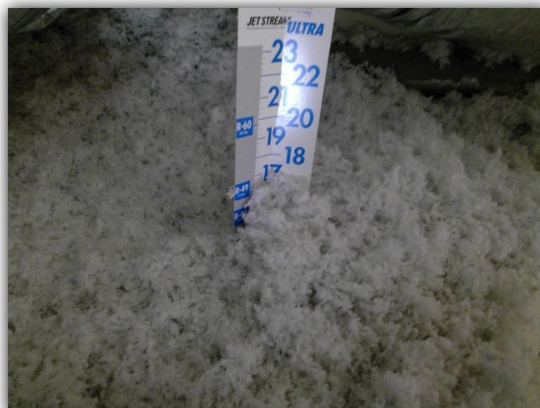
- The roof structure attic space ventilation appears to be marginal at the time of this inspection. It is recommended to increase the amount of lower and upper ventilation to help prevent heat buildup in the attic space area.

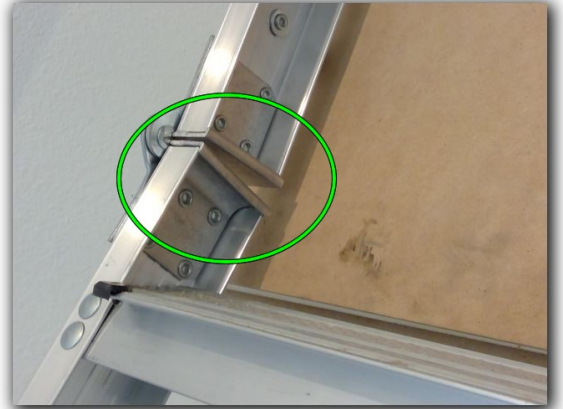
Upstairs Stairwell Attic Ladder

- The attic ladder was observed to have gaps at the joints when the ladder was fully extended. Improvements are recommended for reasons of safety.

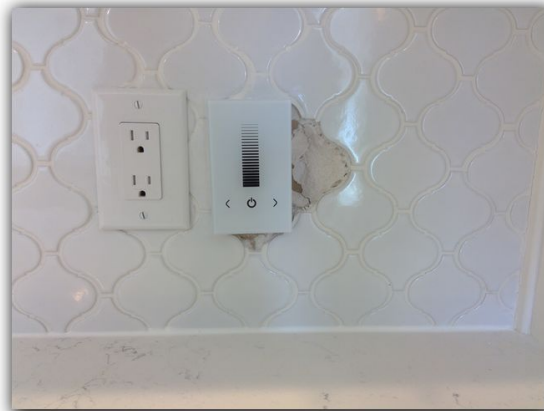
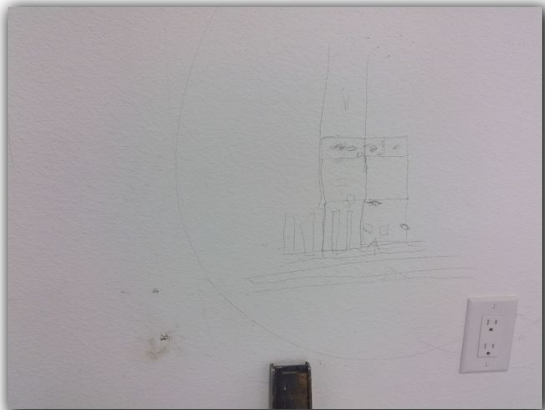
Note: Nail heads were observed to be pushing through the interior finish in one or more locations.

- The wall texture has some deterioration and/or damage in the garage, stairway, various locations throughout the house and paint touch ups are recommended.
- Wall surface damage was observed in the kitchen.

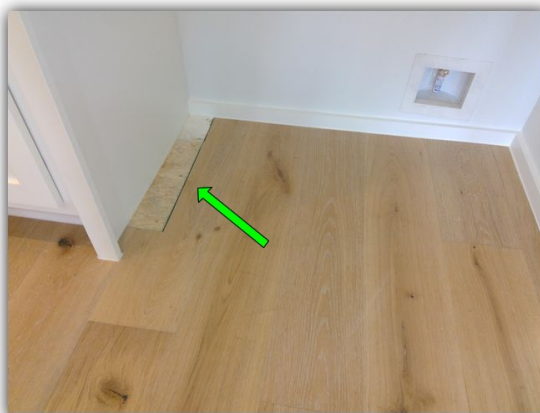
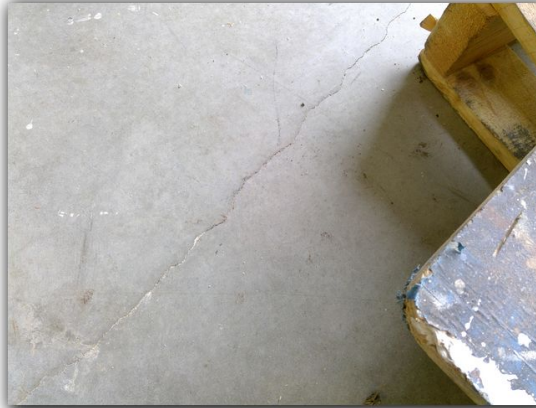
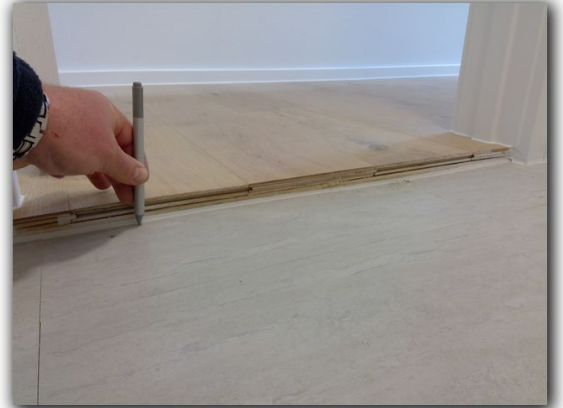
Floors

- The study closet door area is missing a transition strip. There should be a transition/threshold where the elevations of multiple floor surfaces are different.
- The floor covering was observed to be damaged in the kitchen.
- **Note:** Some cracking of the garage concrete floor finish was observed.

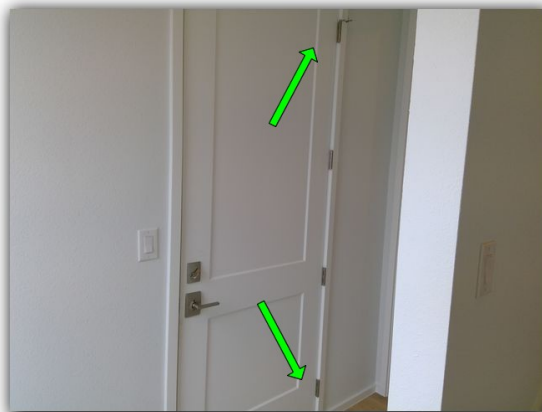
Garage Entry Door

- The garage entry door is not equipped with a self-closing device.

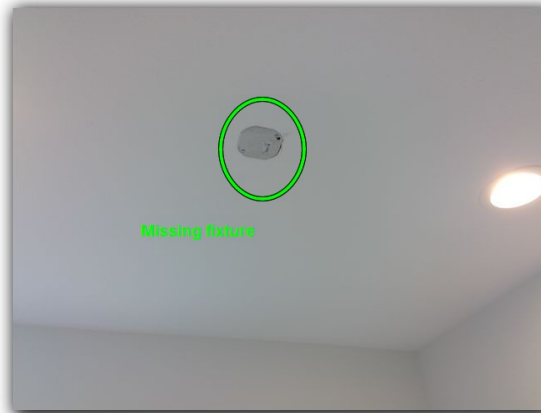
Fixtures

- Some of the light fixtures have been removed and/or missing. The missing fixtures should be replaced where the junction boxes have been covered.

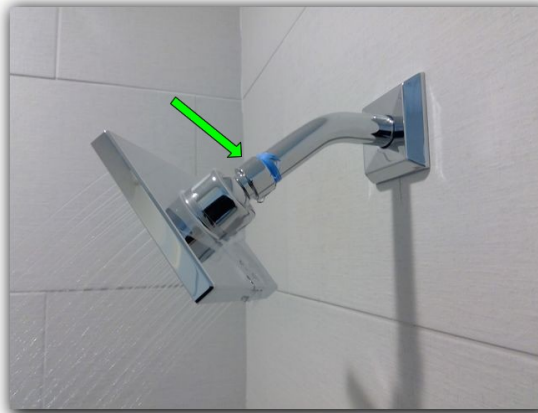
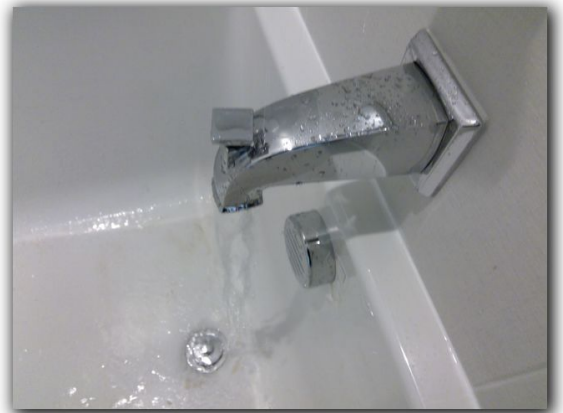
Lavatory / Sink

- The bathtub shower head diverter is not functioning properly.
- The shower spout is leaking at the neck connection.

- The stopper does not appear to be functioning properly.

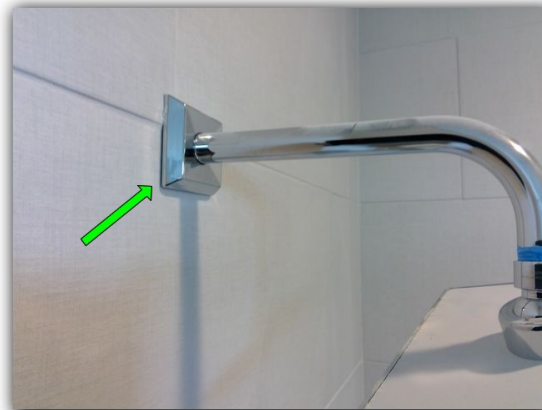
Shower

- The faucet assembly is not sealed at the wall. This condition has the potential to allow water to leak back into the wall cavity.

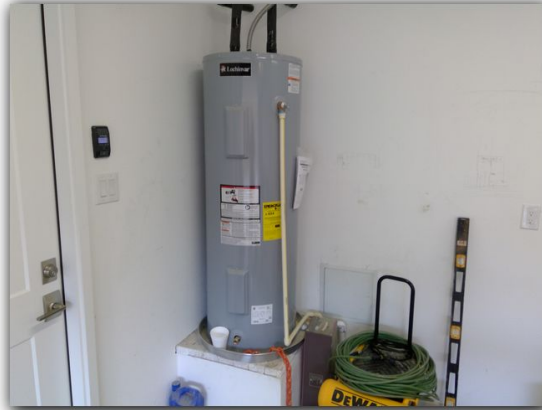
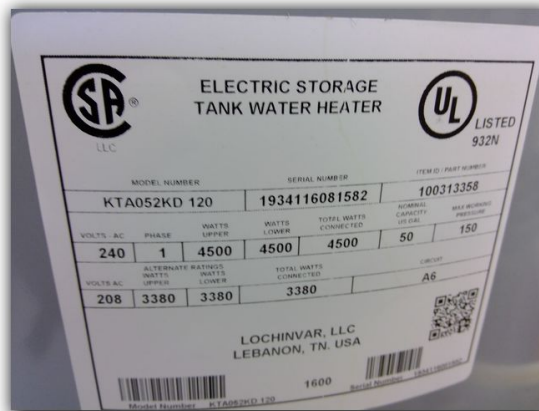
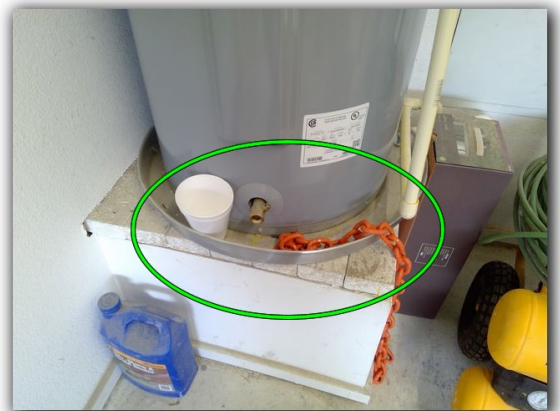
- **Note:** The debris in the water heater pan should be cleaned out to help prevent the pan drain line from being clogged.

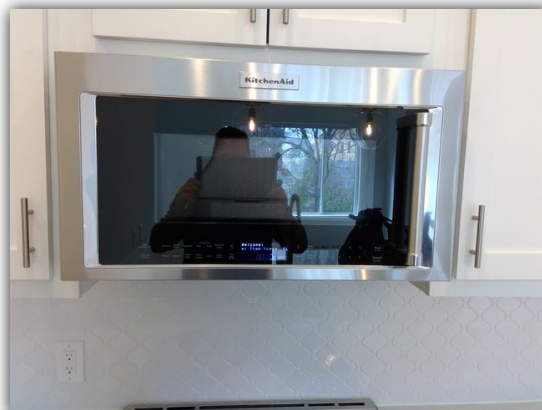
- The range exhaust vent filter is missing.

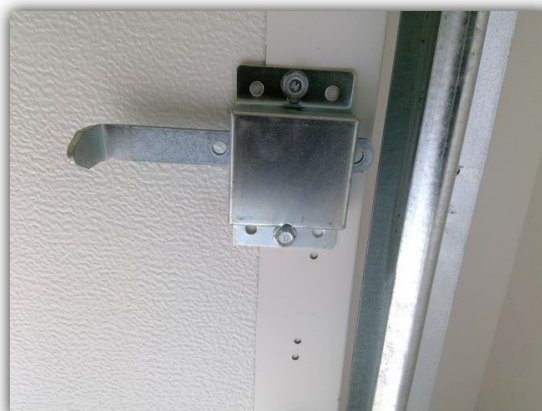
- When an automatic garage door opener is in use, the manual lock should be disabled or removed.
