March 24, 2020

PROPERTY INSPECTION REPORT

Concerning: 222 Lovely Lane, Delightful, TX 75165

By: Nathan Ross, Lic #20282

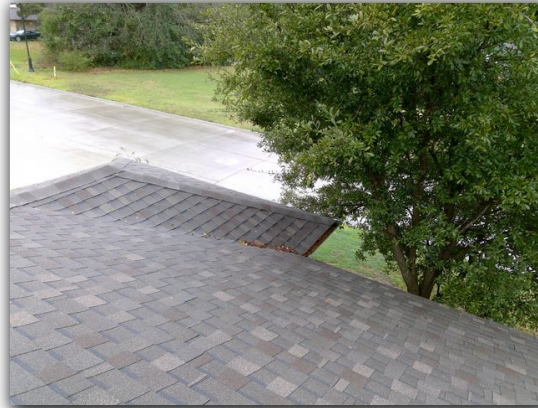
Flashing Details

The flashing details needs to be checked, reset or repaired as necessary. The observations made to support the rendering of this opinion are listed but may not be limited to:

- One or more of the roof level plumbing vent stack flashing details are buckled downward around the plumbing stack. This condition could allow water penetration at this point and corrective measures are recommended.
- The storm collar(s) at the roof level gas equipment vent pipe(s) need to be properly sealed to help prevent water intrusion into the structure.
- The lead jack flashing at the plumbing vent stack needs to be checked, reset or repaired as necessary. The lead jack flashing detail was observed to be improperly installed at one or more of the roof level plumbing vent pipes. The lead flashing should run full length of the vent pipe and turn down into the top of the vent pipe to help prevent water intrusion at this point.
- Some of the metal flashing details were observed to be rusted and should be corrected as necessary.

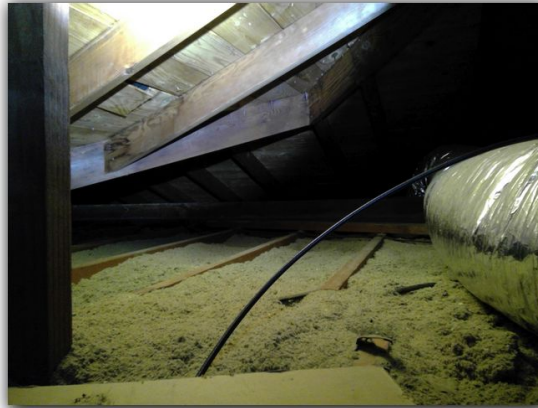
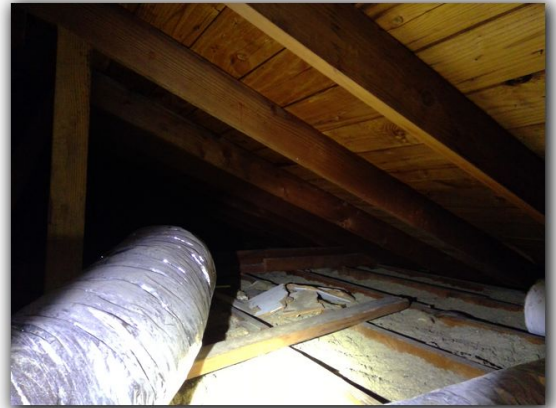
Roof Sheathing

- Some noticeable sags and/or depressions were observed in the roof sheathing (decking).
- Some roof sheathing (decking) deterioration and/or damage was observed in one or more locations.
- **Note:** There are visible water stains on the roof sheathing (decking) in one or more locations.

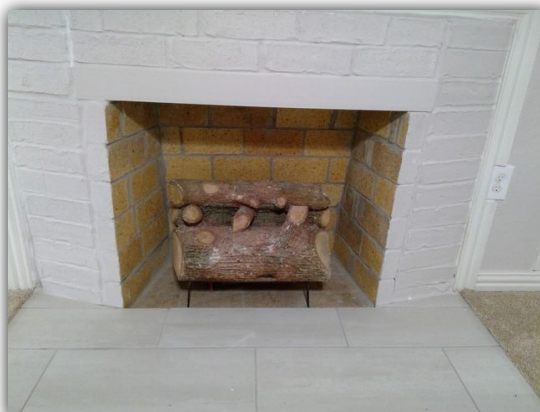
Family Room Fireplace / Chimney

- The firebox does not appear to be vented properly.
- **Note:** There are gas logs installed in the firebox at the time of this inspection. I was unable to view the floor of the firebox at the time of this inspection.

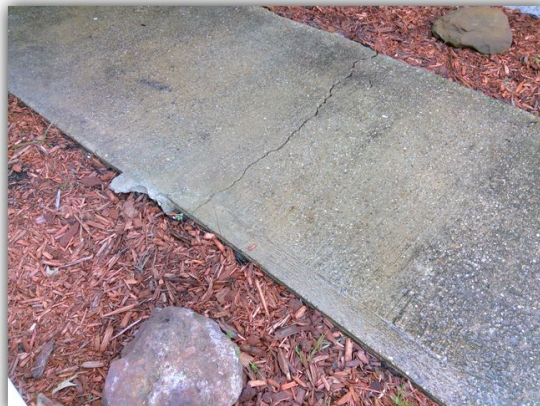
Sidewalk(s)

- The sidewalk has settled somewhat. If this condition persists or if the sidewalk becomes a trip hazard, improvements should be undertaken.

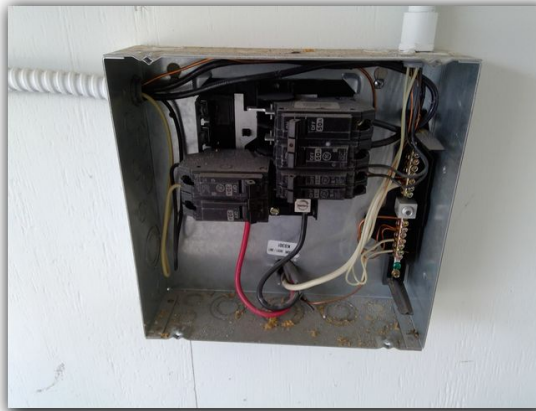
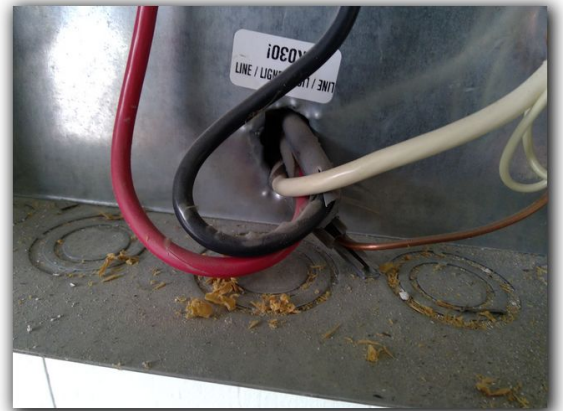
- The breakers (overcurrent devices) in the electrical panel are not properly labeled.
- The wires entering the electrical cabinet are not properly secured or protected from the sharp edges of the cabinet.
- The ground wires and the neutral wires are not properly separated in the sub-panel electrical cabinet. The neutral wires should be on their own isolated bus bar and the ground wires should be connected to the sub-panel cabinet. Although the sub-panel is functional, it does not meet current National Electrical Code standards.

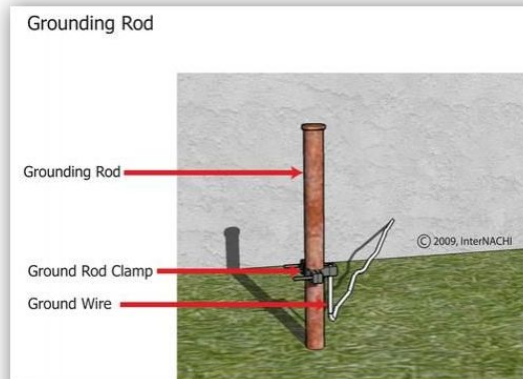
Grounding / Bonding

- I was unable to locate a grounding rod (Grounding Electrode) or supplement grounding source for the electrical system. This condition should be further investigated and corrected if necessary.
- I was unable to locate the electrical bond connection for the gas piping back to the grounding electrode system. All bond connections should be accessible for inspection, repair or replacement. This condition should be further investigated and corrected if necessary.

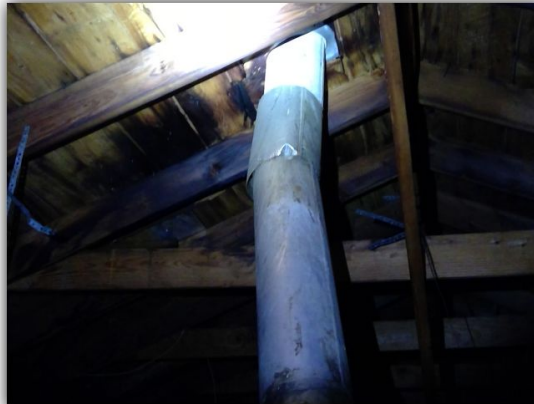
- There is visible rust in and around the burner chamber. There is visible evidence of water leakage into the burner chamber from the cooling coils.
- The electrical branch wires are not properly secured to the heater housing.

- The exposed electrical service wires to the heating equipment should be enclosed in conduit.
- The heater flue is in poor condition and replacement is recommended for reasons of safety.

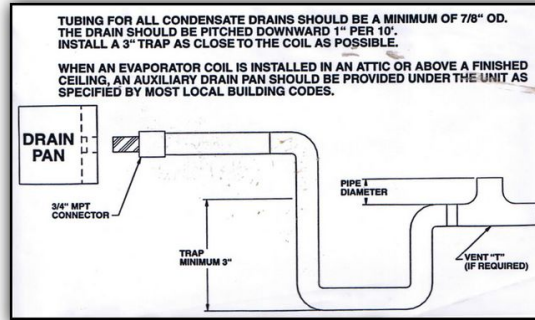
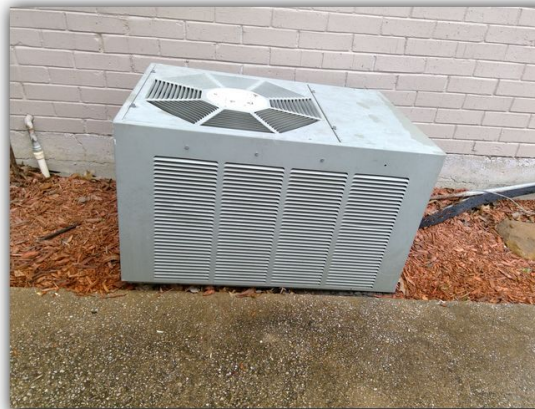
- **Note:** Previous water leakage was observed from around the base of the indoor coil housing. This condition should be closely monitored.

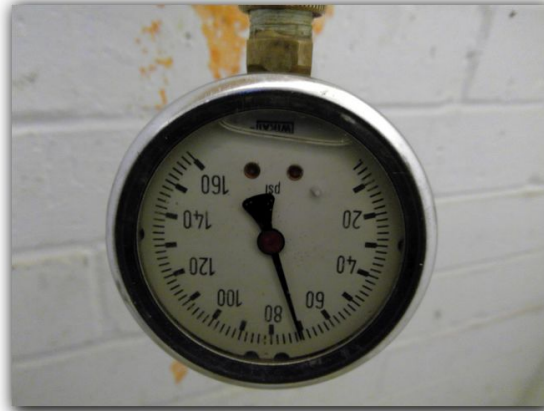
Water Supply System

- All exposed water supply lines in the crawl space area should be insulated to help protect them from possible freeze damage.

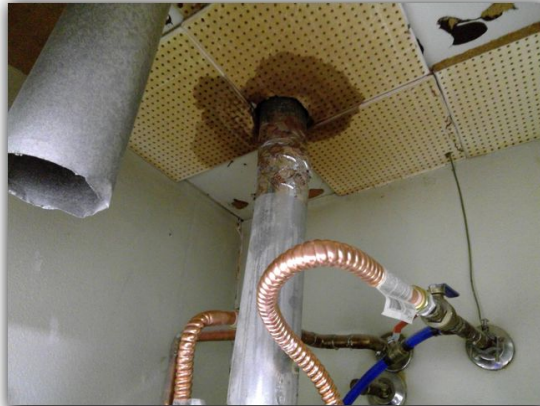
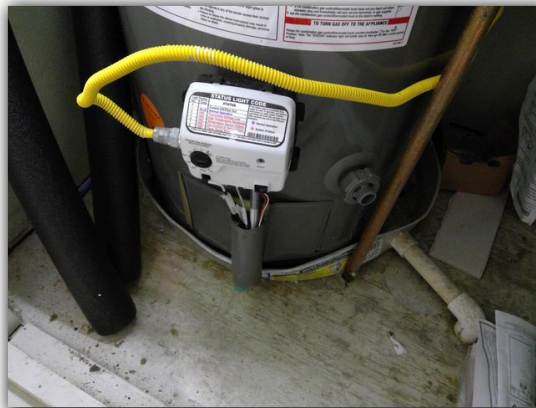
- The pan under the water heater was observed to be damaged and repairs are recommended.
- The water heater flue (vent pipe) has inadequate clearance from combustable materials. Double walled vent pipes should have at least 1-inch of clearance and single walled vent pipes should have at least 6-inches of clearance from combustable material.
- The water heater compartment has inadequate combustion air ventilation. There should be a minimum of 100 square inches of combustion air ventilation provided within 12-inches of the top and bottom of the closet.
- **Note:** The debris in the water heater pan should be cleaned out to help prevent the pan drain line from being clogged.

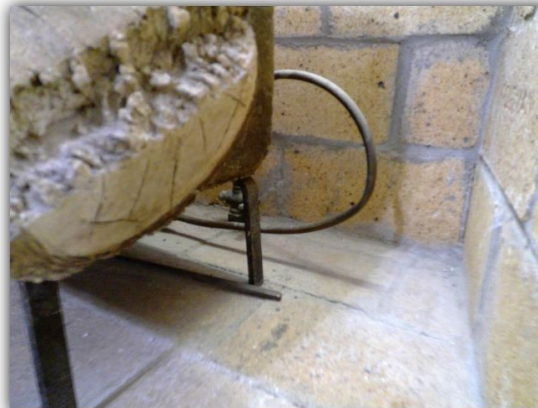
- There are Teflon coated brass gas appliance connectors in use at one or more of the gas appliances. Brass is no longer an acceptable material to be used as a gas supply connector and should be replaced with an approved gas appliance flexible connector.
- The gas service line for the family room should not be made of copper. Under current installation standards, copper is no longer an acceptable material to use for gas lines.
