## PROPERTY INSPECTION REPORT

Prepared For: Sally Samples

Concerning: Luxury Blvd, Arlington, TX 76006

By: Nathan Ross, Lic #20282

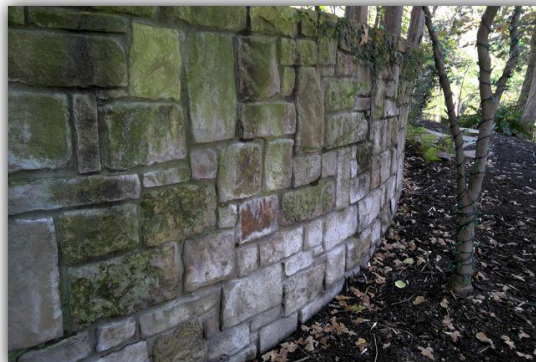
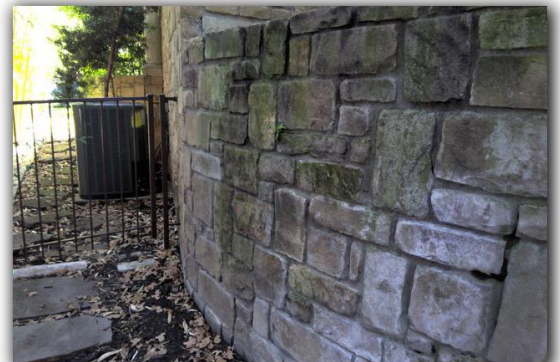
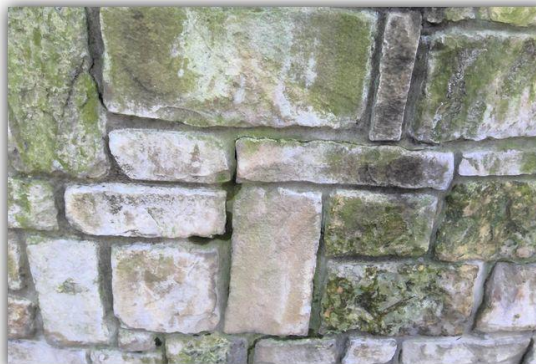
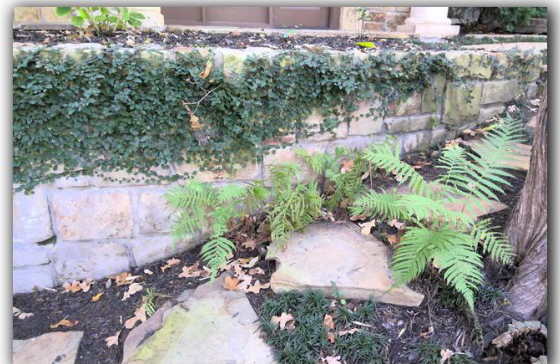
#### **Retaining Wall(s)**

- Ground erosion and/or subsidence was observed at and around the retaining wall area. This condition needs to be corrected to help maintain the integrity of the retaining wall components.

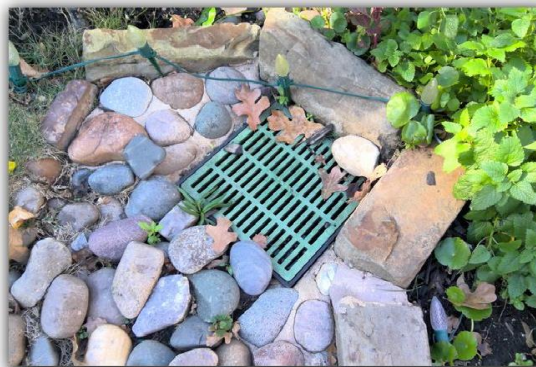
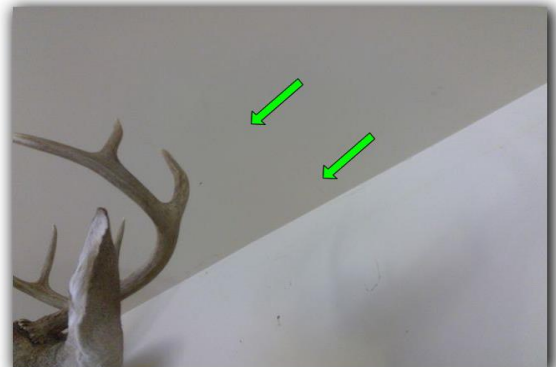
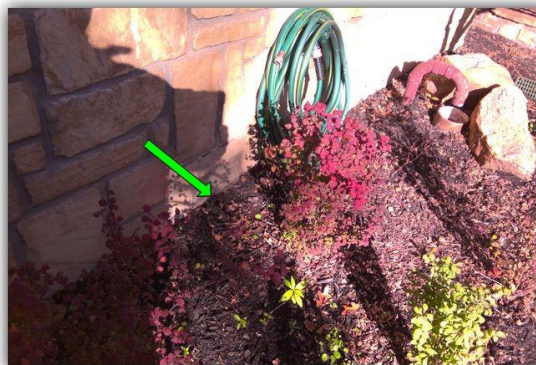
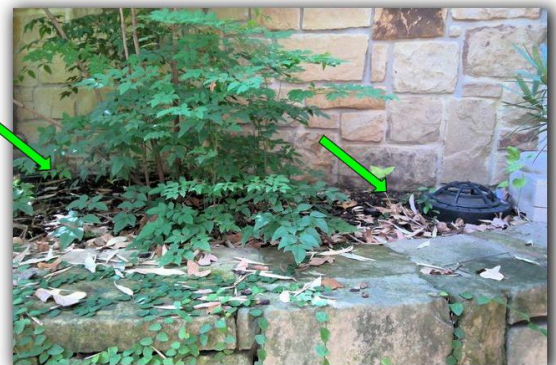
- Poor to negative site drainage was observed on the east side of the structure. Proper drainage is needed to help prevent water from standing and/or pooling next to the foundation beam. Corrective measures may be needed if the water stands within 10-feet of the foundation perimeter beam for more than 24-hours.
- The soil line is too high on the east side, north side of the structure. Under current building standards there should be at least 4-inches of foundation visible below masonry veneer and 6-inches of foundation visible below wood type veneer.

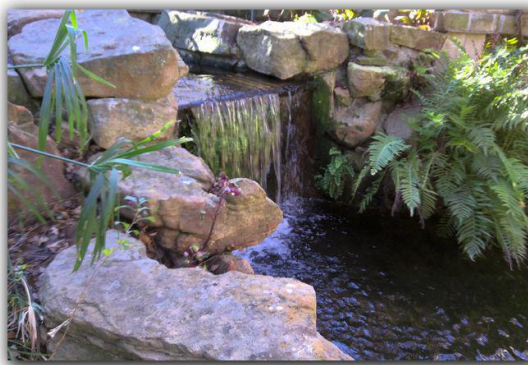
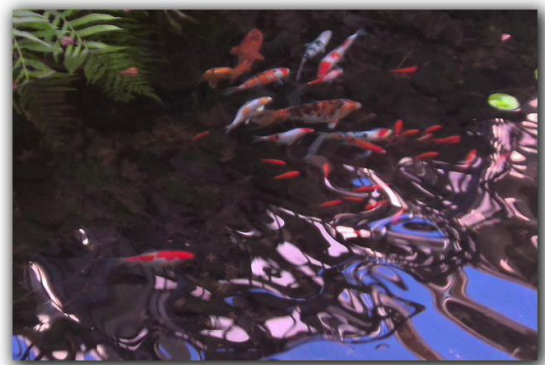
#### **Waterfall and associated components-**

- **Note:** The exterior waterfall and Coy/ fish pond and associated components are beyond the. scope of a home inspection. It is recommended to monitor and if corrective measures become necessary, consult with the current homeowner or a specialist in this field.

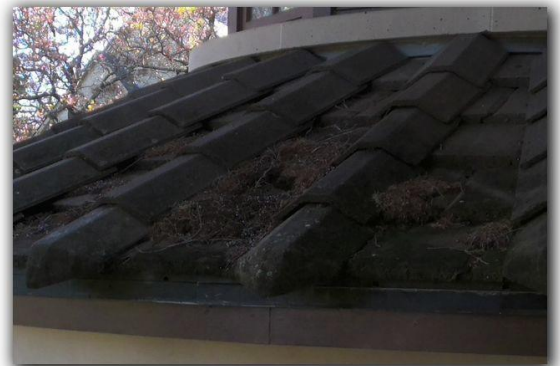
- **Note:** Minor corner cracks were observed on several of the tiles. This is a common condition to observe and no repairs are recommended.
- **Note:** The tile top finish coat was observed to be thinning and/or deteriorated in various locations throughout the roof structure.

- **Note:** Some discoloration of the roofing material was observed.
- **Note:** All debris, such as leaves and branches, should be removed from the roof structure.

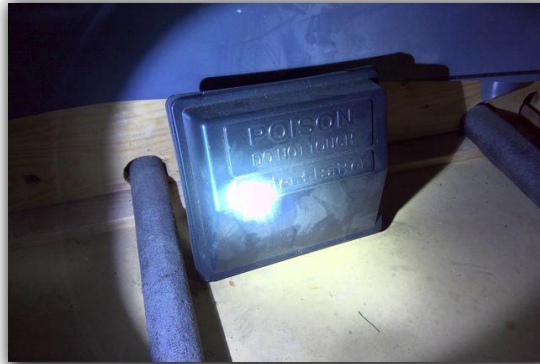
##### Roof Structure

- **Note:** Visible evidence of rodent activity was observed in the attic area. It is recommended to have a Certified Pest Control Operator further evaluate this condition and make corrections as necessary.

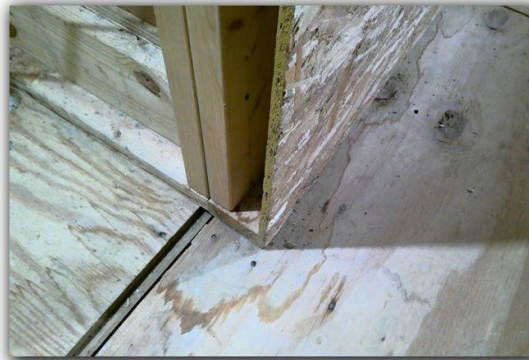
#### Roof Sheathing

- Note: A radiant barrier type of product is installed inside the attic structure. While this can help to improve the energy efficiency of the structure. These types of products can limit the visibility for the inspector. For best results it should be removed prior to any inspections.
- **Note:** There are visible water stains on the roof sheathing (decking) in one or more locations.

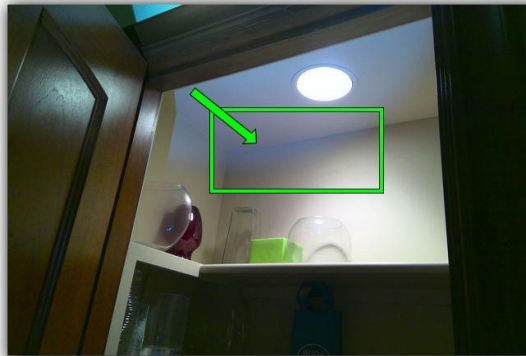
- Moisture stains were observed on the walls in the garage, master bedroom. The cause and remedy should be further evaluated and corrected as necessary.
- The wall texture has some deterioration and/or damage in the garage.
- Wall surface damage was observed in the front entry hallway closet.
- **Note:** There is evidence of painting and patching to the interior finish and prior interior finish repairs. This condition could limit the Inspectors visual observations and ability to render accurate opinions as to the performance of the structure.

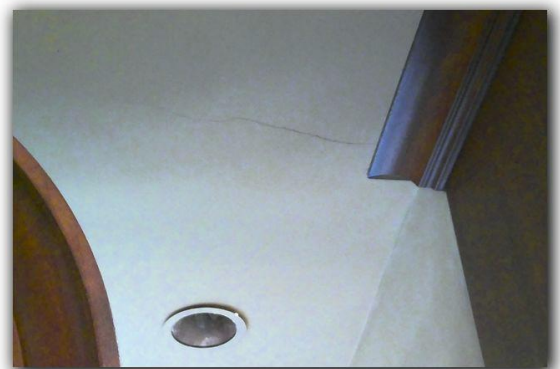
- Ceiling stress cracks were observed in the garage 1, garage 2.
- Ceiling joint cracks were observed in the kitchen, pantry.

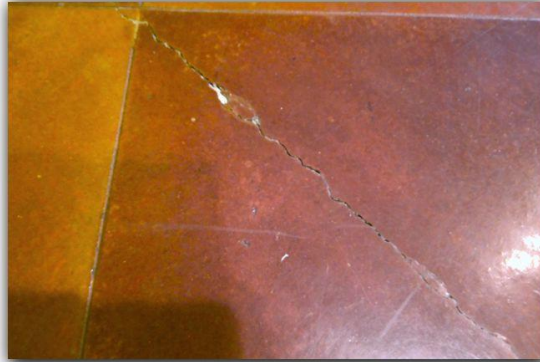
- The floor tile(s) were observed to be cracked and/or damaged in upstairs bedroom hallway, upstairs living room, gameroom.
- **Note:** Some cracking of the garage concrete floor finish was observed.

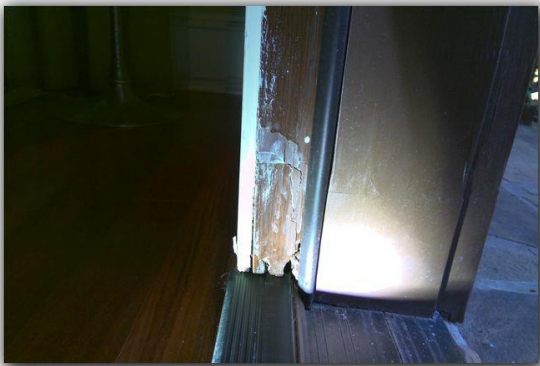
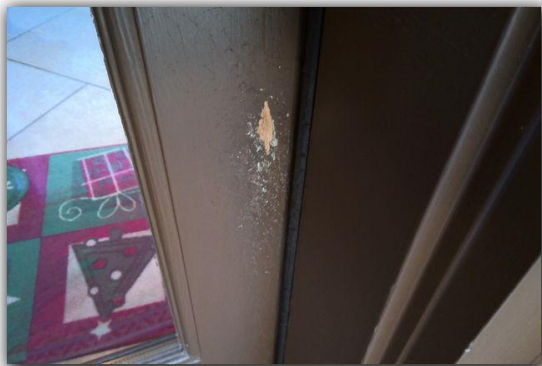
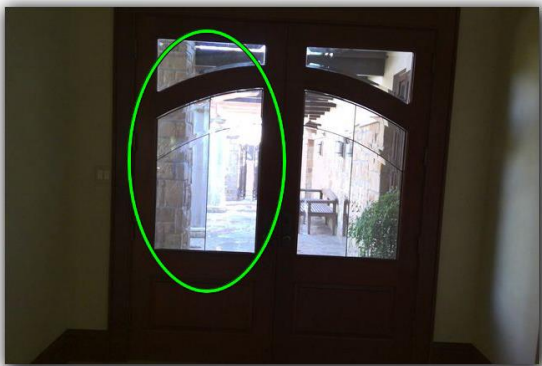
- The exterior door frame has some deterioration and/or damage to the master bedroom back balcony entry door(s).
- The door has some surface damage to the master bathroom back balcony door, backyard entry door.
- Weather-stripping improvements are recommended for the master bedroom back balcony entry exterior door(s).
- Visible evidence of previous water intrusion was observed at and/or around the exterior living room balcony entry side middle bedroom door(s). The cause and remedy should be investigated and corrected as necessary.
- The door frame has some surface damage to the sideyard entry door.
- The door hardware does not function properly to the front entry door.
- The thermal-pane glass has lost its seal to the front entry exterior door(s). This has resulted in condensation and/or a fog like film to develop between the panes of glass.

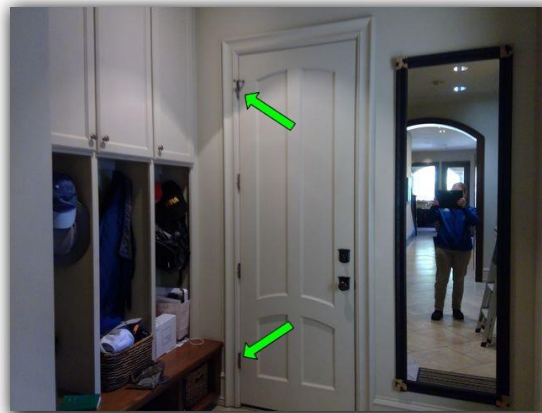
#### Garage Entry Door 1

- The garage entry door is not equipped with a self-closing device.

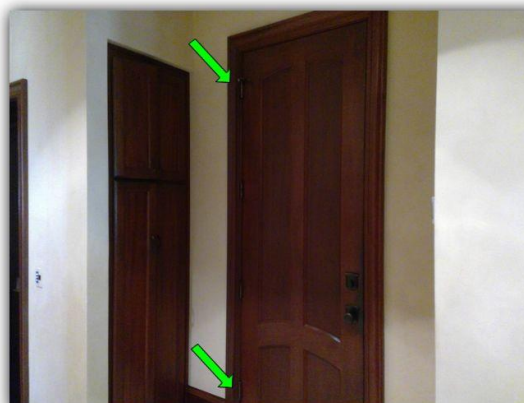
#### Garage Entry Door 2

- The garage entry door is not equipped with a self-closing device.

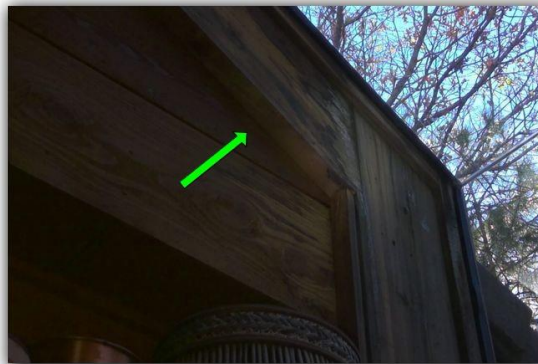
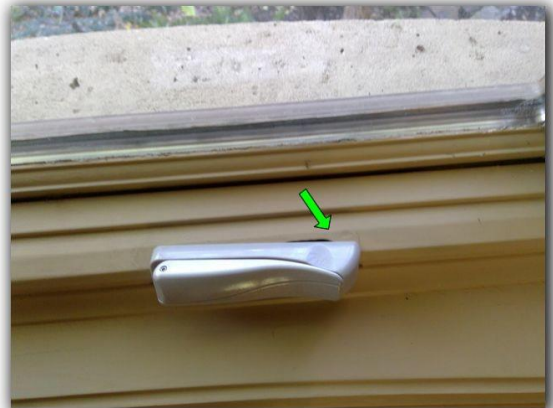
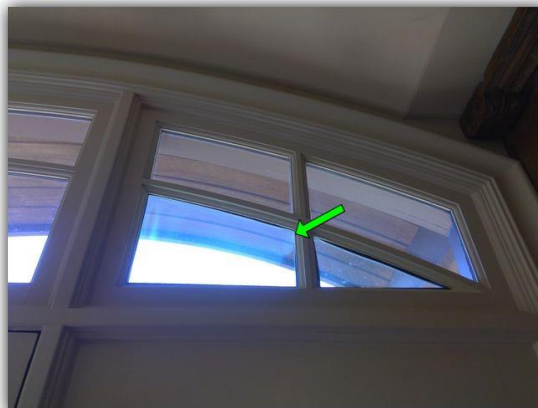
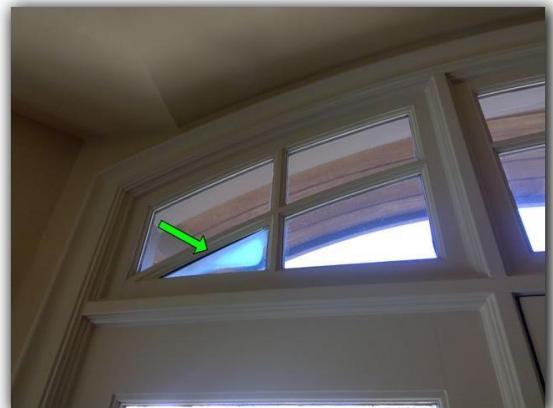
- Window handles(s) were observed to be damaged and/or missing in the workout room.
- One or more of the thermal pane windows were observed to have lost their seals. This has resulted in condensation or a fog like film to develop between the panes of glass. The thermal pane windows no longer function as designed when they loose their seal and replacement may be necessary. The windows that have noticeably lost their seals are listed but may not be limited to the following: upstairs living room, dining room.

- Window lock(s) were observed to be damaged and/or missing in the breakfast area.
- Visible evidence of water intrusion was observed at and/or around the window(s) in the Green/Sunroom. The cause and remedy should be investigated and corrected as necessary.
- **Note:** I was unable to visually inspect or operate of some of the windows due to height, window treatments, personal effects, large, heavy or fragile storage and/or furniture.
- **Note:** The windows are dirty and need to be cleaned. Dirt on the windows can limit visibility when inspecting the thermal panes and their seals. It is recommended to inspect clean windows for best results.

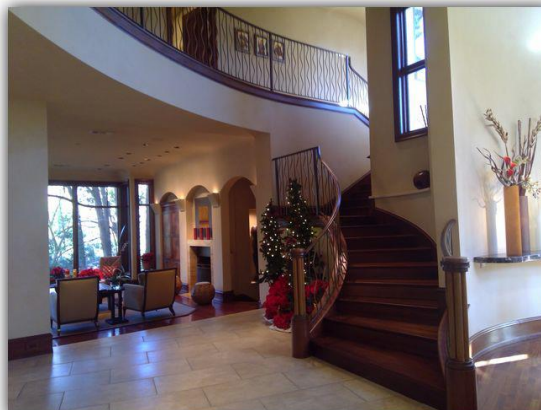
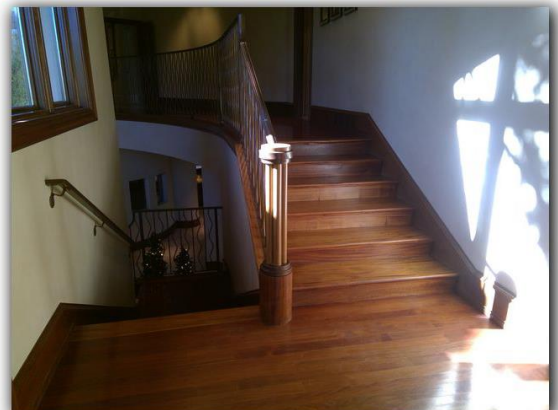
- One or more of the stairway risers do not appear to meet current building standards. The stairway risers should not extend more than 7 ¾-inches and there should not be a difference more than 3/8-inch between any of the risers. This condition can cause a tripping hazard while traversing the stairway components.

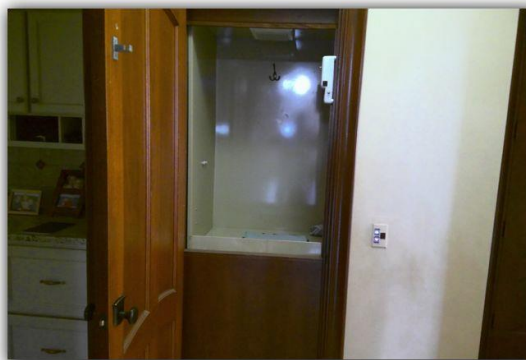
#### Interior Stairway Master Bathroom

- There is no handrail in place for the stairwell. For improved safety, it is recommended that a handrail be installed.

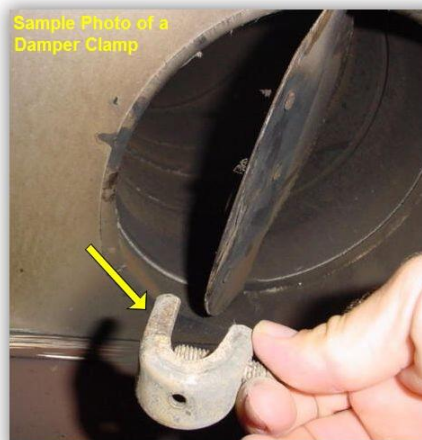
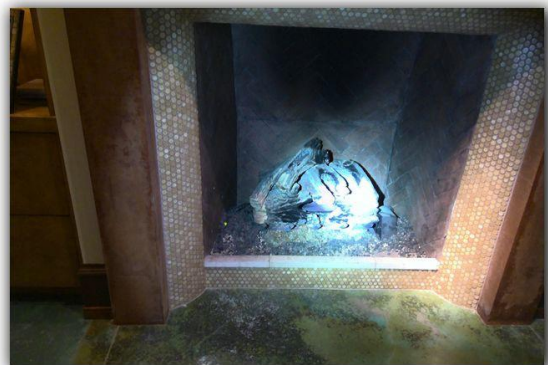
#### Study Area Fireplace / Chimney

- When artificial gas logs are installed in a firebox with a damper; the damper should be permanently blocked open with a damper clamp to prevent accidental spillage of carbon monoxide into the living space.
- **Note:** There are gas logs installed in the firebox at the time of this inspection. I was unable to view the floor of the firebox at the time of this inspection.

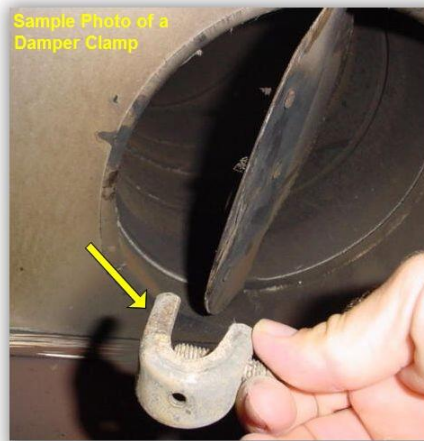
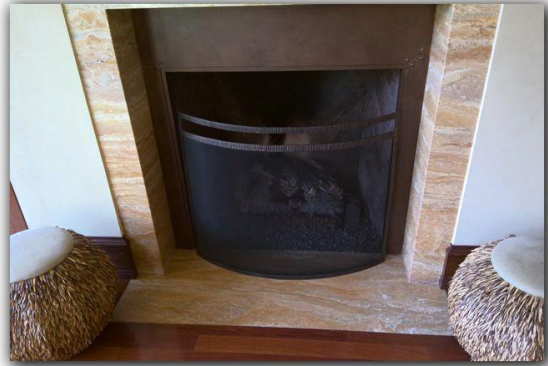
#### Family Room Fireplace / Chimney

- **Note:** There are gas logs installed in the firebox at the time of this inspection. I was unable to view the floor of the firebox at the time of this inspection.
- When artificial gas logs are installed in a firebox with a damper; the damper should be permanently blocked open with a damper clamp to prevent accidental spillage of carbon monoxide into the living space.

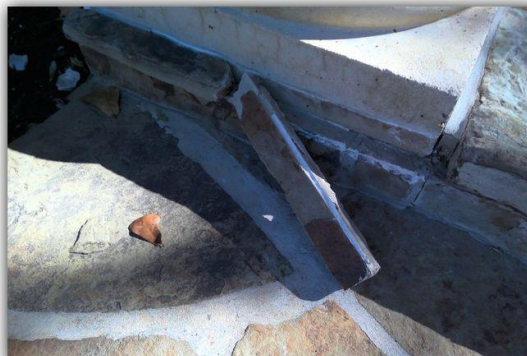
##### **Porches -Rear**

- The stones are damaged and loose and repairs are necessary .

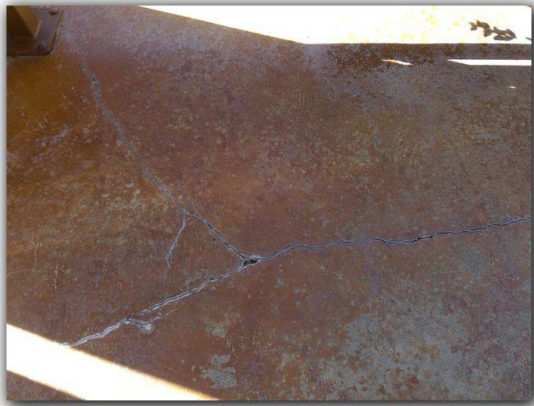
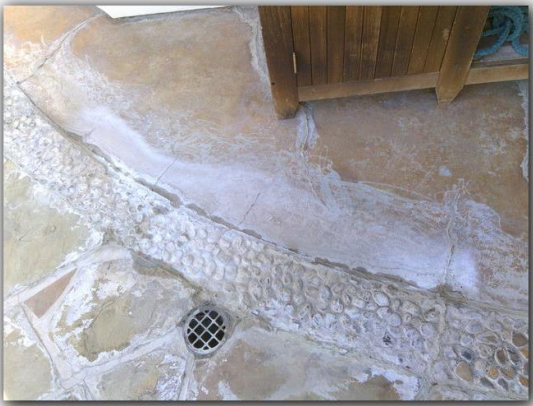
**Living Room Balcony**

- Some deflection and/or cracking of the patio concrete flatwork was observed.
- The balcony floor / flatwork appears to be holding water. This condition needs to be further evaluated and corrected as necessary.

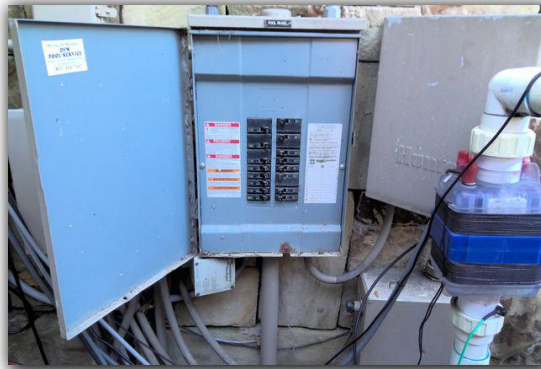
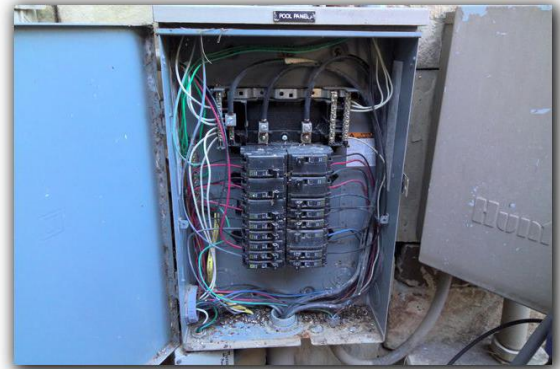
- The breakers (overcurrent devices) in the electrical panel are not properly labeled.
- The panel box does not have proper clearance in front of the cabinet. The panel box cover plate (Dead Front) and/or cabinet should be readily accessible and cover easily removable at all times. Under current electrical standards, the accessible workspace around the panel box should be at least 36-inches in depth in front of the cabinet and 30-inches in width or the width of the equipment. Clothes, shelves, cabinets, foliage, etc should not block the workspace in front of the cabinet.
- Some of the electrical cabinet interior components were observed to have some minor rust and/or corrosion on them. This condition should be further evaluated and corrected as necessary.

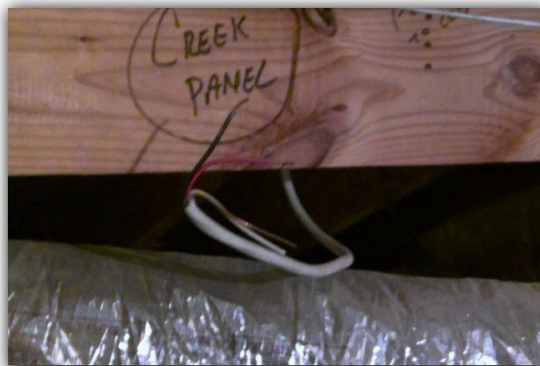
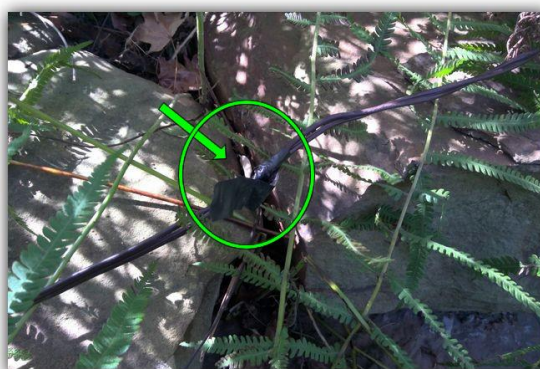
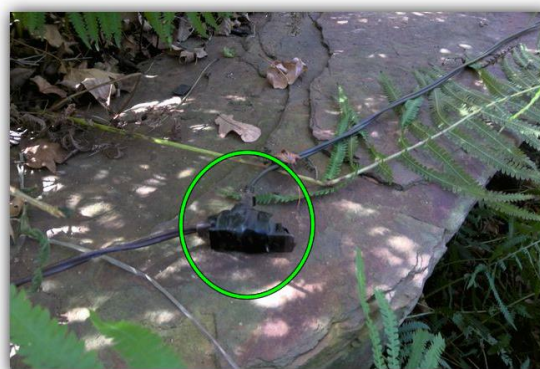
#### Distribution Wiring

- Spliced wires were observed in the waterfall. The spliced wires need to be properly enclosed in an electrical junction box for reasons of safety.
- Electrical flex extension cords should not be used for permanent wiring or pass through walls or ceilings. The improper use of extension cord was observed in or around the north exterior waterfall area.
- Open end wires were observed attic area.

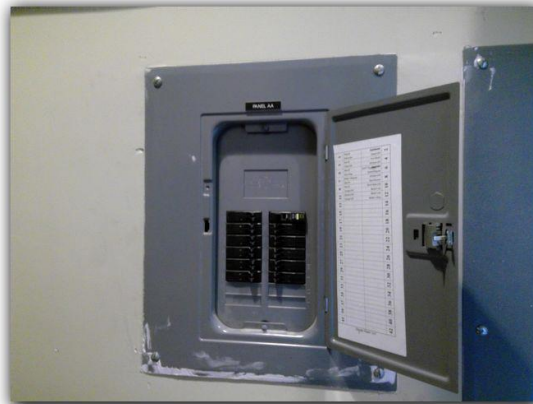
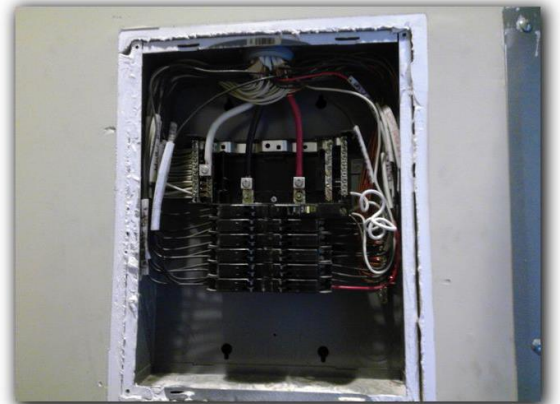
**Sub Panel AA**

- None of the required dwelling unit devices, receptacle and lighting outlets (switches, receptacles and fixtures) are connected to an arc-fault circuit-interrupter (AFCI) circuit device. Under the current National Electrical Code, all of the living area devices, receptacle and lighting outlets (switches, receptacles and fixtures) should be connected to an arc-fault circuit interrupter (AFCI) device.

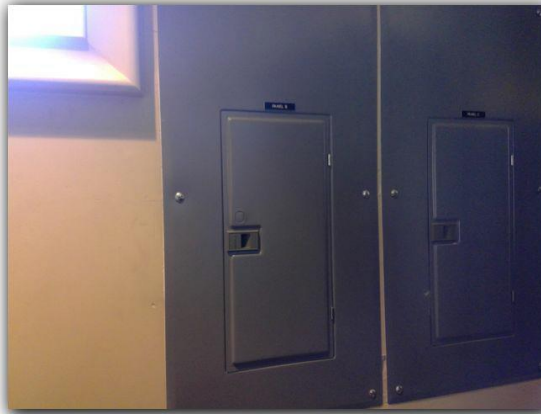
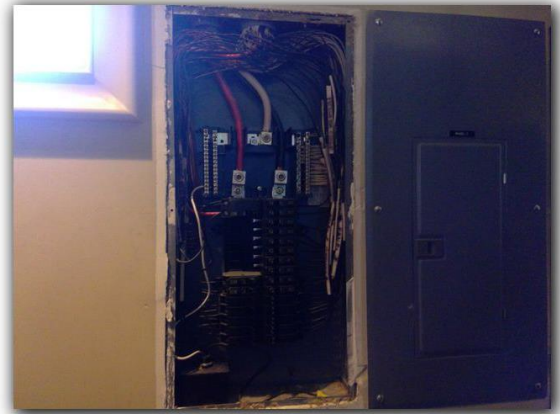
- The breakers (overcurrent devices) in the electrical panel are not properly labeled.
- None of the required dwelling unit devices, receptacle and lighting outlets (switches, receptacles and fixtures) are connected to an arc-fault circuit-interrupter (AFCI) circuit device. Under the current National Electrical Code, all of the living area devices, receptacle and lighting outlets (switches, receptacles and fixtures) should be connected to an arc-fault circuit interrupter (AFCI) device.

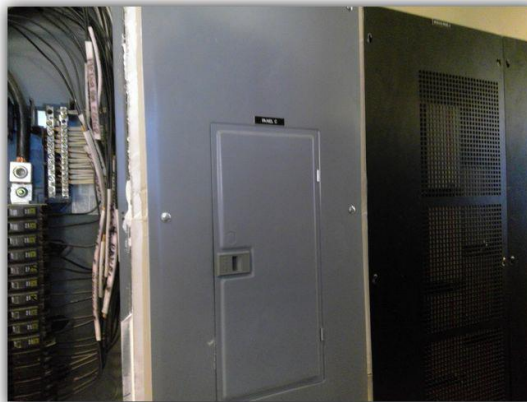
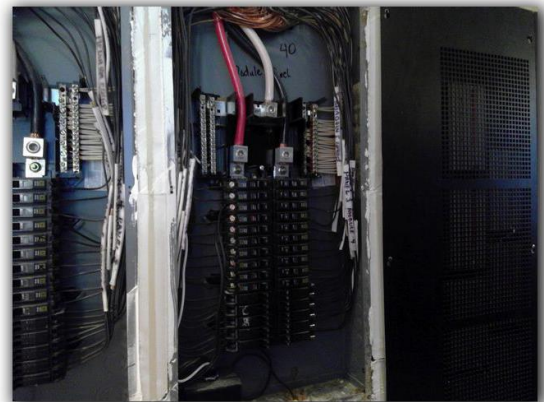
### Sub Panel C

- The breakers (overcurrent devices) in the electrical panel are not properly labeled.
- None of the required dwelling unit devices, receptacle and lighting outlets (switches, receptacles and fixtures) are connected to an arc-fault circuit-interrupter (AFCI) circuit device. Under the current National Electrical Code, all of the living area devices, receptacle and lighting outlets (switches, receptacles and fixtures) should be connected to an arc-fault circuit interrupter (AFCI) device.

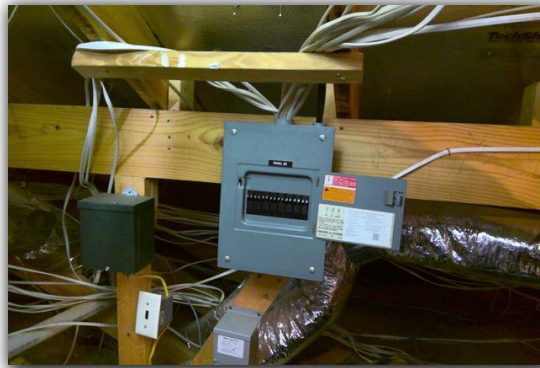
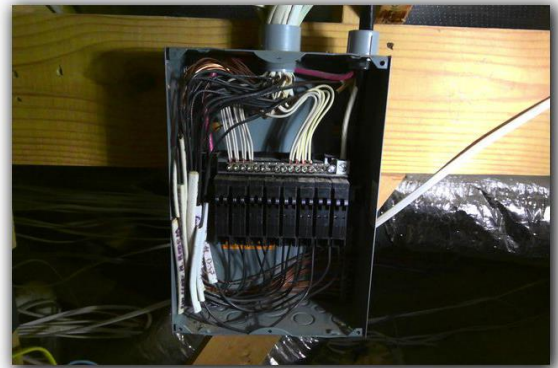
- None of the required dwelling unit devices, receptacle and lighting outlets (switches, receptacles and fixtures) are connected to an arc-fault circuit-interrupter (AFCI) circuit device. Under the current National Electrical Code, all of the living area devices, receptacle and lighting outlets (switches, receptacles and fixtures) should be connected to an arc-fault circuit interrupter (AFCI) device.

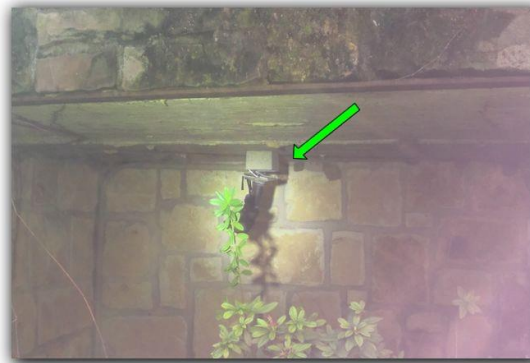
### Fixtures

- One or more of the light fixtures are loose at the ceiling mount in the east exterior wall under bridge.
- One or more of the light fixtures appear to be inoperative in the upstairs rear middle bedroom closet, upstairs bedroom bathroom, upstairs front corner bedroom closet. This may be due to a bad bulb or some other unknown condition. This condition should be further evaluated and corrected as necessary.
- The ceiling fan is not balanced properly and wobbles when operated in the side middle bedroom.

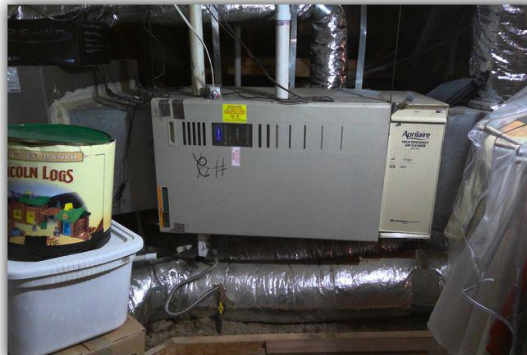
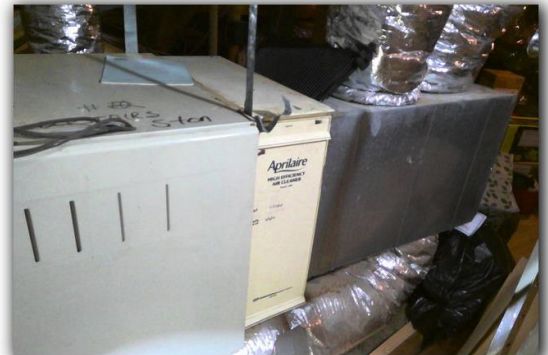
**Upstairs Central Heating System – #2** Energy Source: Gas

The HVAC system needs to be checked and serviced by a Qualified / Licensed HVAC Technician. The observations made to support the rendering of this opinion are listed but may not be limited to the following:

- The indoor blower motor is out of balance and causes the unit to vibrate more the normal.
- The indoor blower observed to be dirty and should be cleaned to help improve the efficiency of the unit.
- The heater gas supply line is not equipped with a sediment trap just before the gas appliance connector. This condition does not meet current installation requirements and should be corrected.

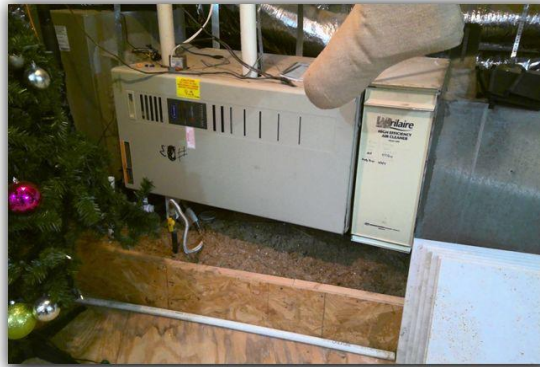
The HVAC system needs to be checked and serviced by a Qualified / Licensed HVAC Technician. The observations made to support the rendering of this opinion are listed but may not be limited to the following:

- The indoor blower observed to be dirty and should be cleaned to help improve the efficiency of the unit.
- The heater gas supply line is not equipped with a sediment trap just before the gas appliance connector. This condition does not meet current installation requirements and should be corrected.

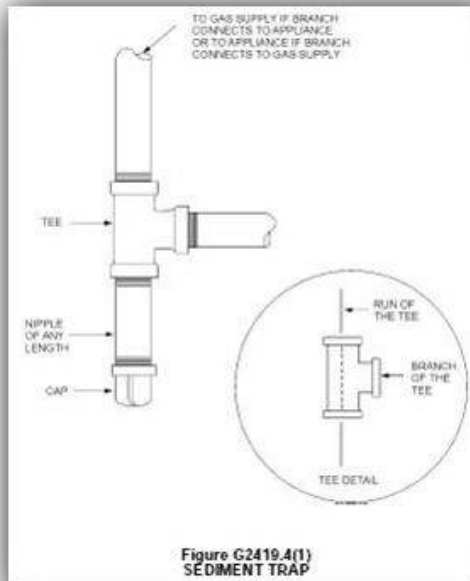
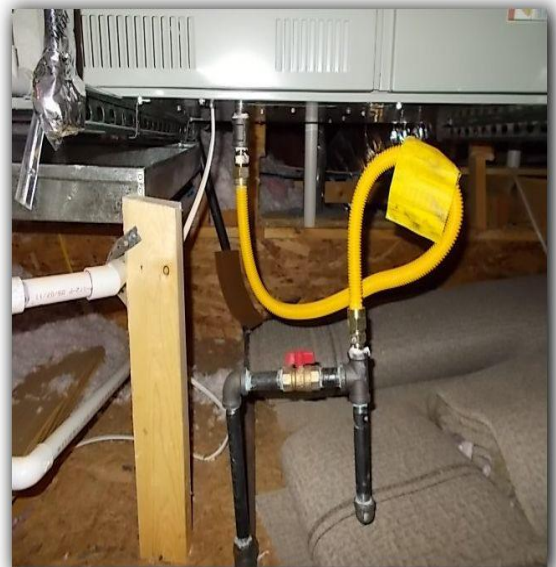
Samples of correct sediment trap installation.

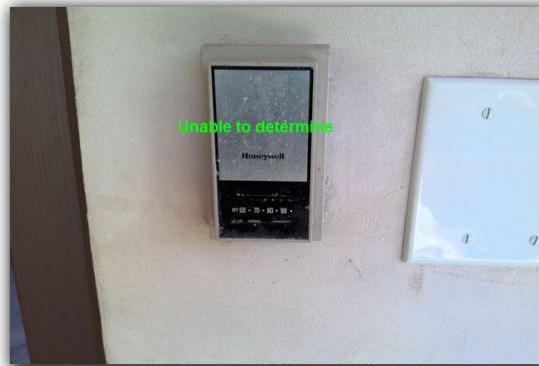
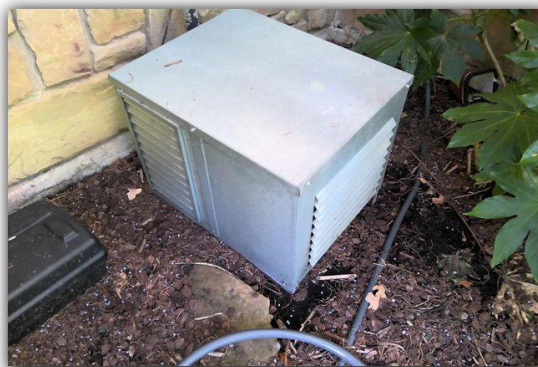
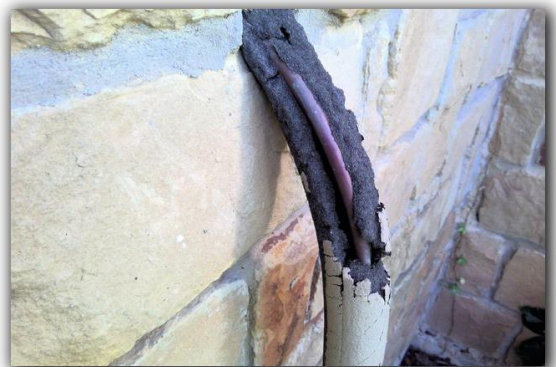
- The outdoor unit of the air conditioning system is out of level. It is recommended that the outside condenser/coils be within 1-inch of level.
- The outdoor unit of the air conditioning system requires cleaning.

- The outdoor unit of the air conditioning system is noisy. The cause and remedy should be further evaluated and corrected as necessary.
- Damaged, deteriorated and/or missing insulation on the refrigerant lines should be repaired or replaced at the outside condenser.

- The electrical service disconnect is installed behind the outside condenser/coil. This does not meet the clearance requirements of the National Electrical Code or the International Residential Code and should be corrected as necessary.

- **Note:** The support pad under the outside condenser/coil is undersized for the unit that is in place.
- Additional Notice from the Inspector: There is a thermostat on the back porch that does not appear to be functional at this time. The inspector was unable to determine what it may control.

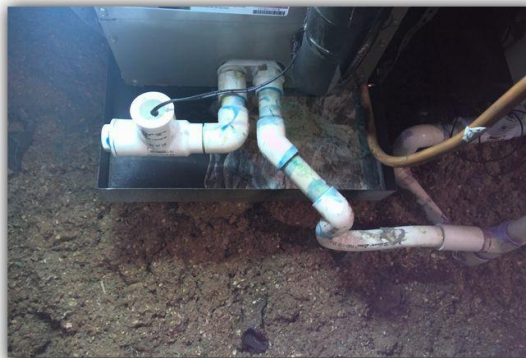
- The outdoor unit of the air conditioning system requires cleaning.
- The electrical service disconnect is installed behind the outside condenser/coil. This does not meet the clearance requirements of the National Electrical Code or the International Residential Code and should be corrected as necessary.

- The dirty air filter should be replaced.
- The secondary drain line on the coil housing is capped at the time of this inspection. It is recommended to remove the cap on the secondary drain line to allow for the drain to function properly when necessary.

- The thermostat is poorly located. The thermostat is located in a bedroom/study area. This type of installation will not allow the thermostat to properly read the conditioned air of the common living space when the bedroom door is closed. You should consider relocating the thermostat into the common living area..

- **Note:** Previous water leakage was observed from around the base of the indoor coil housing. This condition should be closely monitored.
- **Note:** The heavy foliage at and around the outside condenser/coils should be trimmed back a minimum of 18-inches to help improve air circulation.

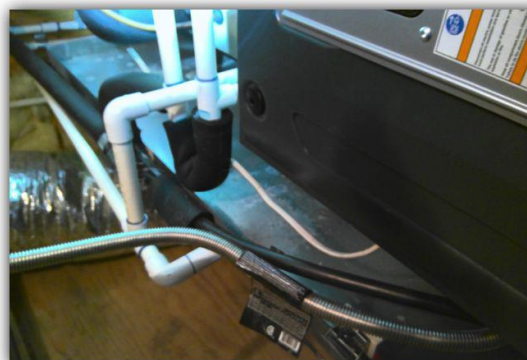
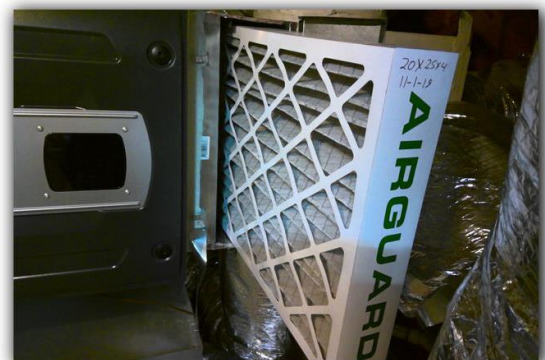
#### Upstairs Master Bedroom Central Cooling System #4

- The electrical service disconnect is installed behind the outside condenser/coil. This does not meet the clearance requirements of the National Electrical Code or the International Residential Code and should be corrected as necessary.
- The dirty air filter should be replaced.
- **Note:** Previous water leakage was observed from around the base of the indoor coil housing. This condition should be closely monitored.

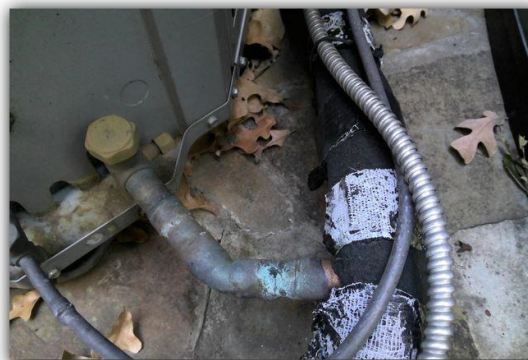
### Upstairs Central Cooling System #2

- The electrical service disconnect is installed behind the outside condenser/coil. This does not meet the clearance requirements of the National Electrical Code or the International Residential Code and should be corrected as necessary.
- The dirty air filter should be replaced.
- Damaged, deteriorated and/or missing insulation on the refrigerant lines should be repaired or replaced at the outside condenser.
- The dirty air filter should be replaced.
- The secondary drain line on the coil housing is capped at the time of this inspection. It is recommended to remove the cap on the secondary drain line to allow for the drain to function properly when necessary.
- **Note:** Previous water leakage was observed from around the base of the indoor coil housing. This condition should be closely monitored.

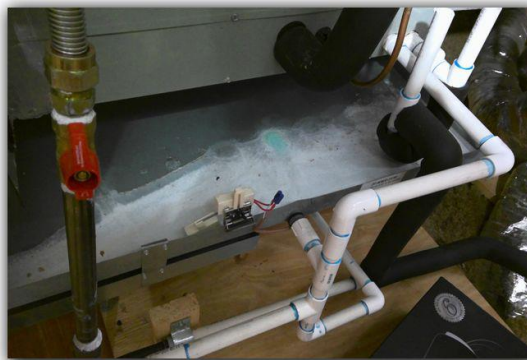
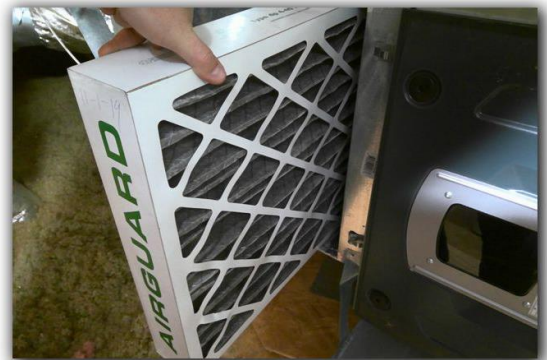
### Central Cooling System #1

- The dirty air filter should be replaced.
- The electrical service disconnect is installed behind the outside condenser/coil. This does not meet the clearance requirements of the National Electrical Code or the International Residential Code and should be corrected as necessary.
- **Note:** Previous water leakage was observed from around the base of the indoor coil housing. This condition should be closely monitored.

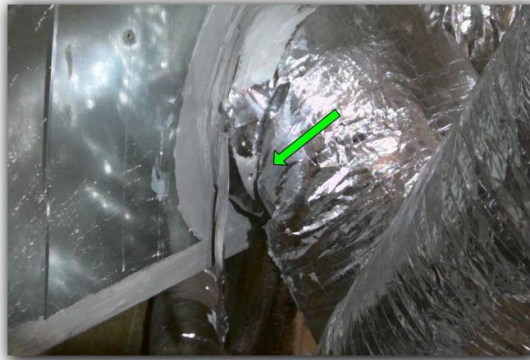
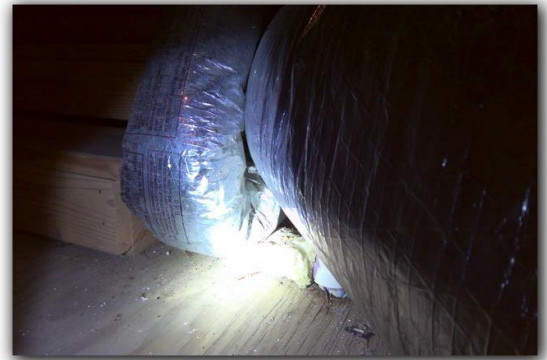
- The duct work in the attic area appears to have excessive sags between the supports. This condition can cause pressure loss and affect the airflow through the duct system.
- Air leaks were detected at and around the ductwork connections and the distribution plenum(s).
- Some of the ductwork in the attic area has been turned to sharply. This will restrict the airflow through the duct system and affect the airflow balance in some areas of the house.

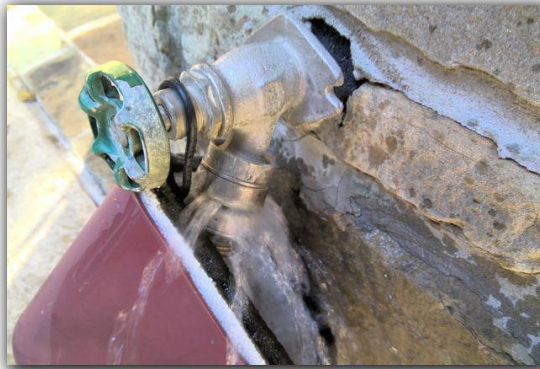
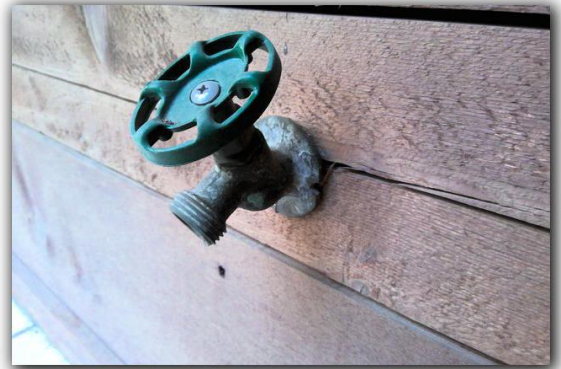
##### Exterior Faucets/Fixtures

- One or more of the exterior water hose bibbs (faucet) do not have a back-flow or anti-siphon device (Vacuum Breakers) in place. **Note:** *This is not uncommon to observe with a home of this age.*
- Water was observed to be leaking back through the vacuum breaker on the south side of the structure. The vacuum breaker is not working as designed.

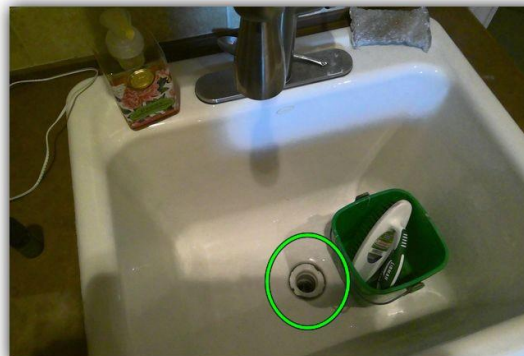
##### Laundry Sink

- The stopper is missing.
- **Note:** Some corrosion was observed at one and/or both of the water supply shutoff valves.

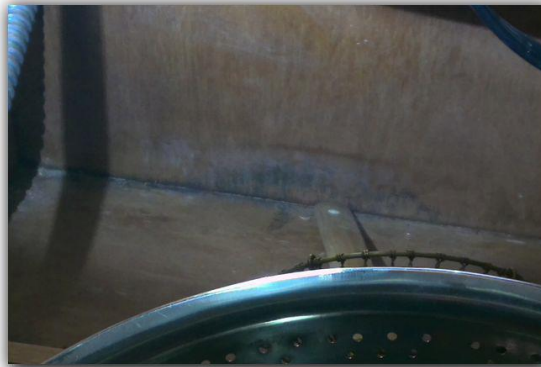
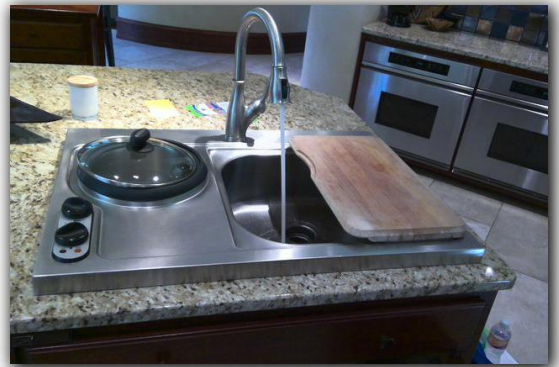
**Kitchen Sink 2**

- There was an unknown dark mold like substance observed in cabinetry under the sink. Evaluation of this substance is beyond the scope of this inspection. If any concerns exist on the type and/or nature of this substance, we recommend further evaluation by a professional in the Air Quality sampling field.
- **Note:** Previous water leaks were observed at and/or around the drain connections under the sink. This would indicate previous problems and should be closely monitored and corrected when necessary.

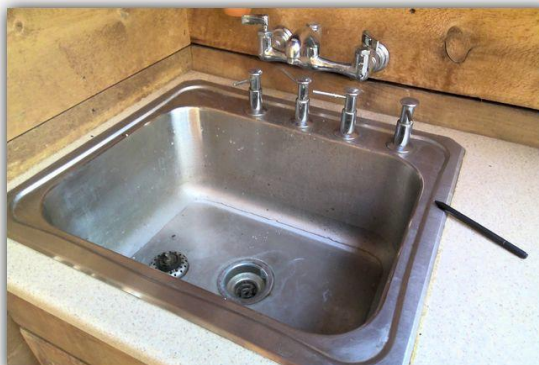
**Green room Utility Sink**

- The sink was observed to drain slowly, suggesting that an obstruction may exist.

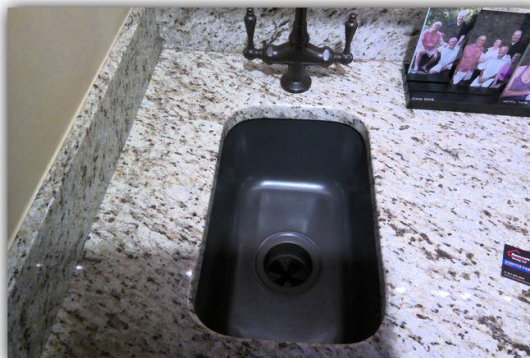
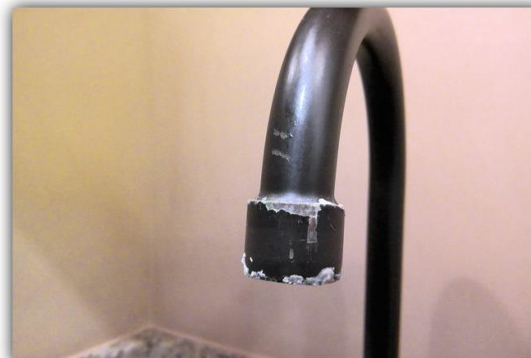
**Wet Bar Sink -Wine Cellar**

- **Note:** The faucet aerator was observed to be clogged and should be cleaned to improve the faucets performance.

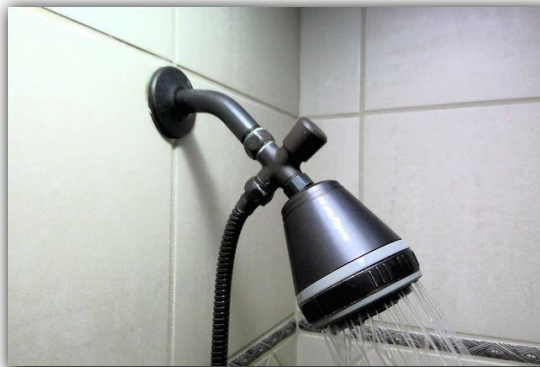
#### *Lavatory / Sink*

- Cracked, deteriorated and/or missing shower stall grout and/or caulking should be repaired or replaced as necessary.
- The shower spout is leaking at the neck connection.

- **Note:** Previous water leaks were observed at and/or around the drain connections under the sink. This would indicate previous problems and should be closely monitored and corrected when necessary.

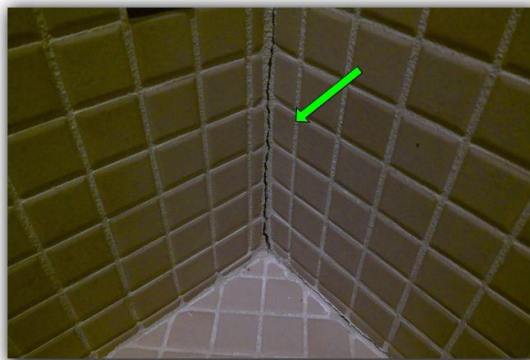
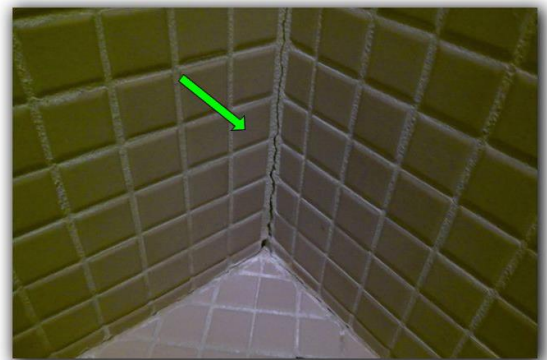
### Pool Bath

- Cracked, deteriorated and/or missing shower stall grout and/or caulking should be repaired or replaced as necessary.

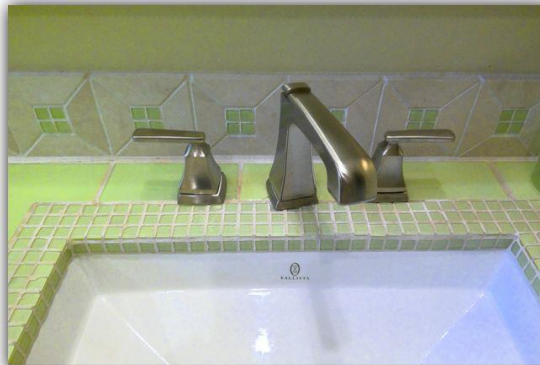
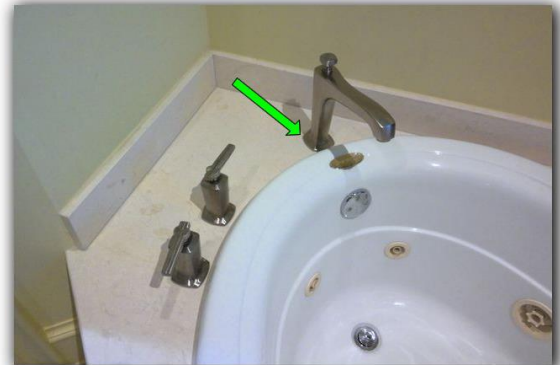
**Side Middle Bedroom Bathroom**

- The faucet assembly is loose.

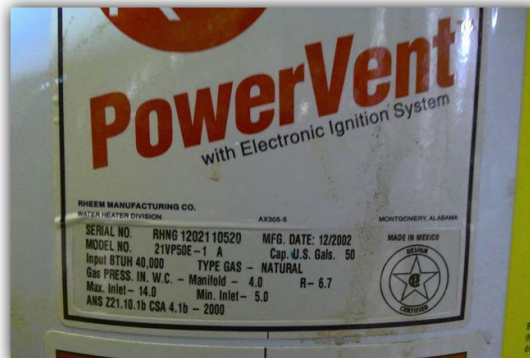
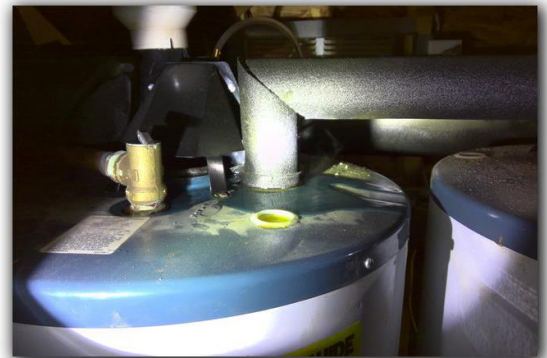
- A water leak was observed at the water heater connection inlet and/or outlet and repair is necessary.
- There is a water leak at the water heater and is currently and actively leaking hot water into the attic area. This condition needs to be further evaluated and corrected.

- The fittings at the top of the water heater are made of dissimilar metals (galvanized steel connected to copper and/or brass). It is recommended to replace the galvanized steel fittings with brass or copper fittings or install a dielectric union between the two dissimilar metals to prevent electrolysis from occurring.

- The auxiliary/secondary drain pan under the water heater is holding water at the time of this inspection. The cause and remedy should be further evaluated and corrected as necessary.

- **Note:** The debris in the water heater pan should be cleaned out to help prevent the pan drain line from being clogged.
- **Note:** There is evidence of prior leakage on or around the water heater housing. This should be closely monitored.

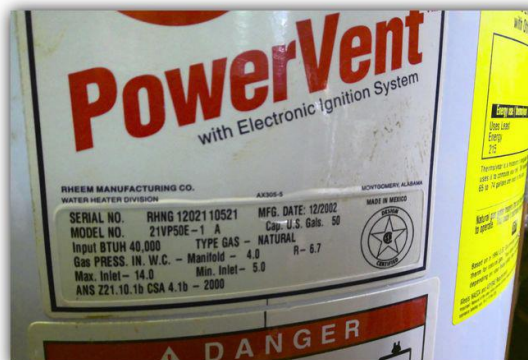
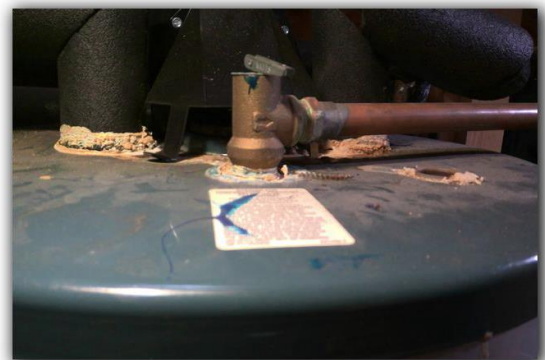
**The water heater appears to be reaching the end of its serviceable life expectancy.**

- A water leak was observed at the water heater connection inlet and/or outlet and repair is necessary.
- Some corrosion was observed on the water supply shutoff valve.

- Some corrosion was observed at the water supply connections at the top of the water heater.
- The fittings at the top of the water heater are made of dissimilar metals (galvanized steel connected to copper and/or brass). It is recommended to replace the galvanized steel fittings with brass or copper fittings or install a dielectric union between the two dissimilar metals to prevent electrolysis from occurring.

- The auxiliary/secondary drain pan under the water heater is holding water at the time of this inspection. The cause and remedy should be further evaluated and corrected as necessary.

- The gas shutoff valve is in a poor location and is hard to reach.
- **Note:** The debris in the water heater pan should be cleaned out to help prevent the pan drain line from being clogged.

- **Note:** There is evidence of prior leakage on or around the water heater housing. This should be closely monitored.
