## PROPERTY INSPECTION REPORT

Prepared For: Sally Samples

Concerning: Luxury Blvd, Arlington, TX 76006

By: Nathan Ross, Lic #20282

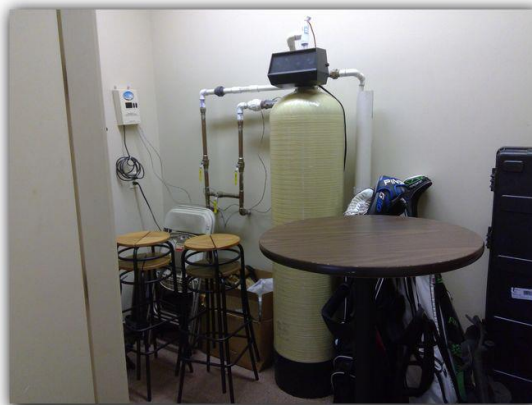
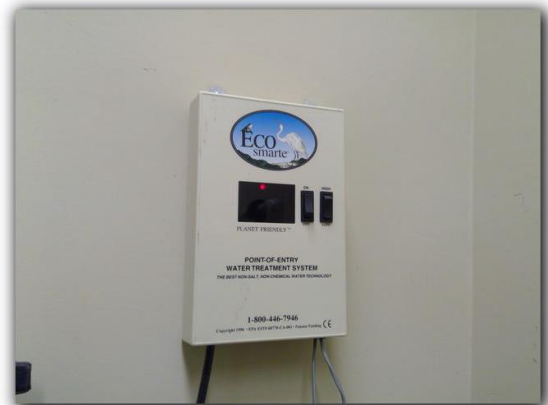
#### Water Softener

- **Note:** There appears to be Water Treatment equipment in place at the time of inspection. Evaluation of this equipment is beyond the scope of a home inspection and it is recommended to have the manufacture further evaluate and make corrections if necessary.

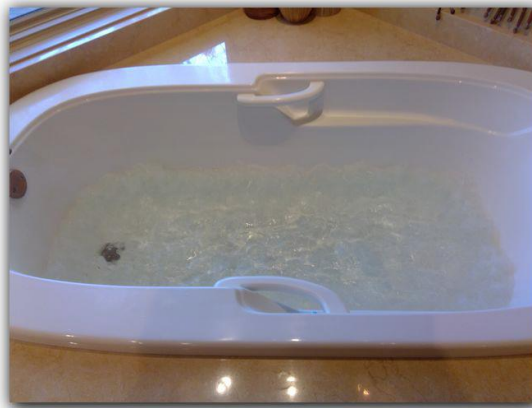
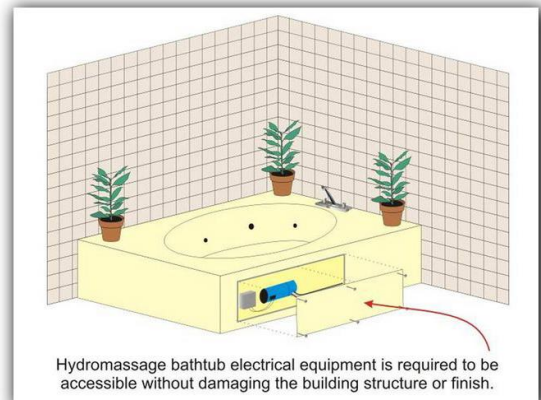
**Hydro-Massage Therapy Equipment #1**

- The access to the hydro-massage therapy equipment motor is not readily accessible and inspection of the equipment lines and motor could not be performed. This does not meet current installation standards.
- I was unable to locate a ground fault circuit interrupter (GFCI) receptacle or breaker for the hydro-massage therapy equipment. The homeowner should be consulted on the location of this GFCI device. If there is no GFCI device installed on the hydro-massage therapy equipment circuit, a GFCI receptacle or breaker should be installed for reasons of safety.

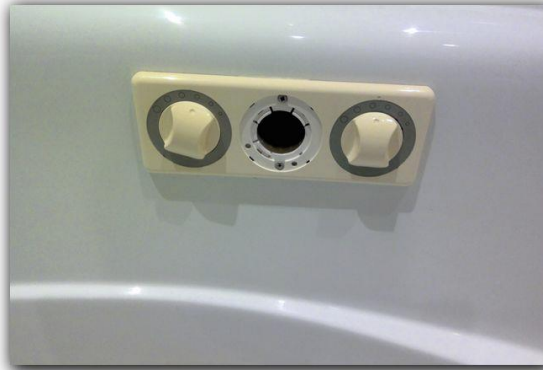
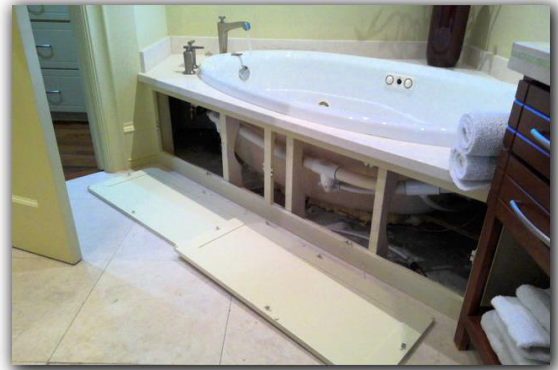
**Hydro-Massage Therapy Equipment #2**

- The hydro-massage therapy equipment on/off button does not function properly.

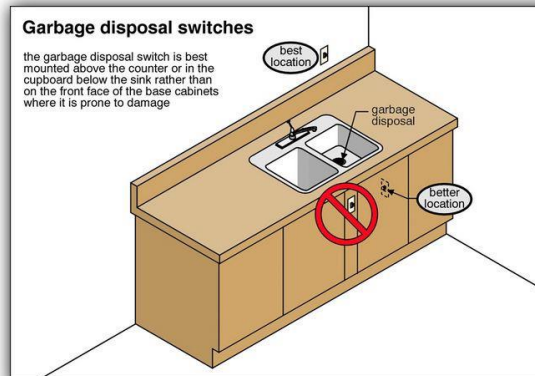
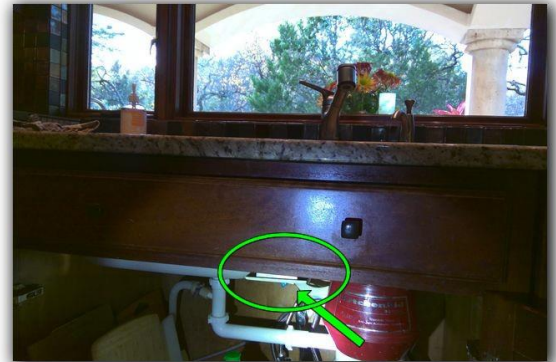
- **Note:** The food waster disposer switch is poorly located. It is recommended that the switch be located above the counter top or inside the kitchen cabinetry.

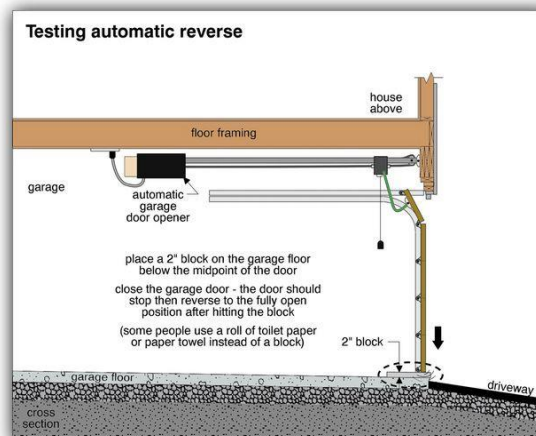
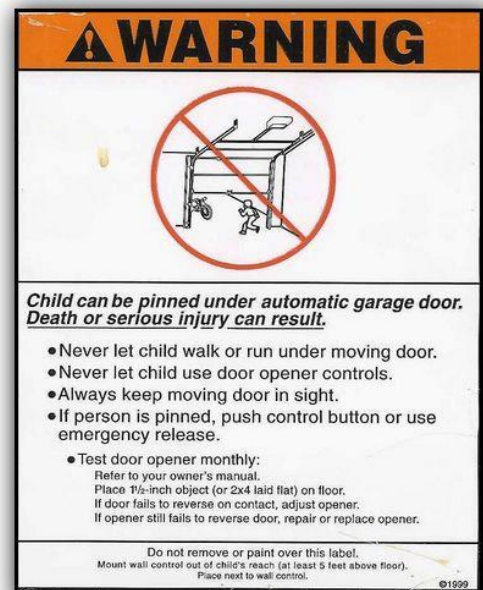
### Overhead Garage Door Operator 4

- The garage door opener **DID NOT** automatically reverse under reasonable resistance when closing. Improvement may be as simple as adjusting the sensitivity control on the opener.
- When an automatic garage door opener is in use, the manual lock should be disabled or removed.

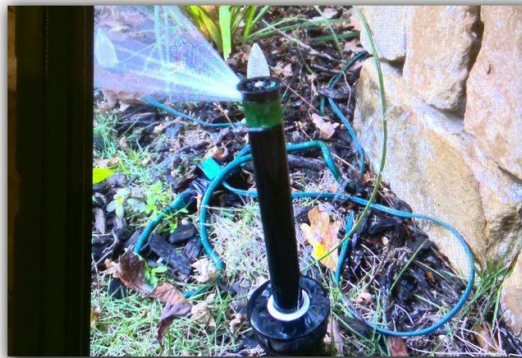
- One or more of the sprinkler heads need to be adjusted and/or straightened so to disperse water properly in station(s); **4, 6, 16, 39**
- One or more of the sprinkler heads need to be adjusted so not to spray water onto the exterior walls, surfaces or windows in stations; **18, 20, 24 , 32.**

- One or more of the sprinkler heads appear to be leaking at the base of the head in station(s); **30** and **32.** The cause and remedy should be further evaluated and corrected as necessary.

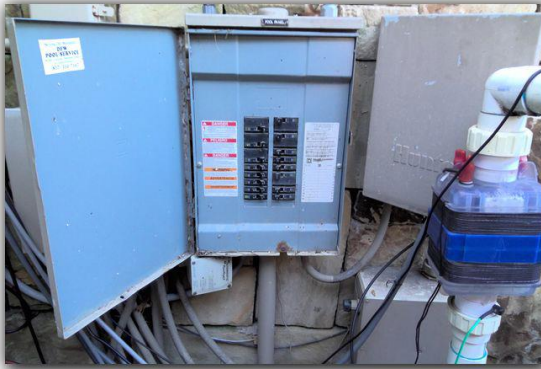
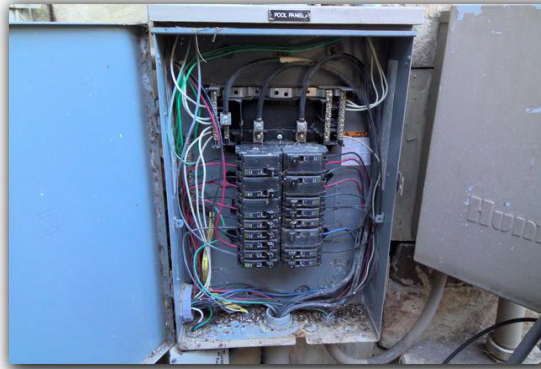
- The panel box does not have proper clearance in front of the cabinet. The panel box cover plate (Dead Front) and/or cabinet should be readily accessible and cover easily removable at all times. Under current electrical standards, the accessible workspace around the panel box should be at least 36-inches in depth in front of the cabinet and 30-inches in width or the width of the equipment. Clothes, shelves, cabinets, foliage, etc should not block the workspace in front of the cabinet.

- Some of the electrical cabinet interior components were observed to have some minor rust and/or corrosion on them. This condition should be further evaluated and corrected as necessary.

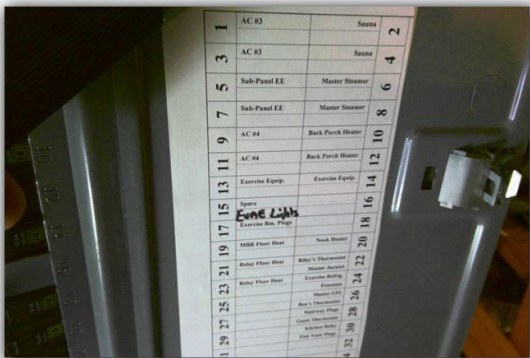
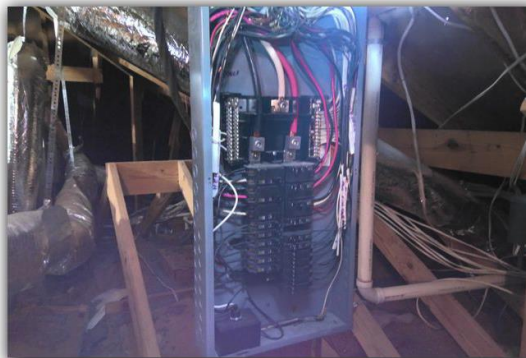
- Open end wires were observed attic area.

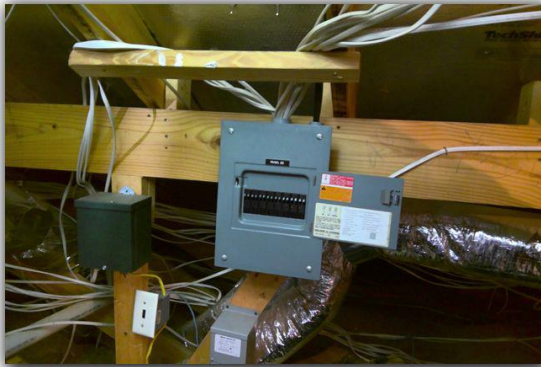
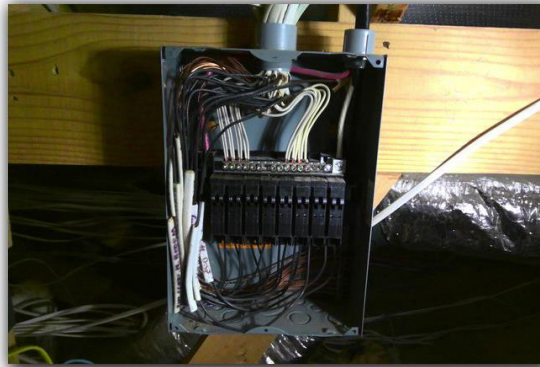
### **Sub Panel #EE**

- None of the required dwelling unit devices, receptacle and lighting outlets (switches, receptacles and fixtures) are connected to an arc-fault circuit-interrupter (AFCI) circuit device. Under the current National Electrical Code, all of the living area devices, receptacle and lighting outlets (switches, receptacles and fixtures) should be connected to an arc-fault circuit interrupter (AFCI) device.

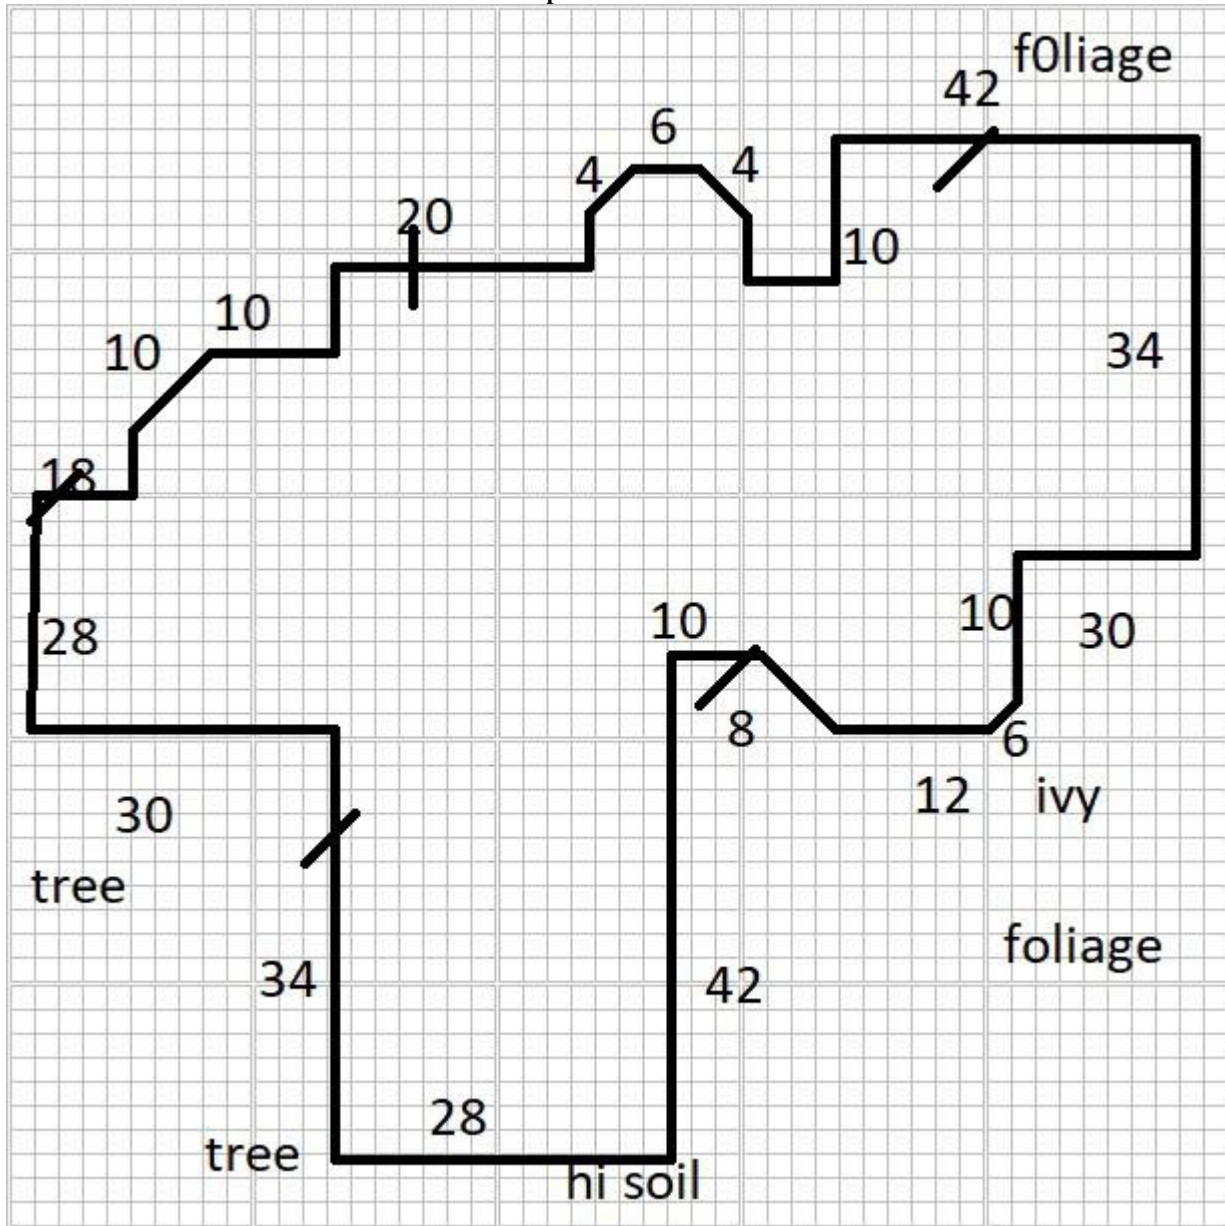
**Diagram of Structure(s) Inspected**Foundation Type: **Slab on Ground**Primary Use: **Residential**

Additional Comments There is no visible evidence of active wood destroying insects found at the time of this inspection.

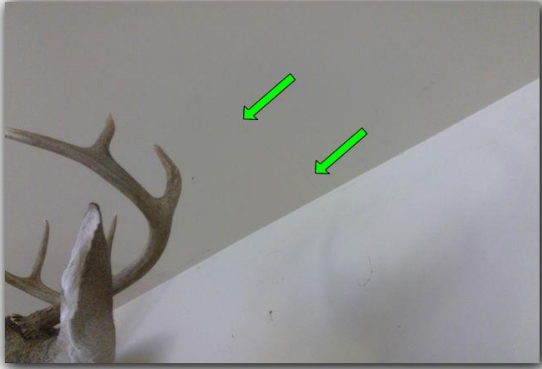
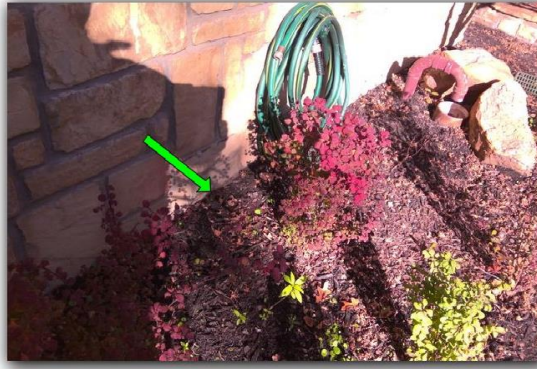
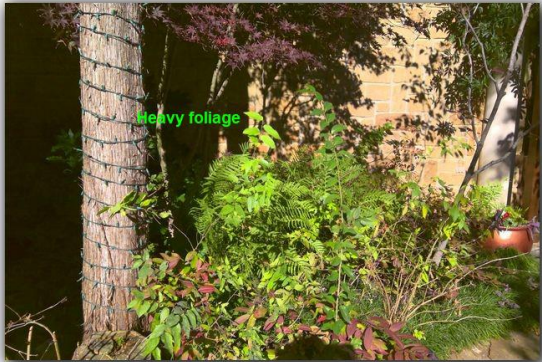
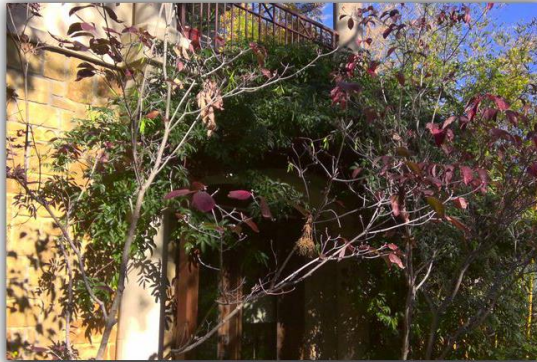
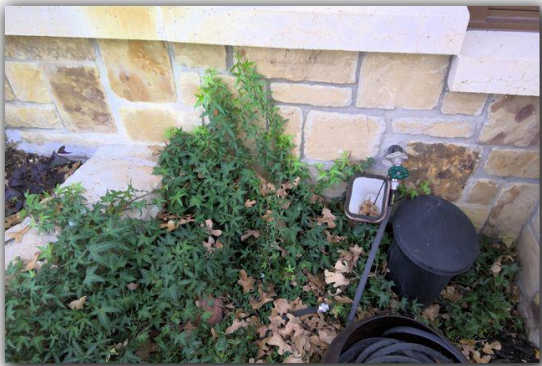
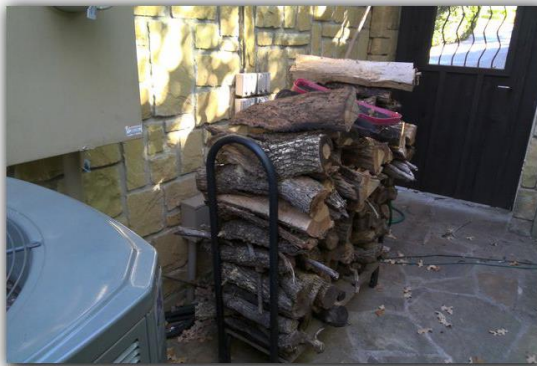
The digital pictures within this report are a representative sample of active/previous wood destroying insects, locations of active/previous infestations, inaccessible areas, conducive conditions, deficiencies or damages in place and should not be considered to show all. There will be active/previous wood destroying insects, locations of active/previous infestations, inaccessible areas, conducive conditions, deficiencies or damages not represented with digital imaging.
