PROPERTY INSPECTION REPORT

Concerning: Pleasantville Place, Anywhere, TX 77777

By: Nathan Ross, Lic #20282

02/20/2020

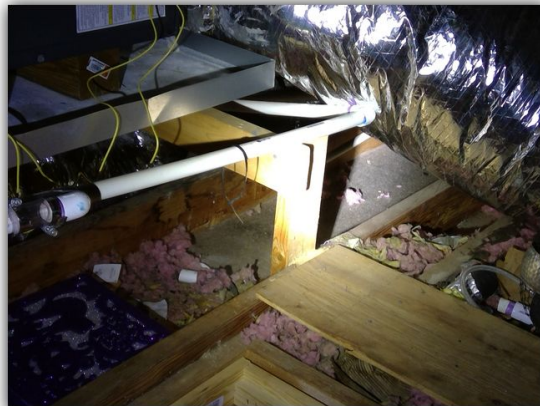
Attic Insulation

- The attic floor insulation was observed to be missing over the stairway, upstairs bedroom hallway area(s).
- The attic floor insulation needs to be redistributed in one or more locations.

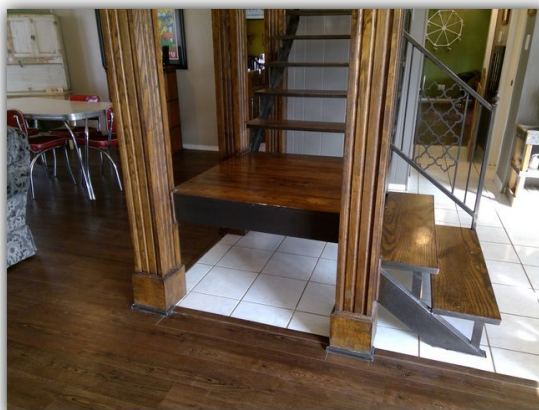
- The stairway handrail does not run continuous from the bottom of the stairwell to the top of the stairwell so to cover all of the steps (treads). Under current building standards all handrails for the stairway should run continuous for the full length of the flight. The handrail should start directly above the lowest step and run continuously to end directly above the top step.

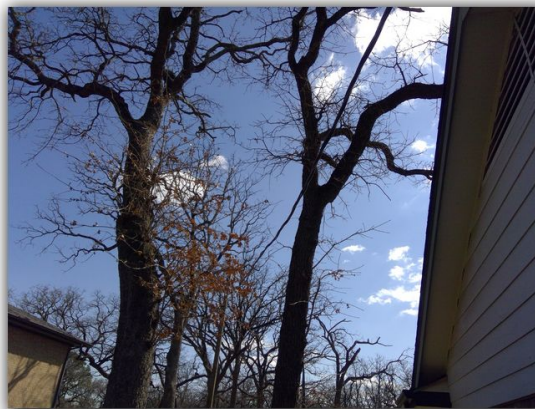
Service Entrance

- The tree branches should be trimmed away from the overhead service wires.

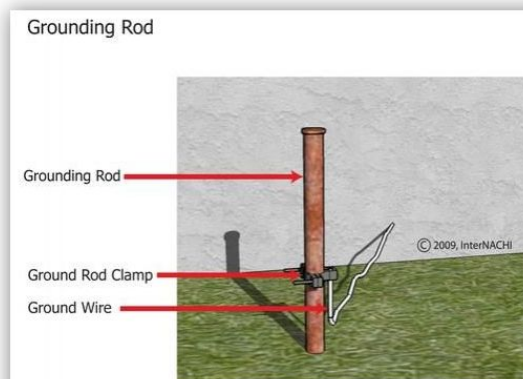
Grounding / Bonding

- I was unable to locate a grounding rod (Grounding Electrode) or supplement grounding source for the electrical system. This condition should be further investigated and corrected if necessary.

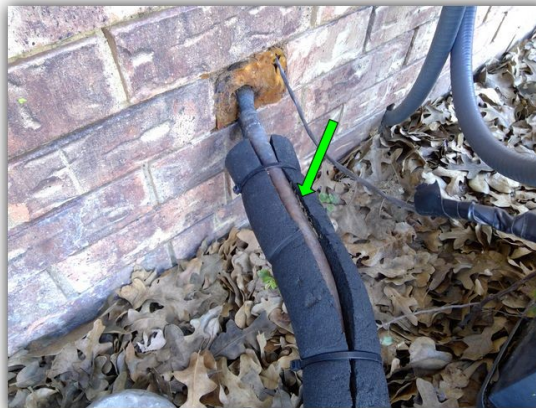
- Damaged, deteriorated and/or missing insulation on the refrigerant lines should be repaired or replaced at the outside condenser.
- The electrical service disconnect is installed behind the outside condenser/coil. This does not meet the clearance requirements of the National Electrical Code or the International Residential Code and should be corrected as necessary.
- The material used to support the heating and cooling equipment in the secondary condensate drain pan is not made of a water resistant material. This condition does not meet current mechanical installation standards.
- **Note:** Previous water leakage was observed from around the base of the indoor coil housing. This condition should be closely monitored.

The HVAC system and equipment needs to be checked and serviced by a Qualified / Licensed HVAC Technician. The observations made to support the rendering of this opinion are listed but may not be limited to the following:

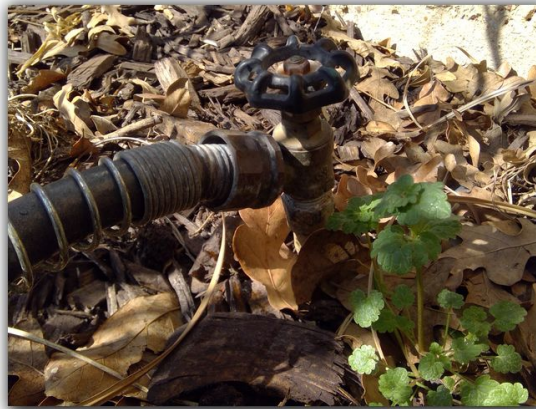
Exterior Faucets/Fixtures

- One or more of the exterior water hose bibbs (faucet) do not have a back-flow or anti-siphon device (Vacuum Breakers) in place. **Note:** *This is not uncommon to observe with a home of this age.*
- The water is turned off to the exterior water hose bibb (faucet) on the north side of the structure. This condition should be further evaluated and corrected as necessary.
- **Note:** The exterior water hose bibb(s) (faucet) adjacent to the home should be protected from physical damage and/or possible freeze.

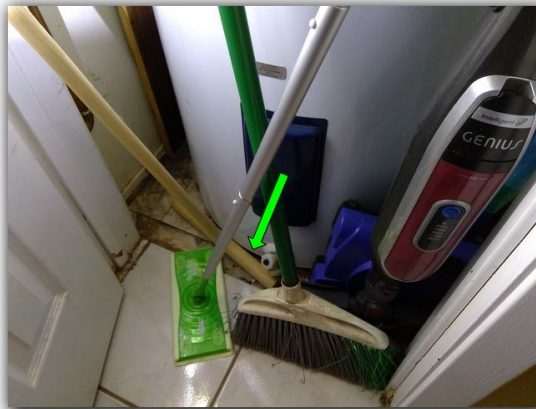
- The fittings at the top of the water heater are made of dissimilar metals (galvanized steel connected to copper and/or brass). It is recommended to replace the galvanized steel fittings with brass or copper fittings or install a dielectric union between the two dissimilar metals to prevent electrolysis from occurring.
- The spliced wires at the top of the water heater should be properly enclosed for reasons of safety.
- There is no pan installed under the water heater.

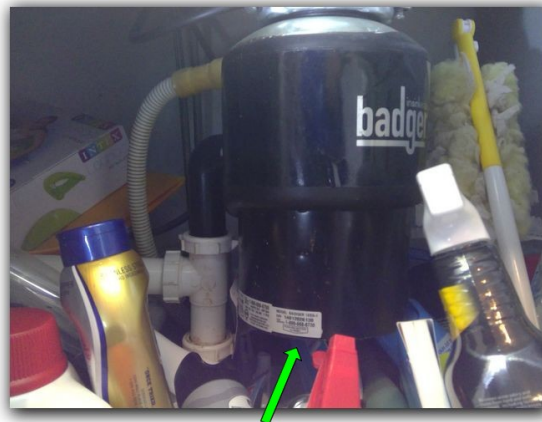
- The electrical wiring to the food waste disposer is not properly secured to the disposer housing.
