December 28, 2020

PROPERTY INSPECTION REPORT

Concerning: 1138 New House St, Fort Worth, TX 76008
(Address or Other Identification of Inspected Property)

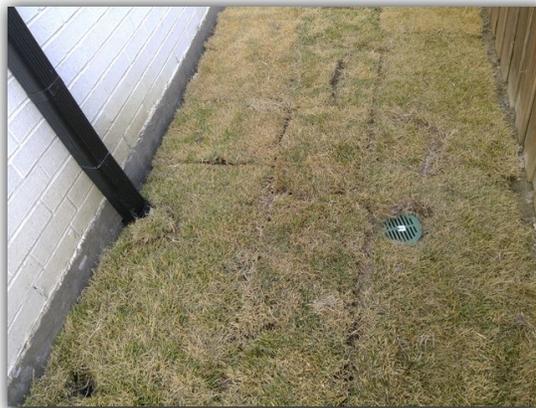
Gutter & Downspout System

All components were found to be performing and in satisfactory condition on the day of the inspection.

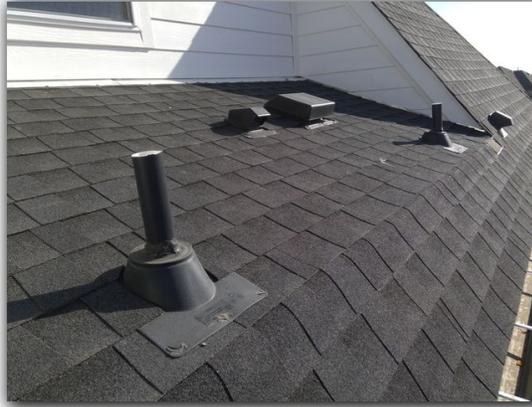
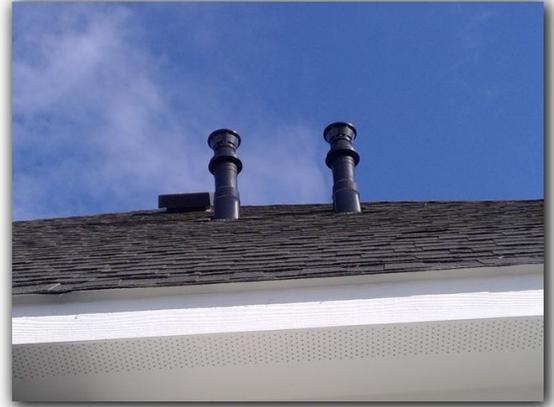
Flashing Details

All components were found to be performing and in satisfactory condition on the day of the inspection.

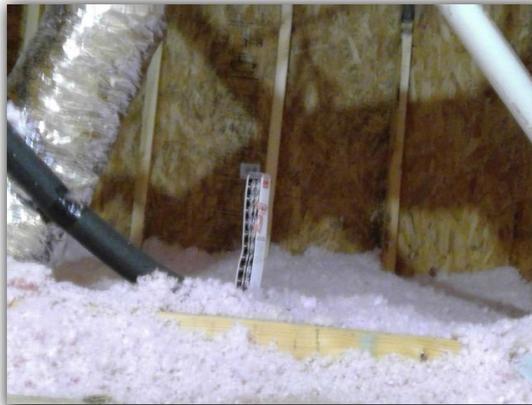
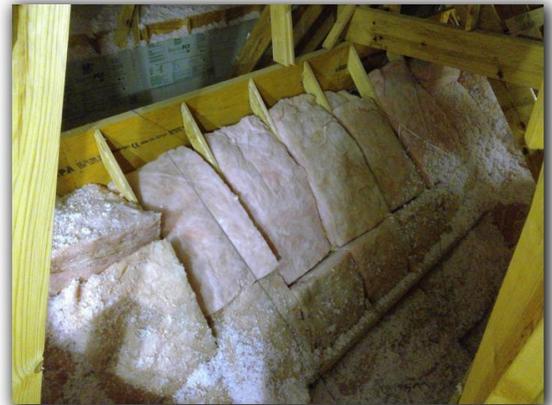
Garage Attic Hatch

All components were found to be performing and in satisfactory condition on the day of the inspection.

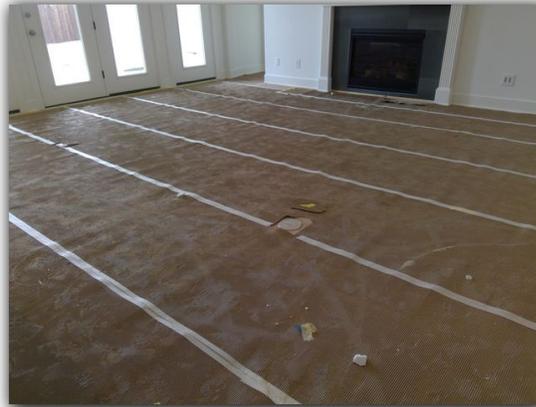
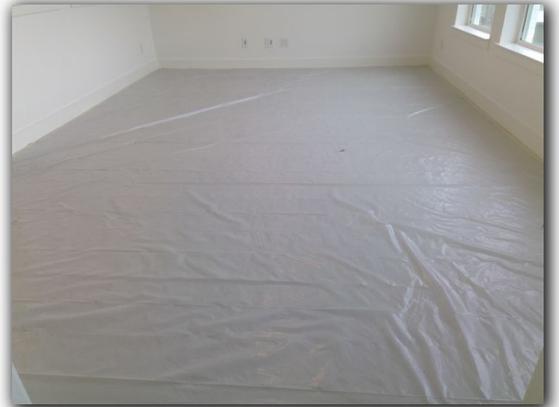
Floors

- **Note:** Most of the flooring was covered at the time of inspection and could not be observed..

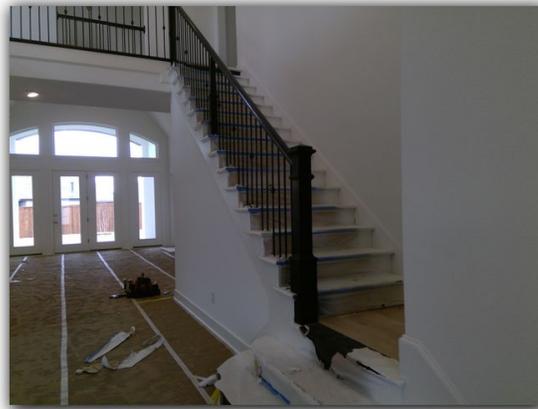
All components were found to be performing and in satisfactory condition on the day of the inspection.

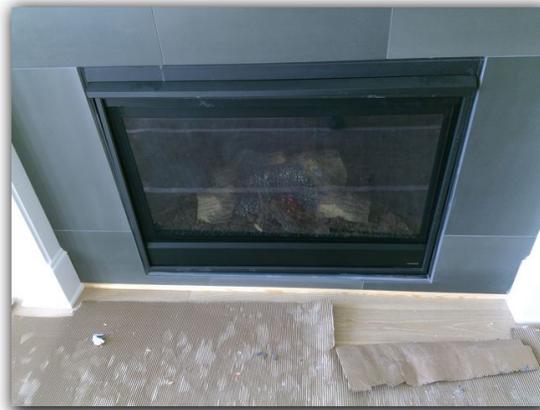
- **Note:** There are gas logs installed in the firebox at the time of this inspection. I was unable to view the floor of the firebox at the time of this inspection.

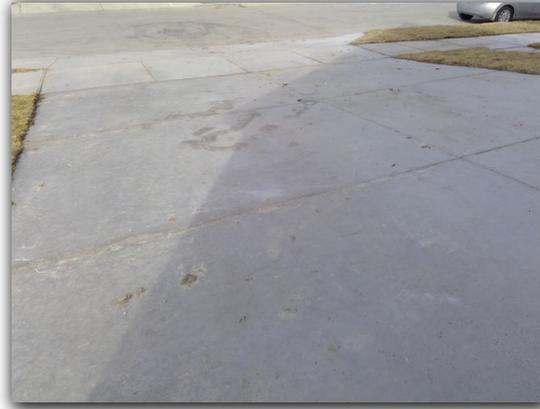
Driveway

All components were found to be performing and in satisfactory condition on the day of the inspection.

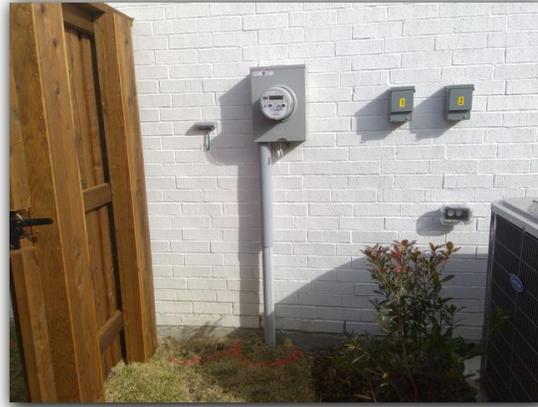
Service Entrance

All components were found to be performing and in satisfactory condition on the day of the inspection.

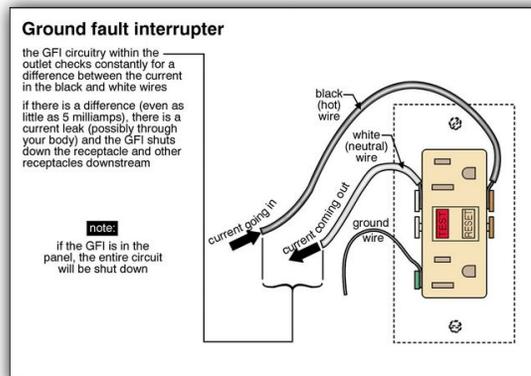
Receptacle Outlets

- The laundry room area receptacles do not appear to be connected to a ground fault circuit interrupter (GFCI) device. Under current electrical standards, all of the receptacles in the laundry room area should have GFCI protection.
- The kitchen counter top receptacles do not appear to be connected to a ground fault circuit interrupter (GFCI) device. Under current electrical standards, all of the kitchen counter top receptacles and any receptacle within 6-feet of the sink should have GFCI protection.

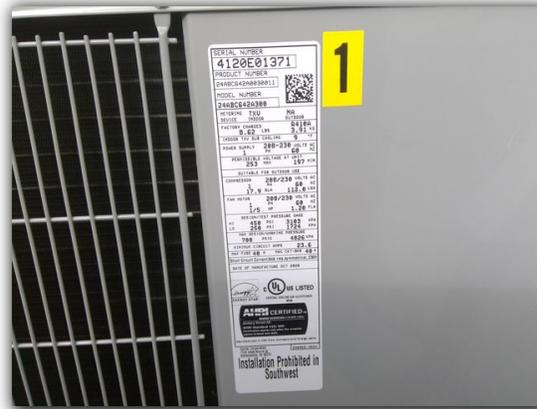
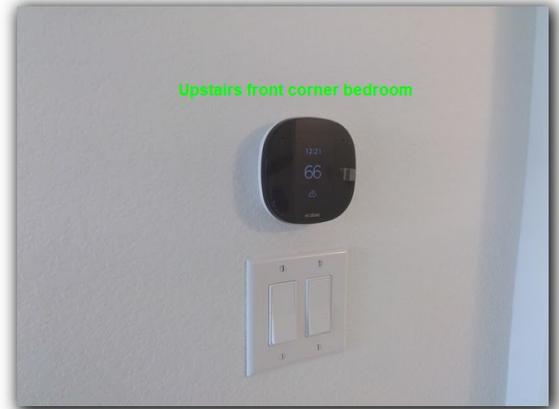
Downstairs Central Cooling System

Today's Temperature Differential (Delta-T): Unable to check Delta-T due to outdoor temperature.

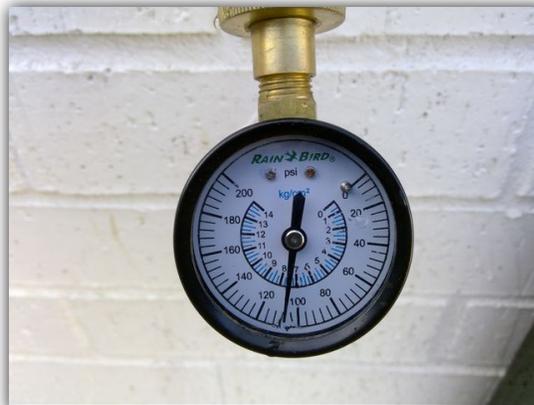
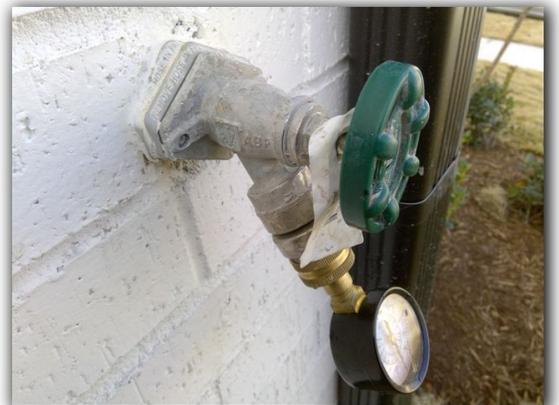
Exterior Faucets/Fixtures

All components were found to be performing and in satisfactory condition on the day of the inspection.

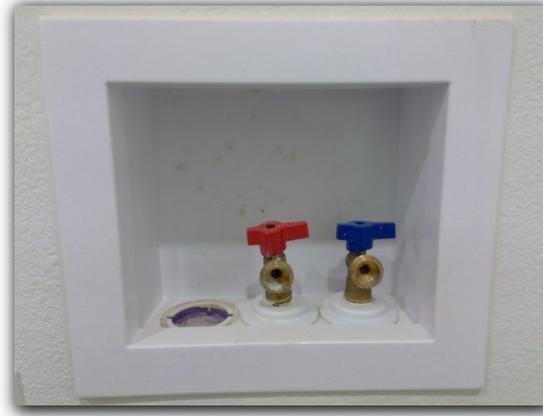
Laundry Connections

All components were found to be performing and in satisfactory condition on the day of the inspection.

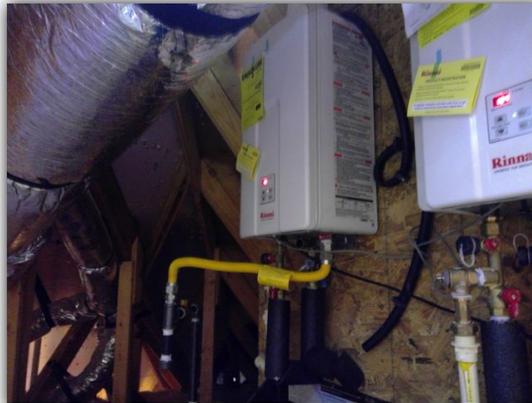
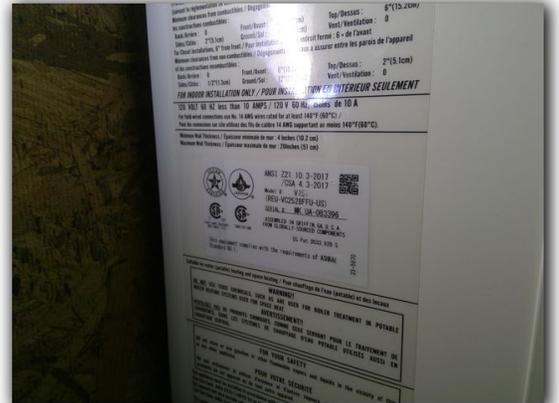
This component appears to be performing adequately at the time of this inspection. It is achieving an operation, function, or configuration consistent with accepted industry practices for its age.

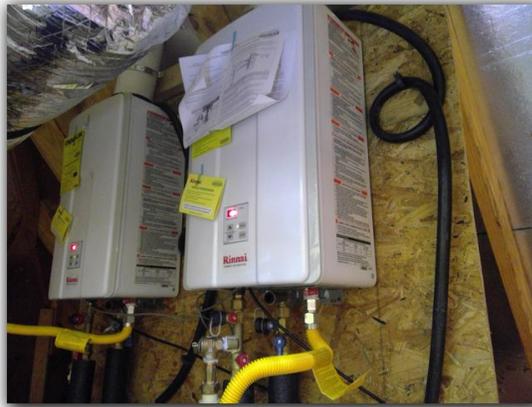
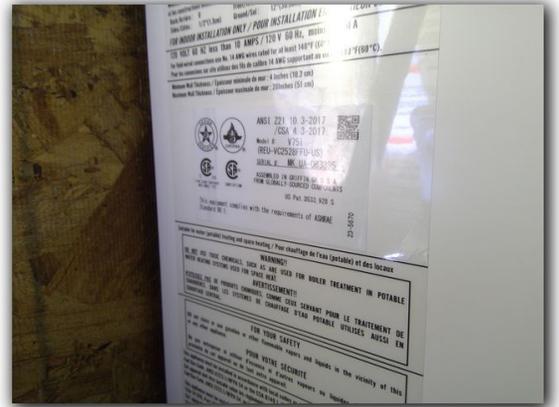
Right Water Heater – Energy Source: Gas
Location: Attic
Approximate Capacity: Tankless Water Heater
Approximate Age: 2020
Brand Name: Rinnai

This component appears to be performing adequately at the time of this inspection. It is achieving an operation, function, or configuration consistent with accepted industry practices for its age.

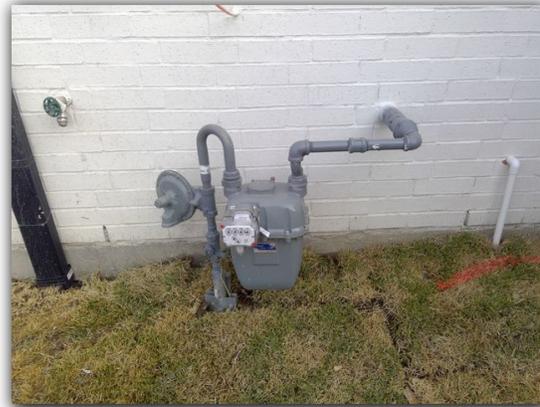
This component appears to be performing adequately at the time of this inspection.

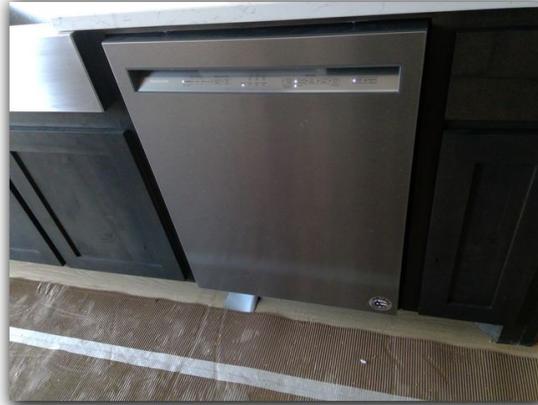
This component appears to be performing adequately at the time of this inspection.

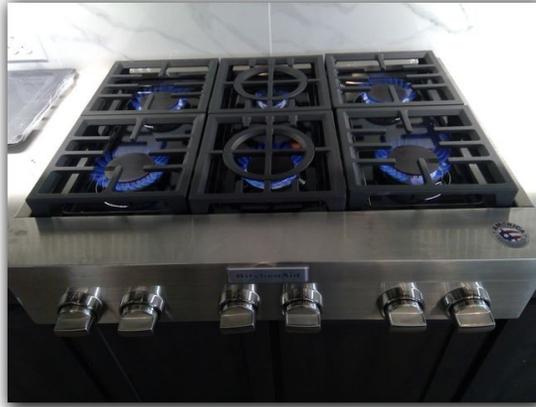
Cooktop Brand Name: KitchenAid

This component appears to be performing adequately at the time of this inspection.

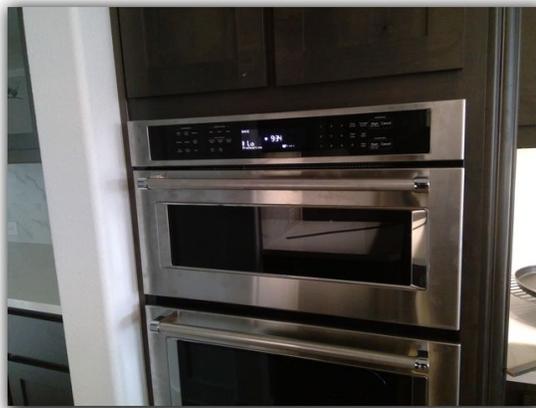
This component appears to be performing adequately at the time of this inspection.

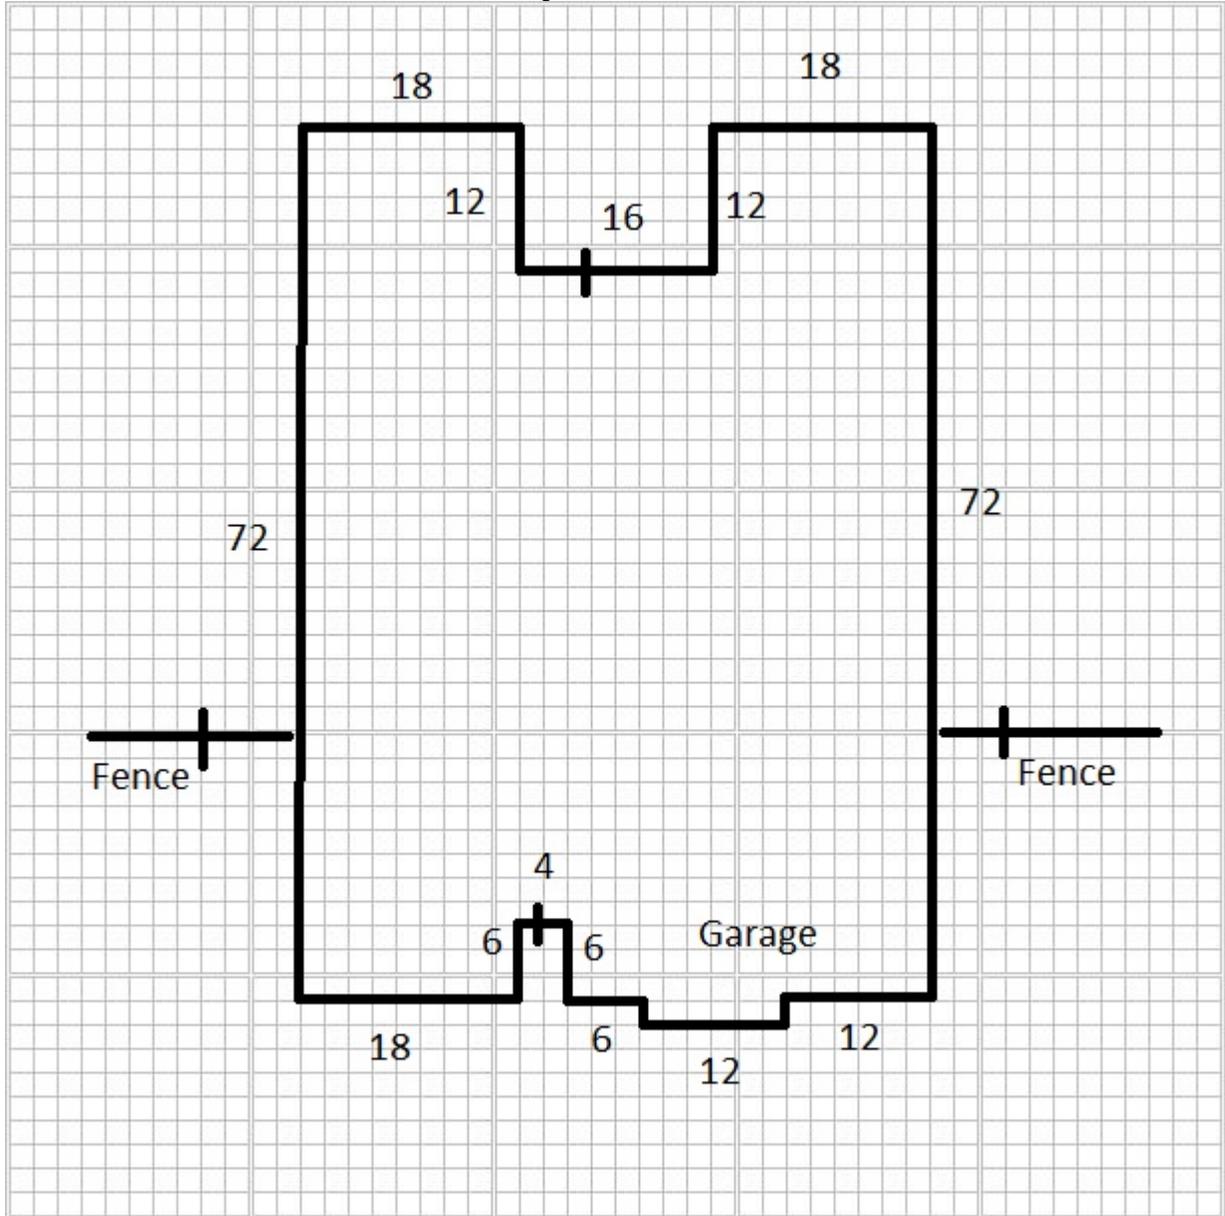
Additional Comments There is no visible evidence of active wood destroying insects found at the time of this inspection.
